EXECUTIVE SUMMARY

Significant particulate buildup is present throughout the lower inlet manifold of Coater 2 RTO, including heavy ash piles on the manifold floor, coating on divider walls, and fouling at the inspection hatch face. Media support baffles and main valve sealing surfaces were inspected post-cleaning and are in serviceable condition with no warping, scoring, or seal ring degradation observed. Primary next step is to remove the accumulated material from the inlet manifold and confirm root cause before flow distribution to the media beds is compromised.

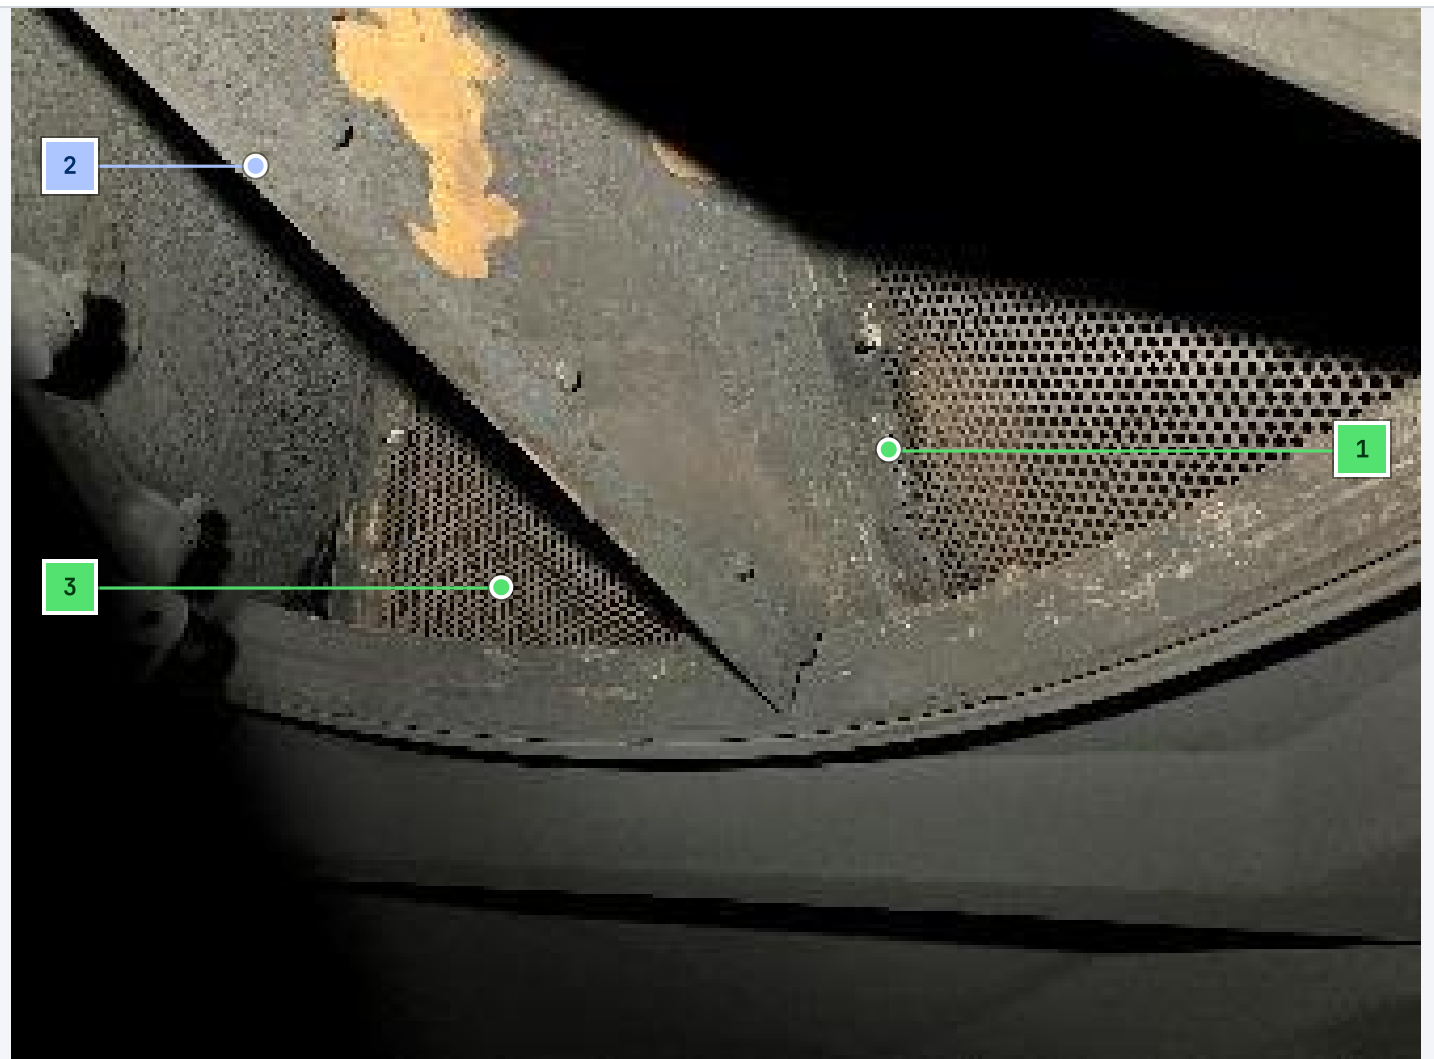
01 Cleaned screen

- 1 Clean Perforated Screen**
Support screen perforations clear post-cleaning
- 2 Residual Deposit**
Yellow residue on baffle plate surface
- 3 Baffle Plate Edge**
Plate seating against housing intact

Perforated support screen under the baffle plate is clear and unobstructed following cleaning, and the plate-to-housing seat is intact. A yellow process residue remains on the baffle plate surface but does not affect flow area.

Wipe down residual process deposit from the baffle plate surface at next entry. No structural action required.

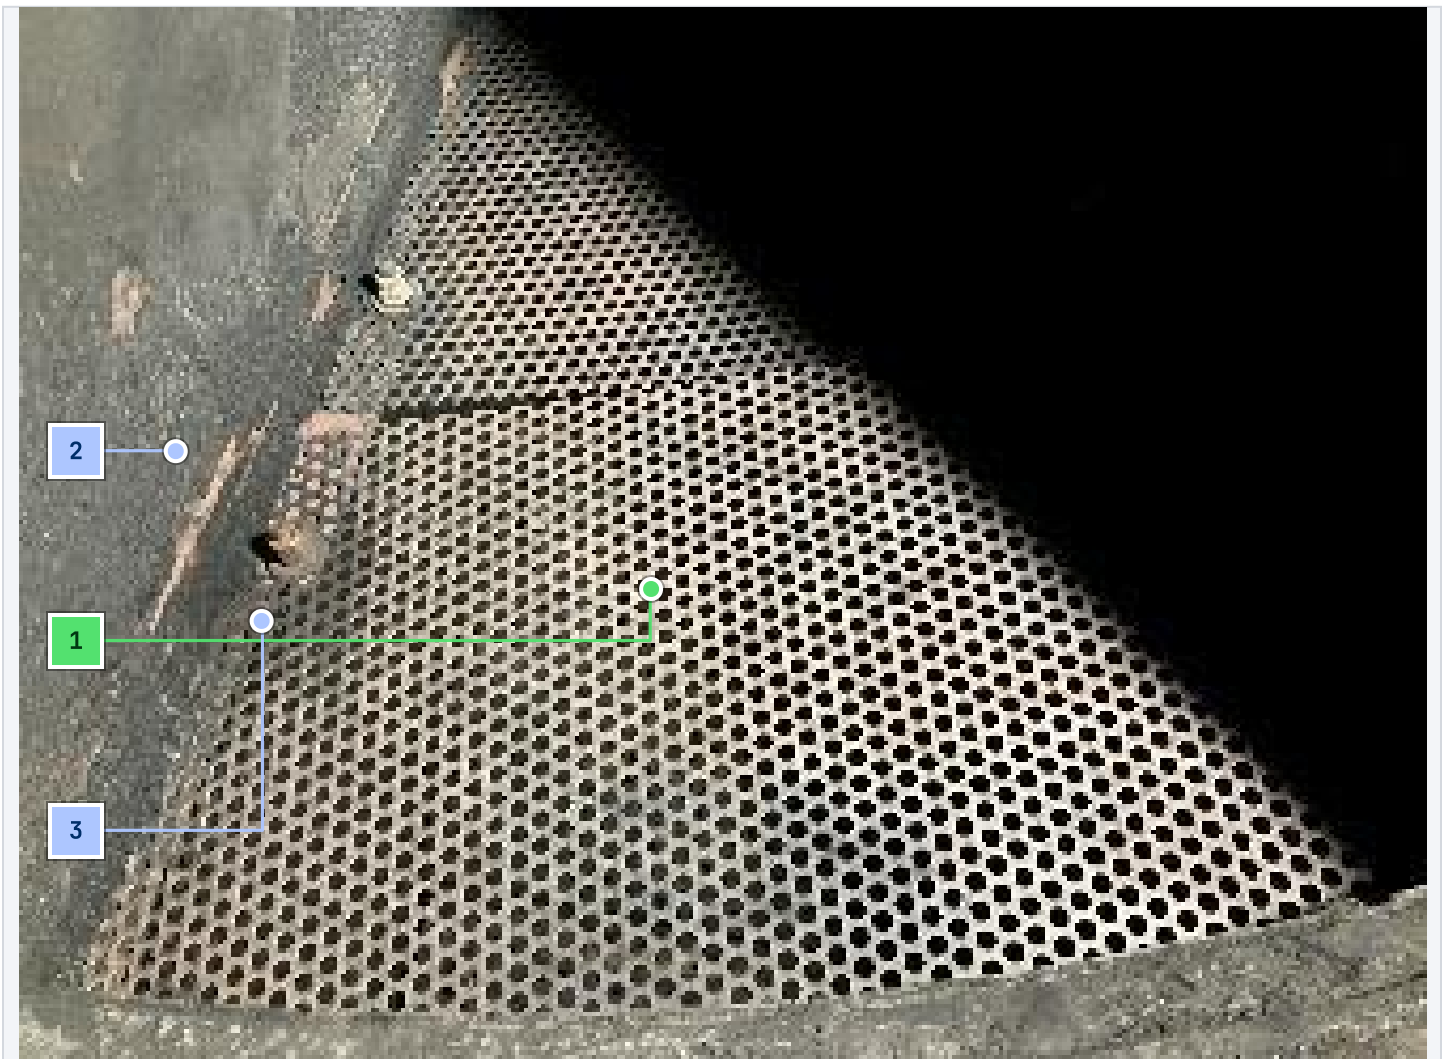
02 Cleaned screen

- 1 Perforated Screen Surface**
Perforations clear and unobstructed post-cleaning
- 2 Edge Frame Condition**
Residual buildup along screen frame edge
- 3 Mounting Hardware**
Fastener seated at screen perimeter

Perforated screen face is fully open post-cleaning with fastener seated correctly at the perimeter. Light residual buildup remains along the frame edge but does not obstruct perforations.

Brush the frame edge during the next cleaning cycle to prevent edge buildup from migrating across the screen.

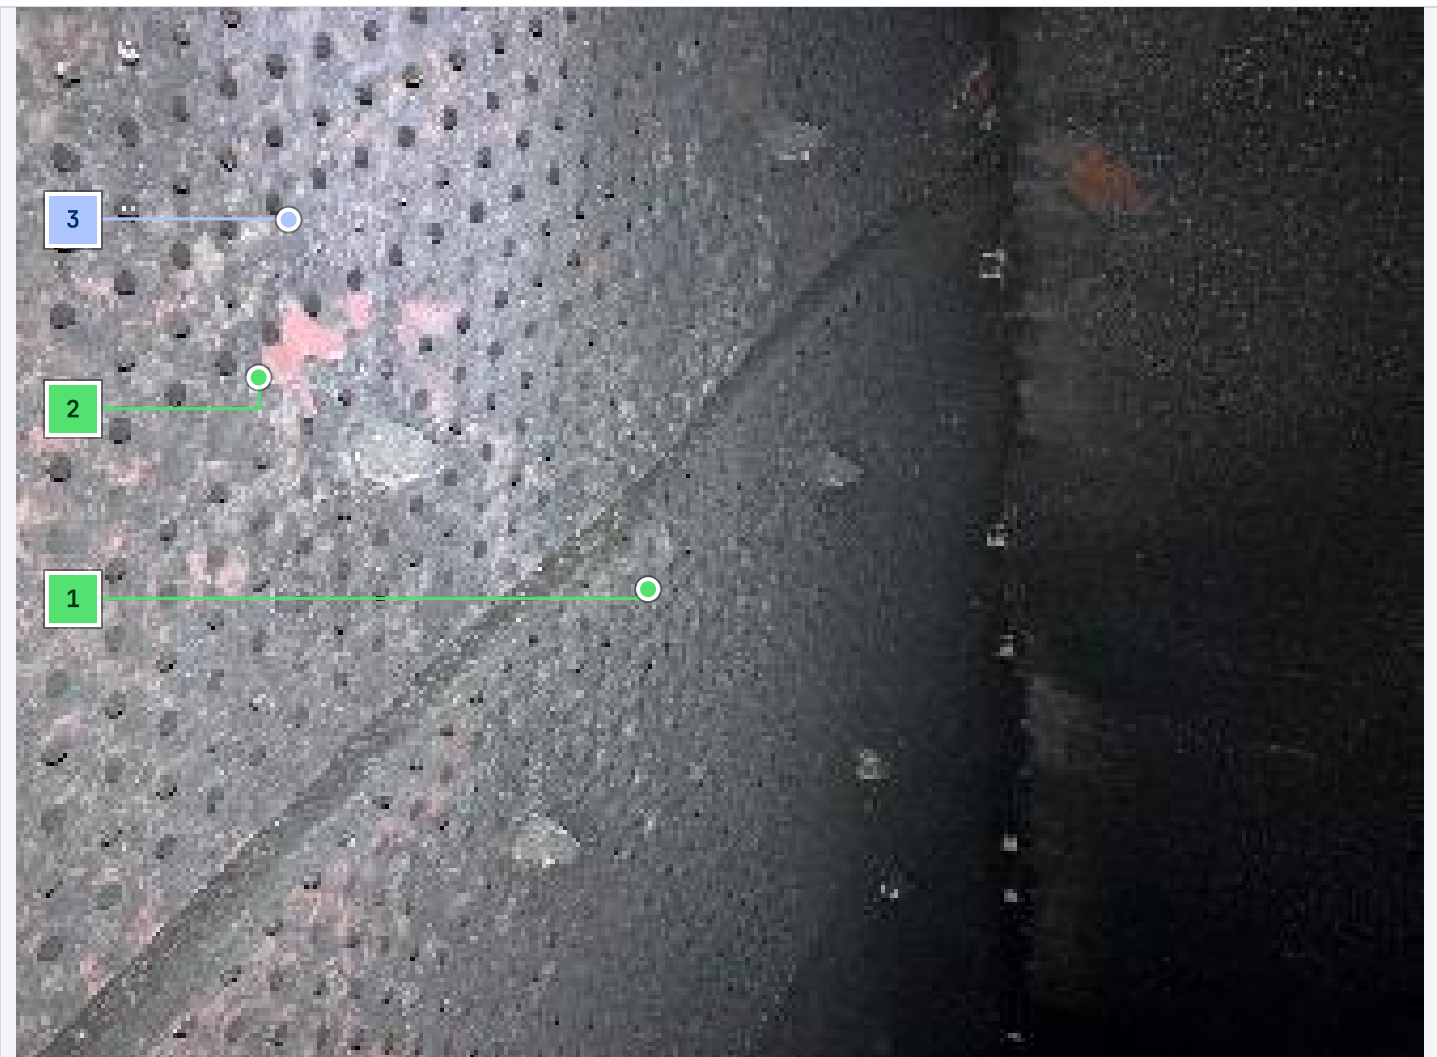
03 Baffle plates at media support

Diagonal seam between baffle plates, intact

Perforations clear after screen cleaning

Light pink residue on baffle surface

Diagonal seam between baffle plates is sound and the perforated support plate is clear after screen cleaning. Light pink residue on the baffle surface is cosmetic and consistent with process carryover.

No action required beyond routine cleaning at the next planned outage.

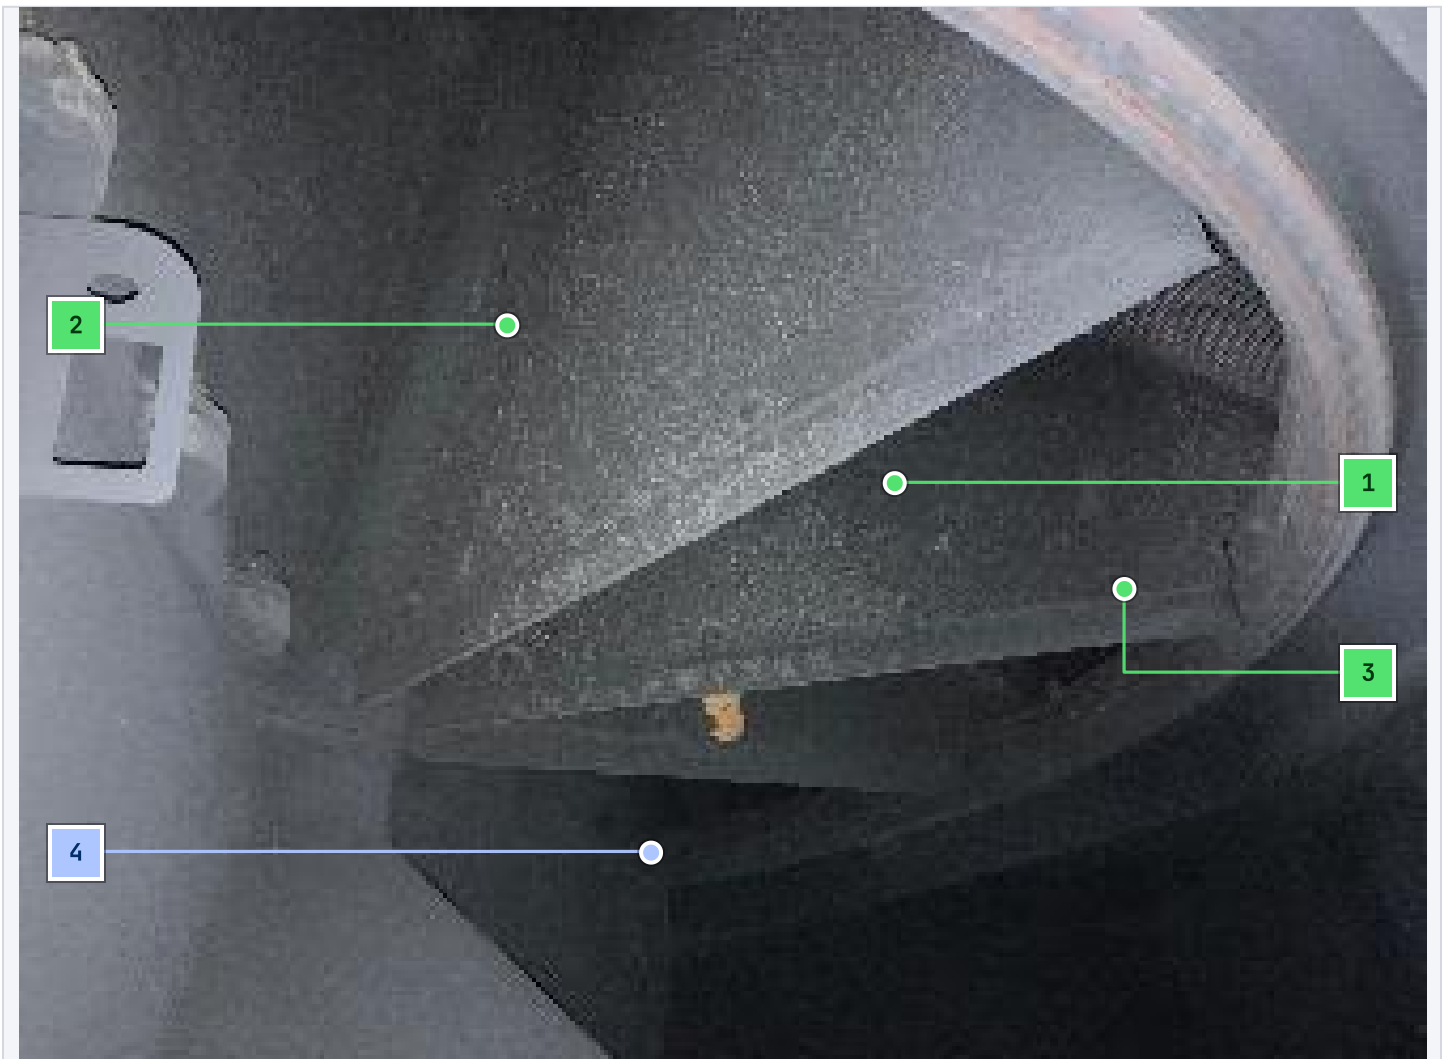
04 Inlet baffle, Valve face, Main valve seal ring, inlet

- 1 Main Valve Seal Ring**
Seal ring seated uniformly along valve face
- 2 Inlet Baffle**
Baffle plate intact, no warping visible
- 3 Valve Face**
Sealing surface clean, no scoring observed
- 4 Inlet Floor**
Minor debris accumulation at inlet base

Main valve seal ring is seated uniformly against the valve face, with no scoring of the sealing surface and no warping of the inlet baffle. Minor debris at the inlet floor is housekeeping-level only.

Clear debris from the inlet floor during next entry and continue periodic seal ring inspection.

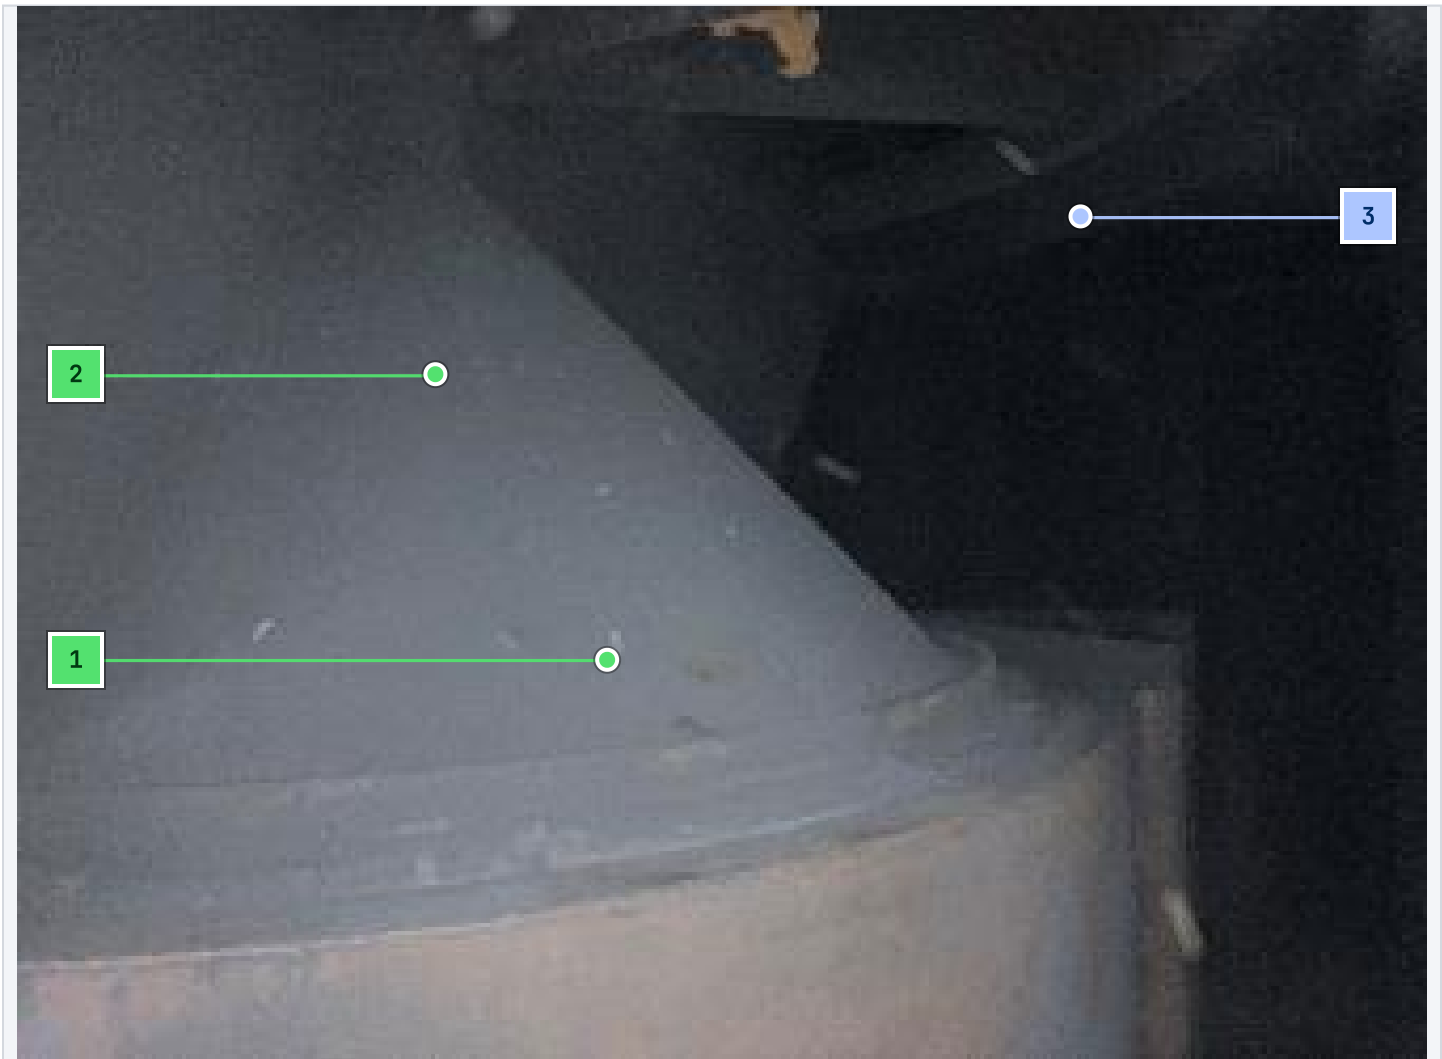
05 Inlet baffle / Valve face / Main valve seal ring / inlet

- 1 Main Valve Seal Ring**
Seal ring interface appears intact, continuous
- 2 Inlet Baffle Cone**
Conical baffle surface clean, no distortion
- 3 Valve Face**
Valve face edge visible, no warping

Conical inlet baffle surface is clean and undistorted, and the seal ring interface against the valve face appears continuous. Valve face edge shows no warping at the visible sector.

No action required. Reconfirm seal ring continuity at next scheduled valve service.

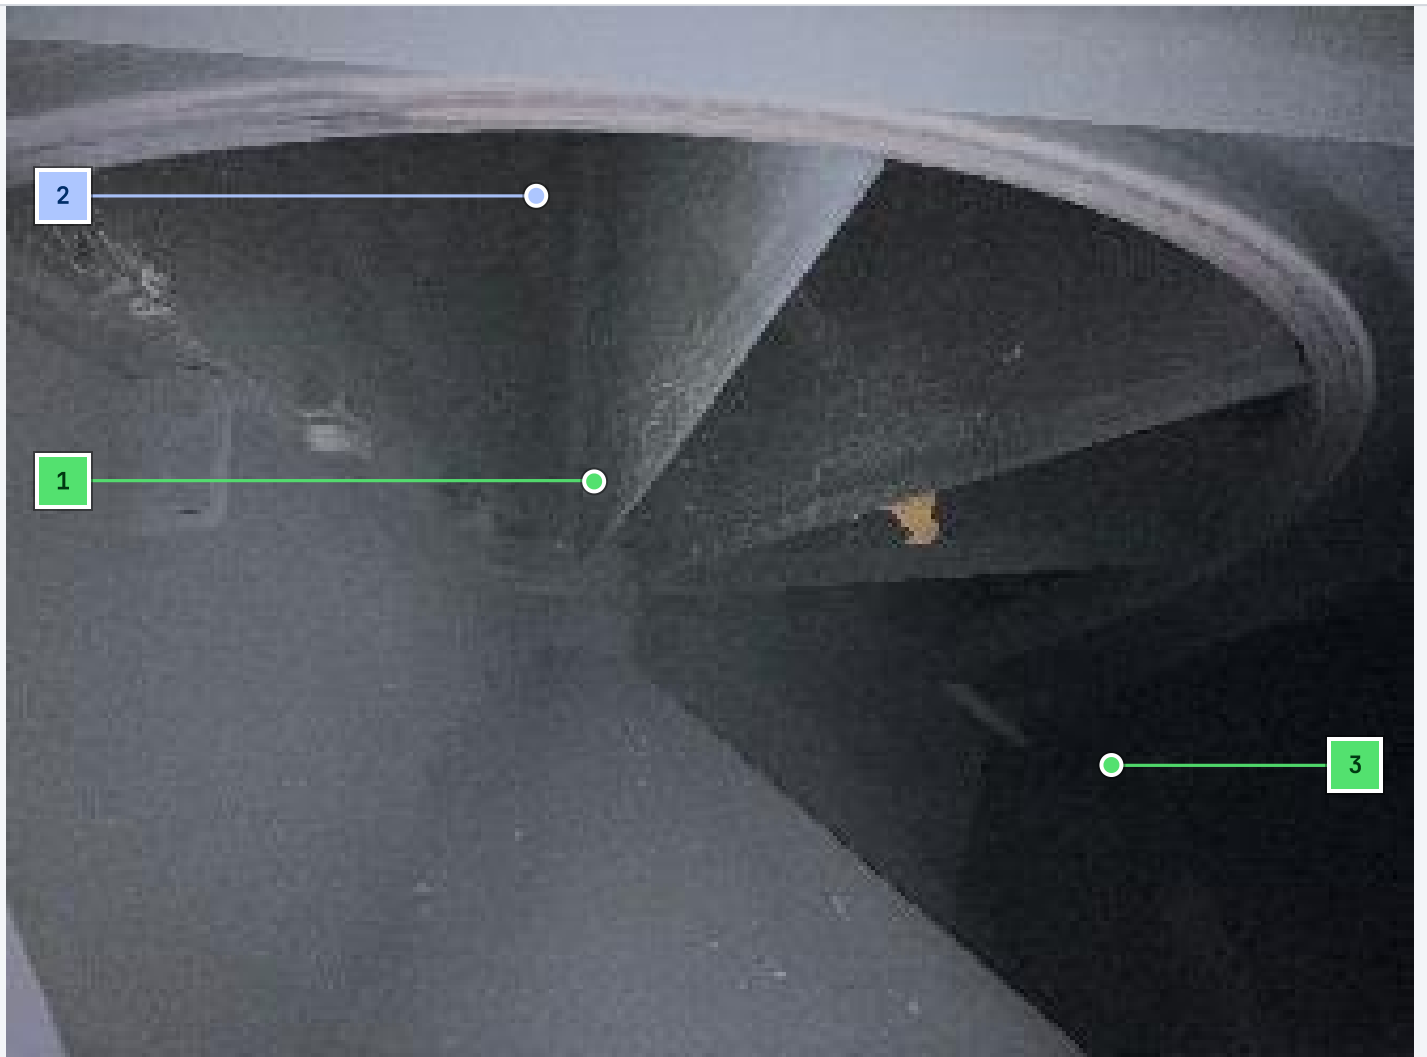
06 Untitled finding

Seal ring intact along valve face perimeter

Baffle edge shows light particulate accumulation

Valve face surface clean, no warping visible

Seal ring tracks intact along the full visible perimeter of the valve face and the valve face sector itself shows no warping. Light particulate accumulation is present on the inlet baffle edge.

Remove particulate from the baffle edge during routine cleaning; no repair needed.

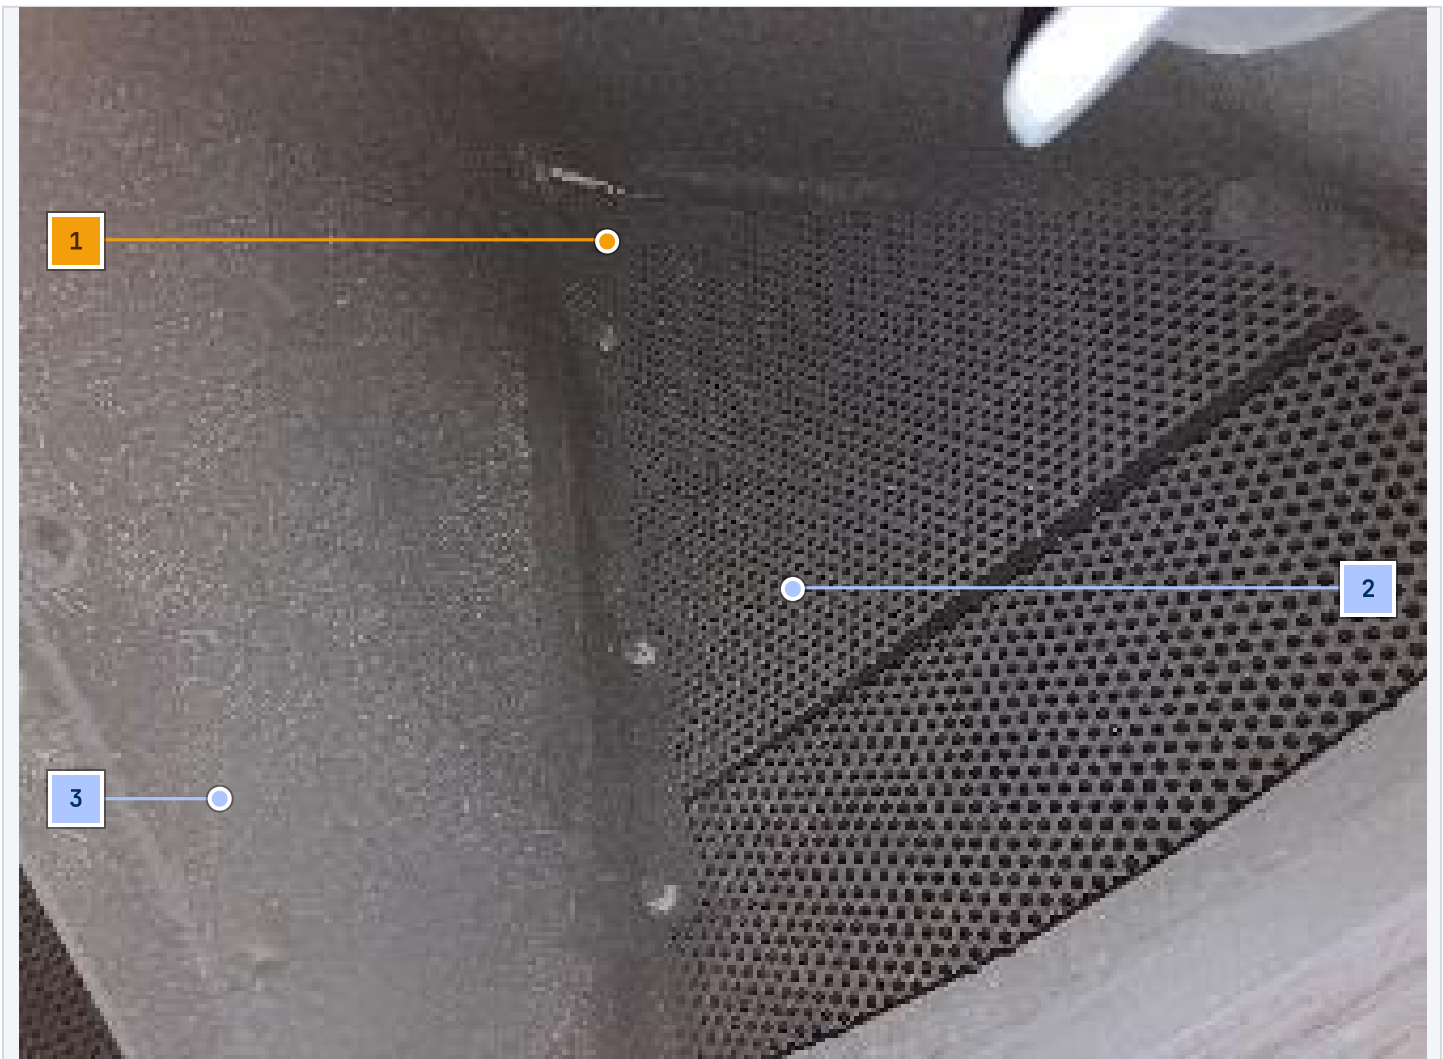
07 Build up in manifold

- 1** **Manifold Build-Up**
Particulate accumulation along perforated plate edge
- 2** **Perforated Distributor**
Flow distribution grid, holes still open
- 3** **Manifold Floor Deposits**
Dust layer settled on manifold wall

Particulate accumulation is building along the perforated distributor plate edge inside the manifold. Distributor holes remain open at this time, but the deposit layer on the manifold wall indicates active fouling.

Vacuum the manifold and clear the perforated distributor edge before holes begin to blind off and distort flow distribution.

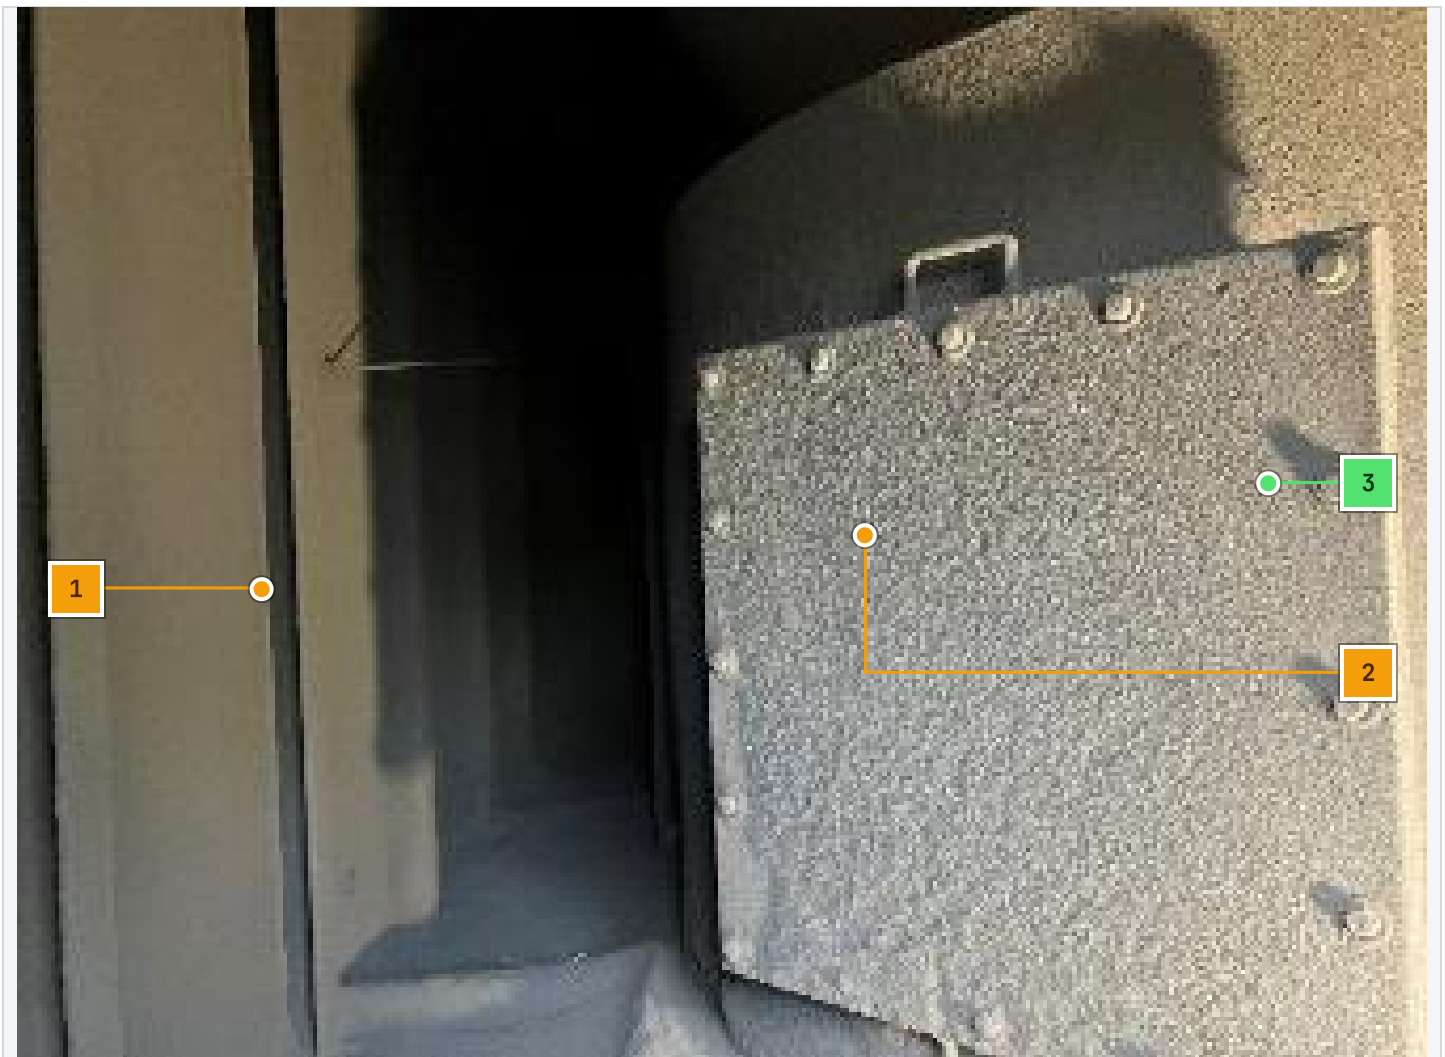
08 Build up in manifold

Particulate accumulation coating interior manifold surface

Heavy deposit layer on inspection door face

Hatch fasteners intact, no visible leakage

Interior manifold surfaces are coated with particulate, and the inside face of the inspection hatch carries a heavy deposit layer. Hatch fasteners and flange seal are intact with no evidence of external leakage.

Clean the hatch face and manifold walls; inspect the hatch gasket during reassembly and replace if deposits have impressed into the sealing surface.

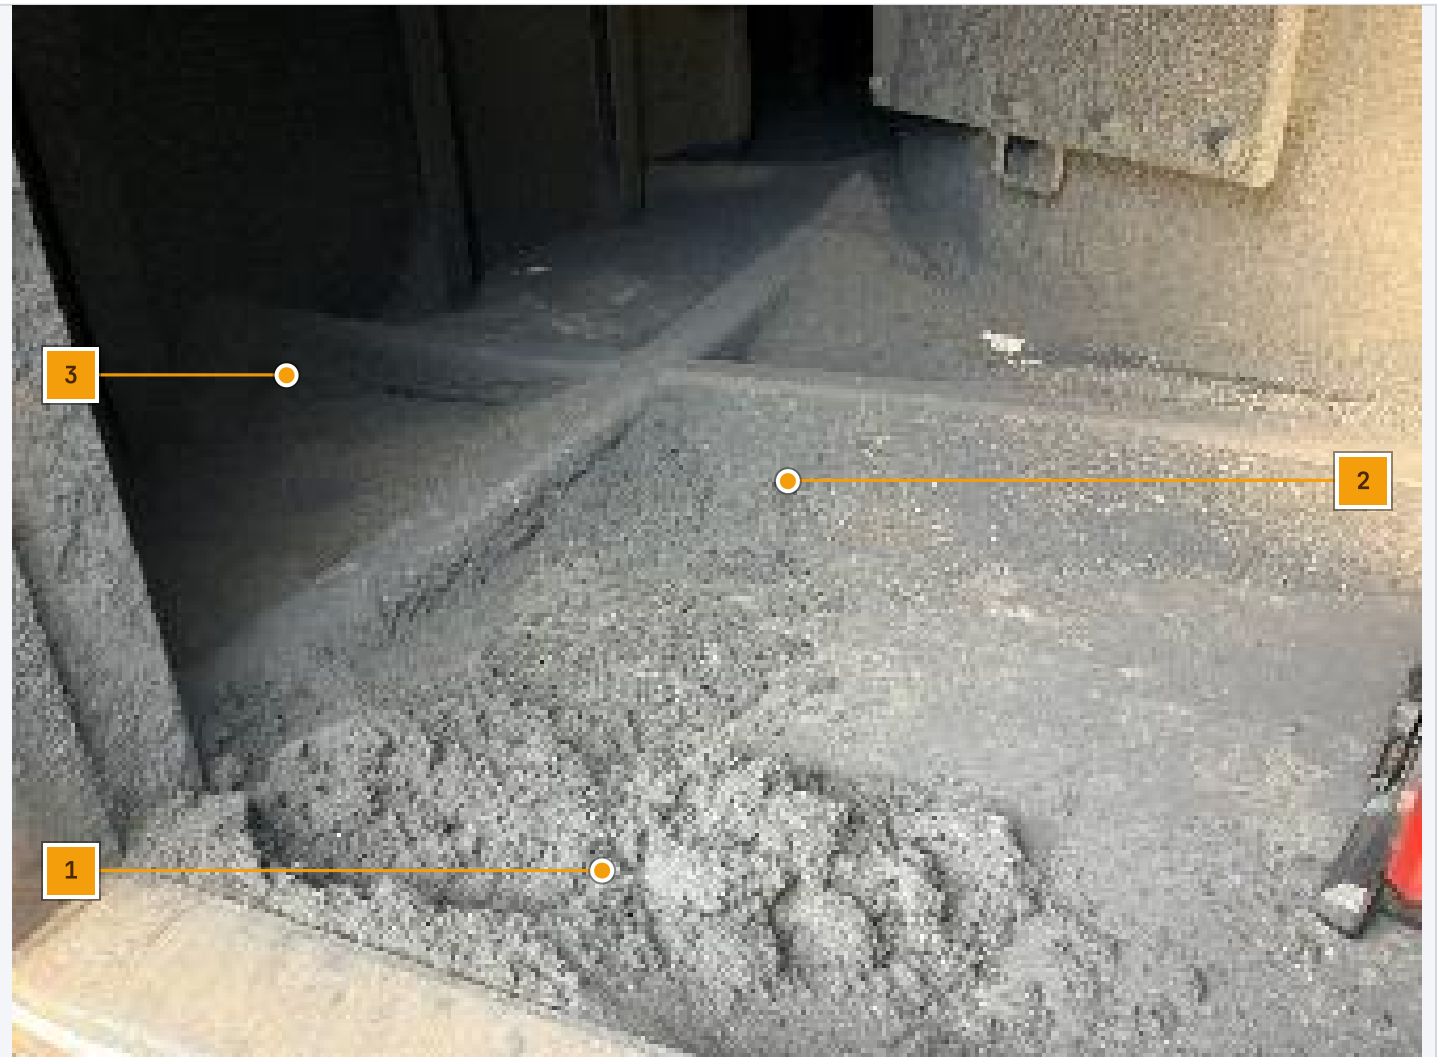
09 Build up in manifold

- 1 Heavy Particulate Pile**
Significant ash accumulation on manifold floor
- 2 Coating On Divider**
Dust layer coating manifold divider walls
- 3 Inlet Duct Buildup**
Buildup obstructing inlet flow path

Significant ash pile has accumulated on the manifold floor, with coating on the divider walls and buildup encroaching on the inlet duct flow path. This level of accumulation will begin to restrict cross-section and skew distribution to the media beds if left.

Remove accumulated ash from the manifold floor and inlet duct immediately, and identify the upstream source driving the loading rate.

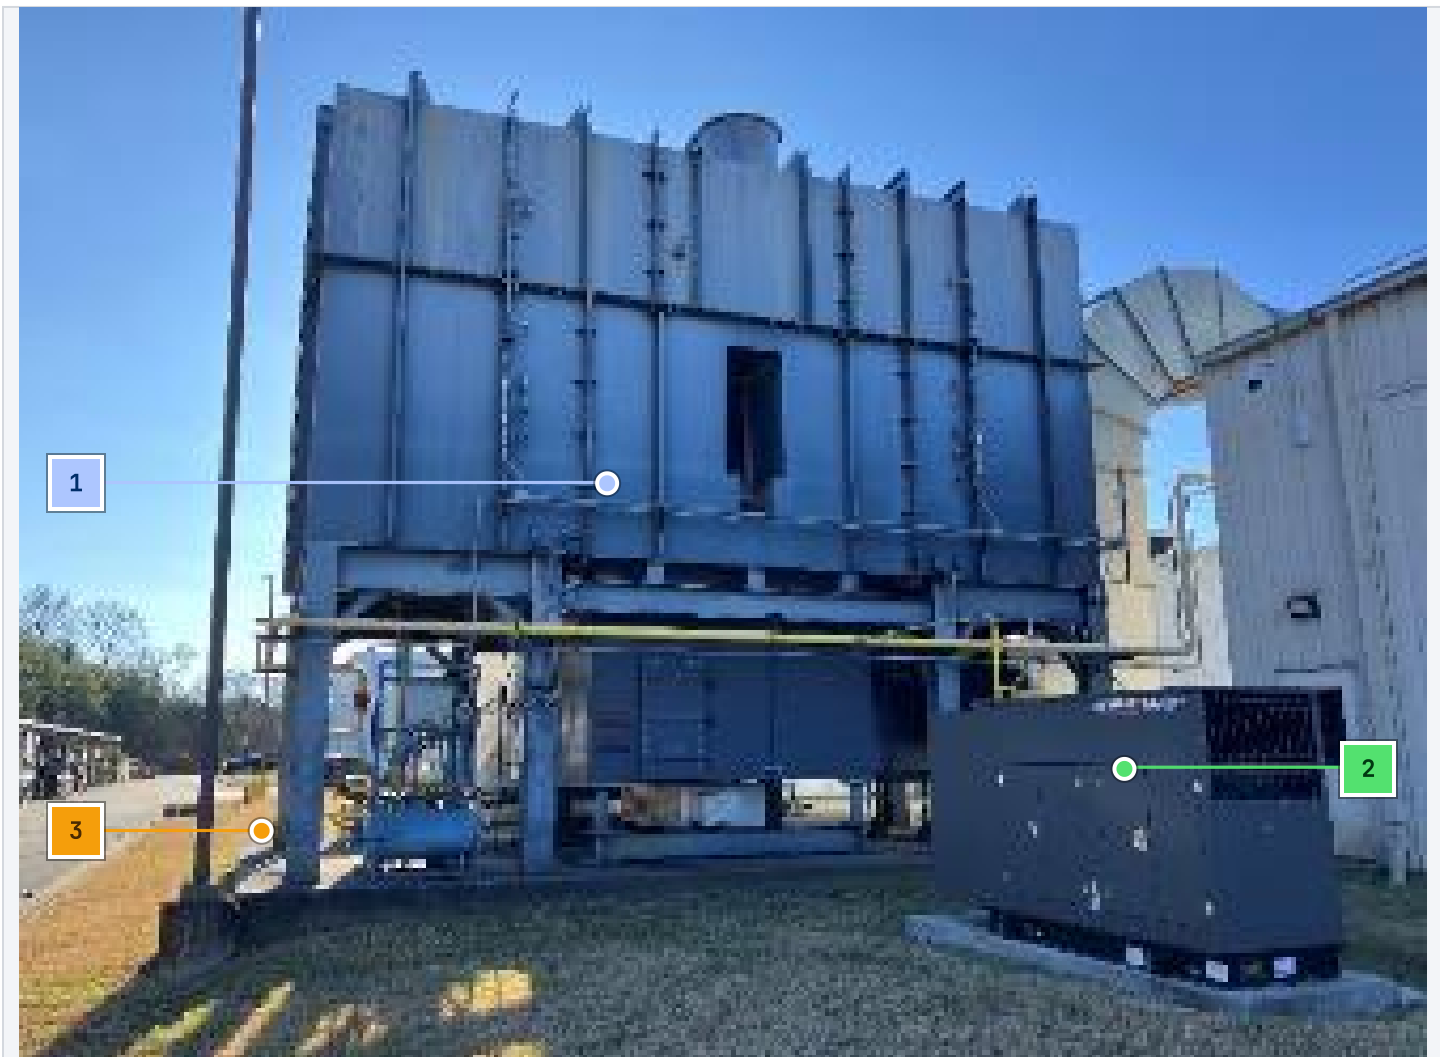
10 RTO overall

Regenerative thermal oxidizer housing, exterior intact

Control or blower cabinet, externally sound

Lower manifold area noted for buildup

Overall exterior of the RTO main vessel and auxiliary enclosure is sound with no external defects observed. Findings of concern are concentrated in the lower base piping manifold area as documented in the preceding photos.

Address lower manifold buildup as the priority work scope; no external vessel action required.
