EXECUTIVE SUMMARY

Two WARNING-level conditions were identified inside VOC Abatement Unit B: protective coating delamination on the inlet baffle exposing bare substrate, and wear streaks with debris on the rotary valve sealing face at the exhaust manifold. Media support screens on both sides clean up well with only cosmetic residual staining, and the main valve seal ring, valve face, and perforated screens are intact. External stack and gas train hardware are sound aside from minor weld-seam oxidation. Schedule coating repair on the inlet baffle and a rotary valve seal face inspection at the next planned outage before fouling and bypass leakage progress.

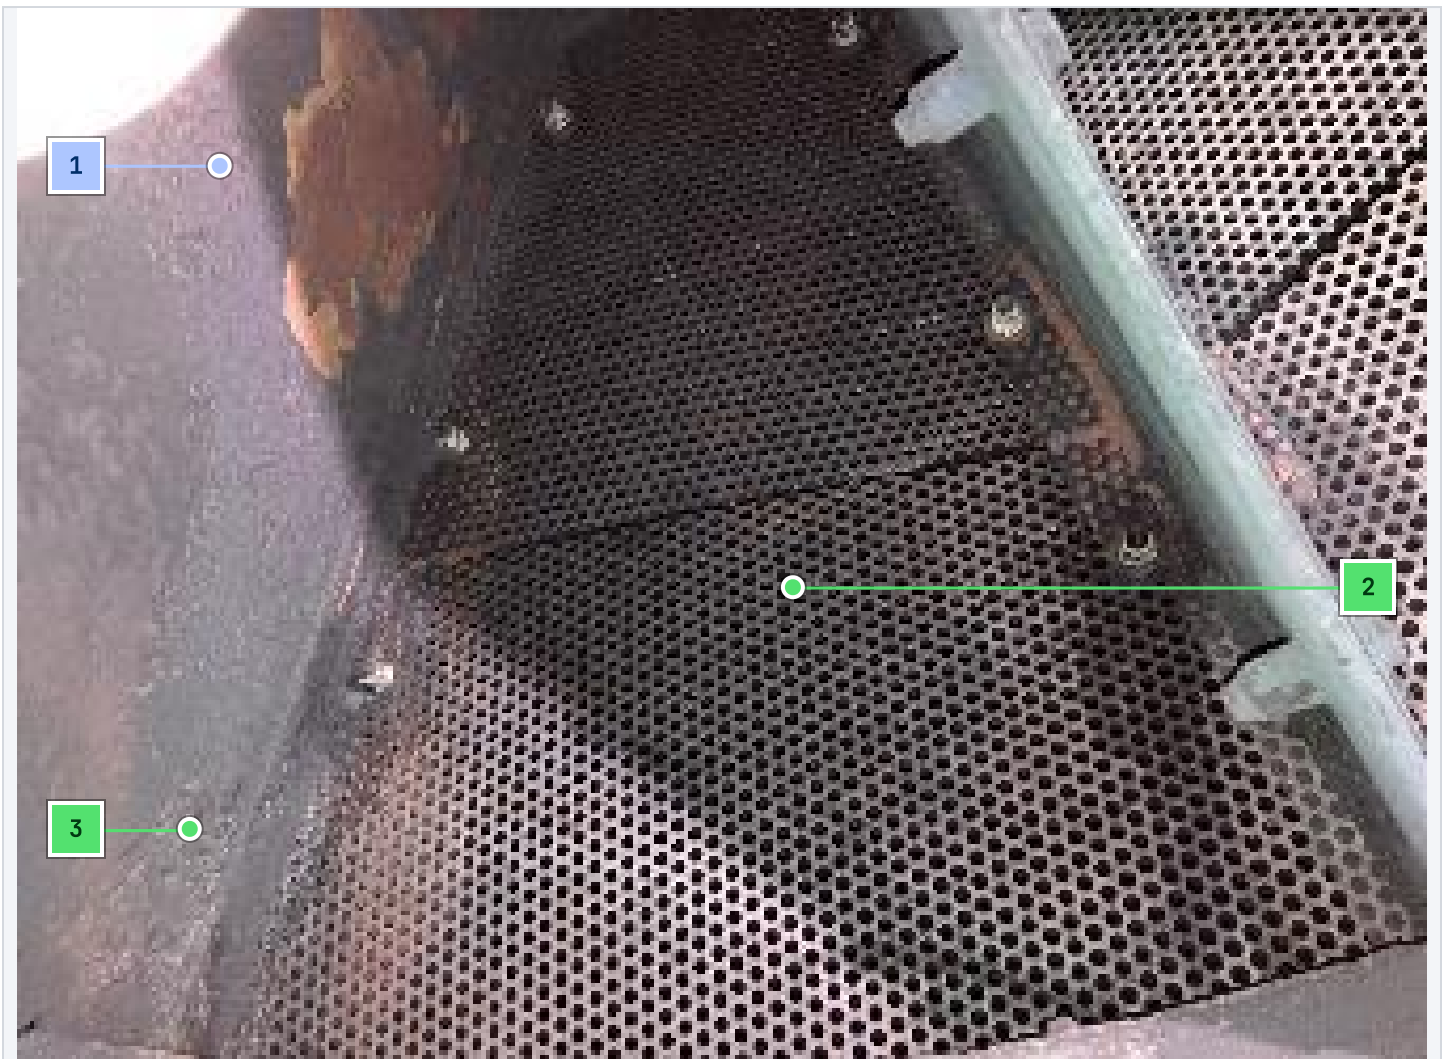
01 Cleaned screen

1 Residual Deposit

Reddish-brown residue remaining on upper wall

2 Clean Perforated Screen

Perforations clear and unobstructed after cleaning

3 Mounting Hardware

Edge fasteners intact, screen seated properly

Media support screen perforations are fully open after cleaning and edge fasteners remain seated. Reddish-brown residue persists on the upper refractory wall above the screen, indicating the wash did not fully reach that surface. No structural concerns on the screen itself.

Re-clean upper chamber walls to remove residual reddish-brown and pink staining for baseline.

Re-clean the upper wall during the next entry to remove residual deposit and establish a clean baseline.

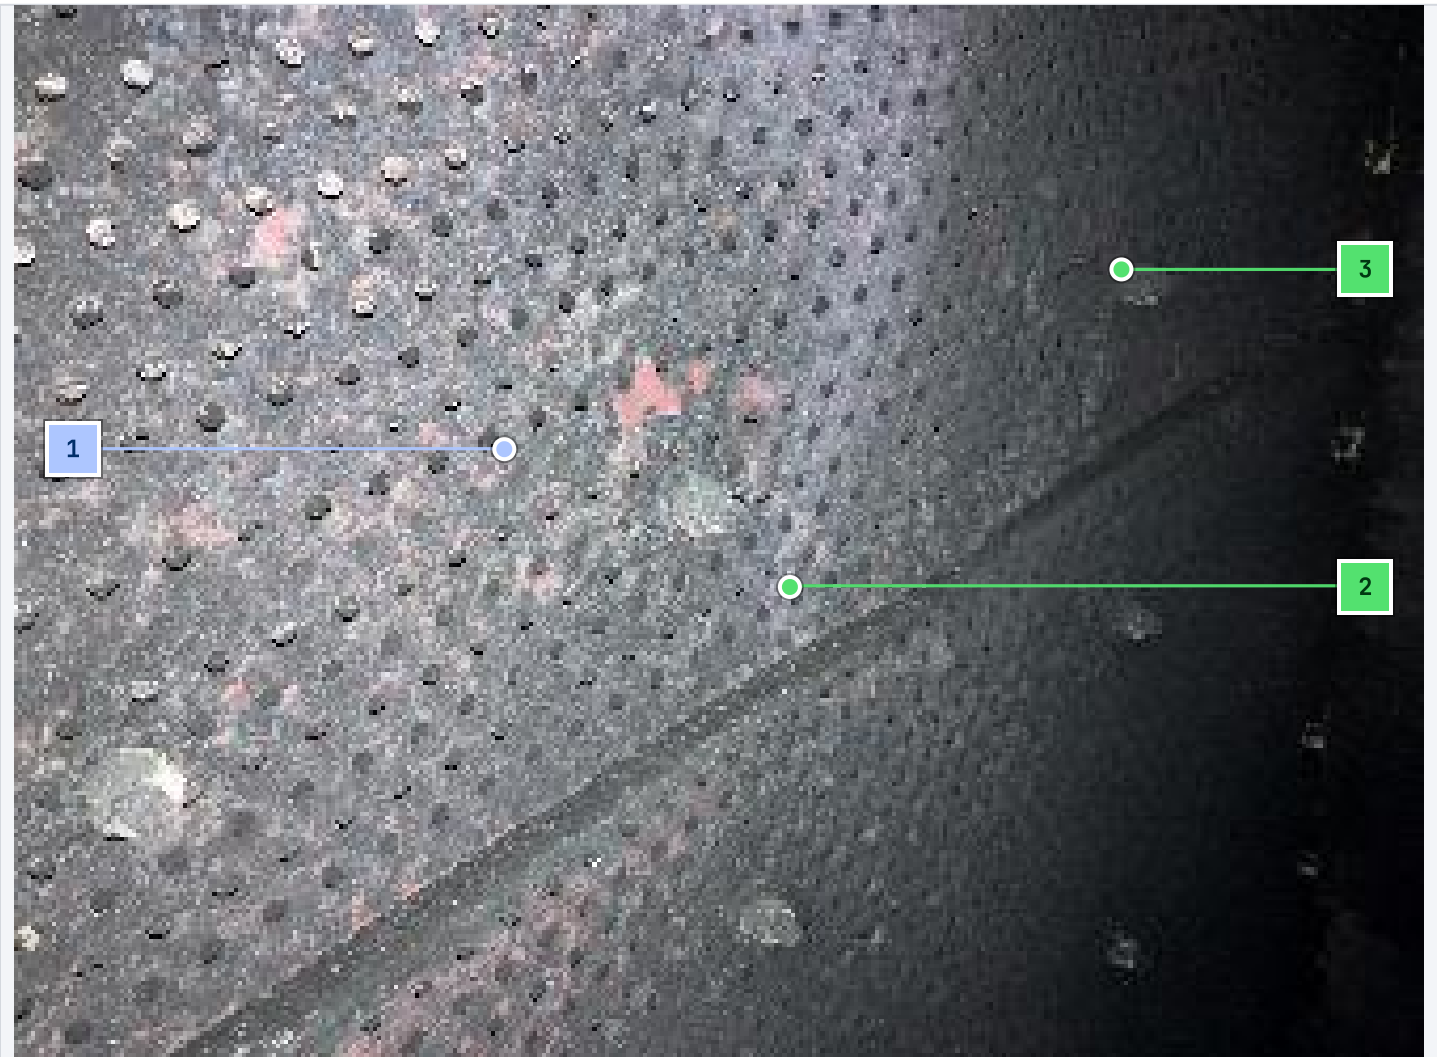
02 Cleaned screen

- 1 Residual Discoloration**
Pink residue staining remains after cleaning
- 2 Support Seam**
Welded seam between screen panels intact
- 3 Perforation Pattern**
Perforations clear and unobstructed post-clean

Welded panel seam and perforation pattern are intact and unobstructed. Pink staining remains across the screen face — cosmetic, consistent with process residue not removed by the wash. No blinding observed.

No action required; note staining as baseline and monitor for any increase in coverage at the next inspection.

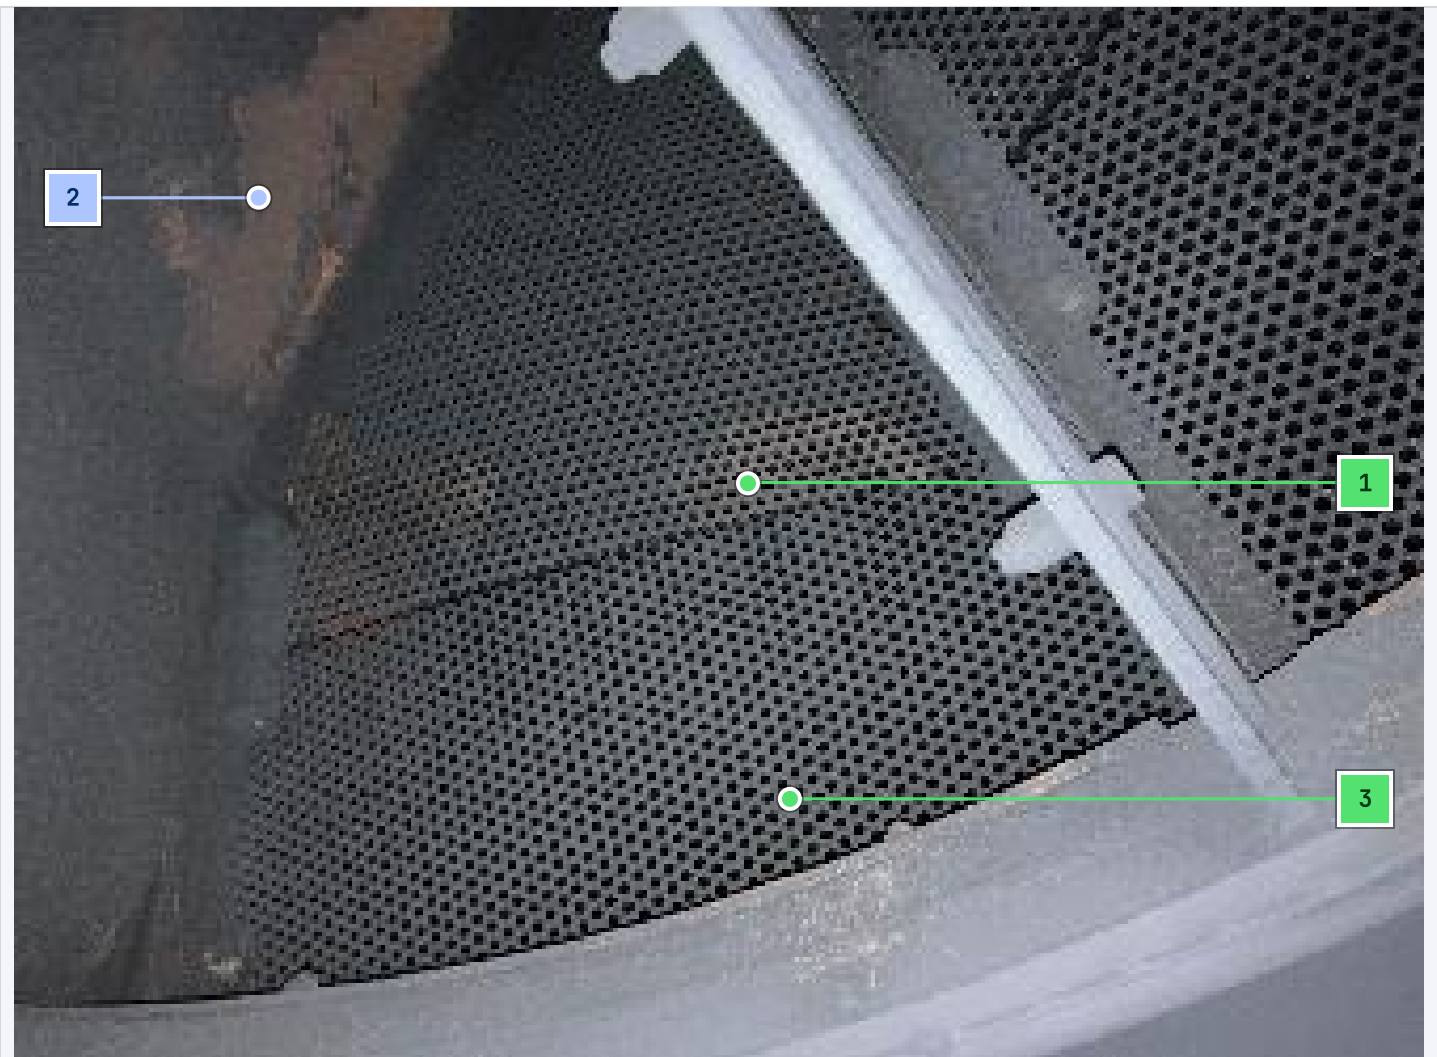
03 Inlet baffle, Valve face, Main valve seal ring, inlet

1 Main Valve Seal Ring

Seal ring intact along valve face edge

2 Inlet Baffle

Baffle surface shows minor surface discoloration

3 Valve Face Perforations

Perforated face clean, no fouling or blockage

Main valve seal ring is continuous along the valve face edge and the perforated valve face is clean with no fouling. Inlet baffle shows minor surface discoloration only, no metal loss visible from this angle.

No action required; confirm baffle coating condition against Photo 4 close-up before closing the inspection.

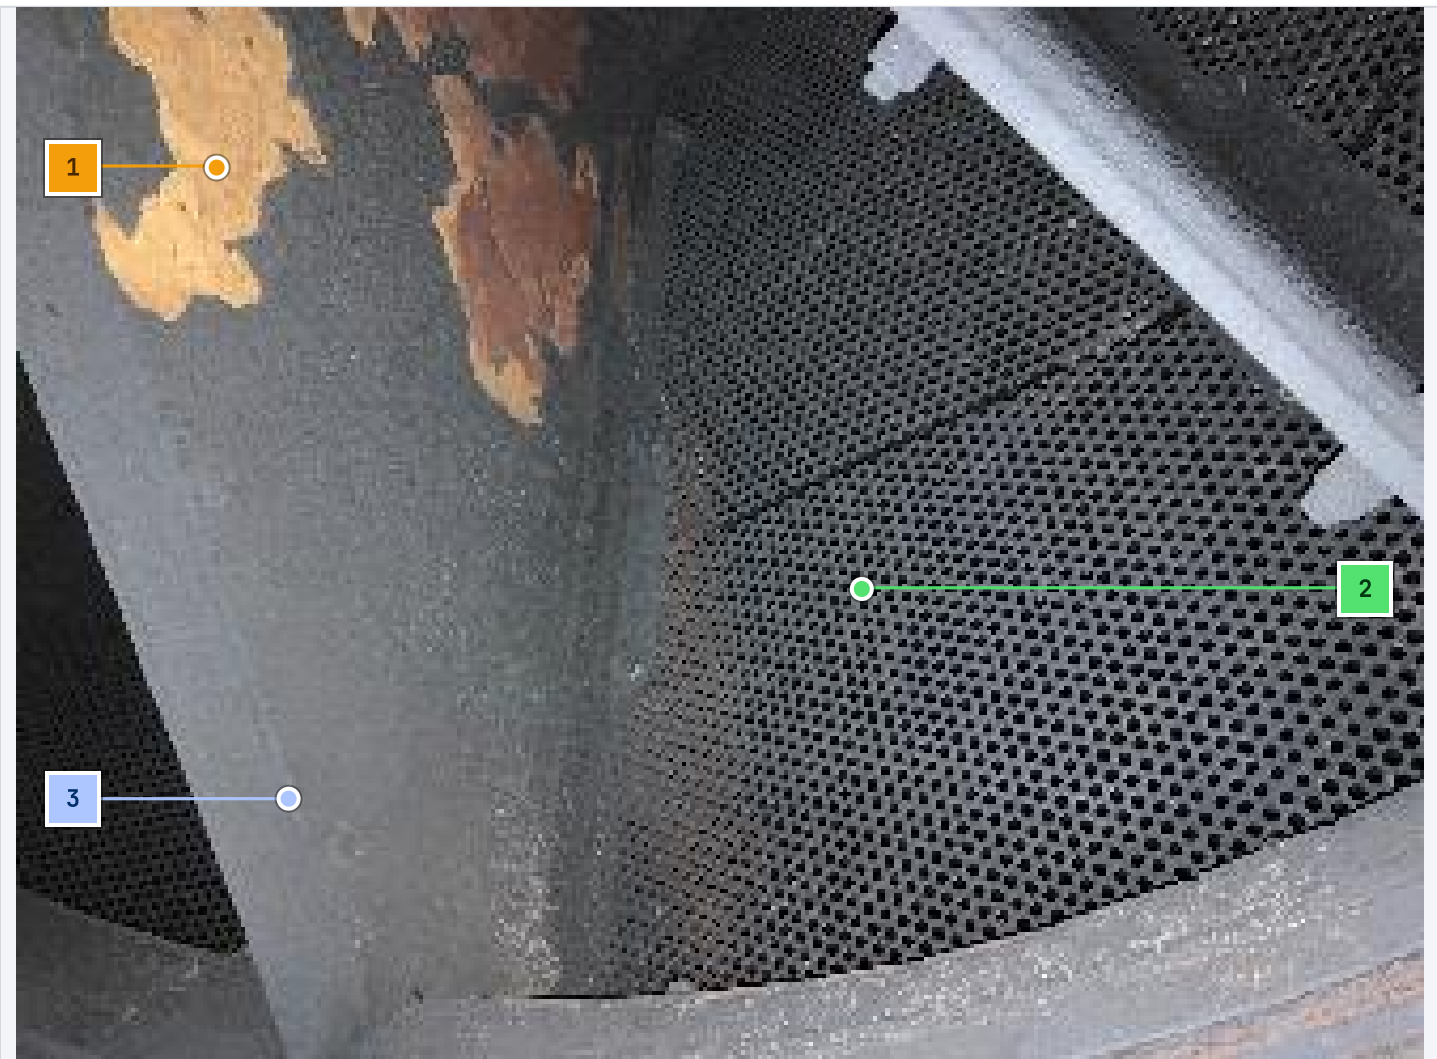
04 Inlet baffle

- 1 Coating Delamination**
Protective coating peeling, exposing substrate to corrosion
- 2 Perforated Baffle Screen**
Perforated baffle plate intact, holes unobstructed
- 3 Baffle-to-Wall Seam**
Joint between baffle and vessel wall, inspect seal

Close-up of the inlet baffle shows protective coating peeling away in sheets, exposing the underlying substrate to the inlet gas stream. The perforated plate itself is intact and unobstructed, but bare substrate will corrode rapidly under VOC-laden inlet conditions. The baffle-to-wall seam should be confirmed sealed while access is open.

Strip and recoat inlet baffle; address exposed substrate before corrosion undercuts adjacent coating.

Verify baffle-to-vessel wall seam integrity and reseal if gaps are confirmed.

Strip loose coating, prep the substrate, and recoat the baffle during the next planned outage. Verify and reseal the baffle-to-wall joint in the same work order.

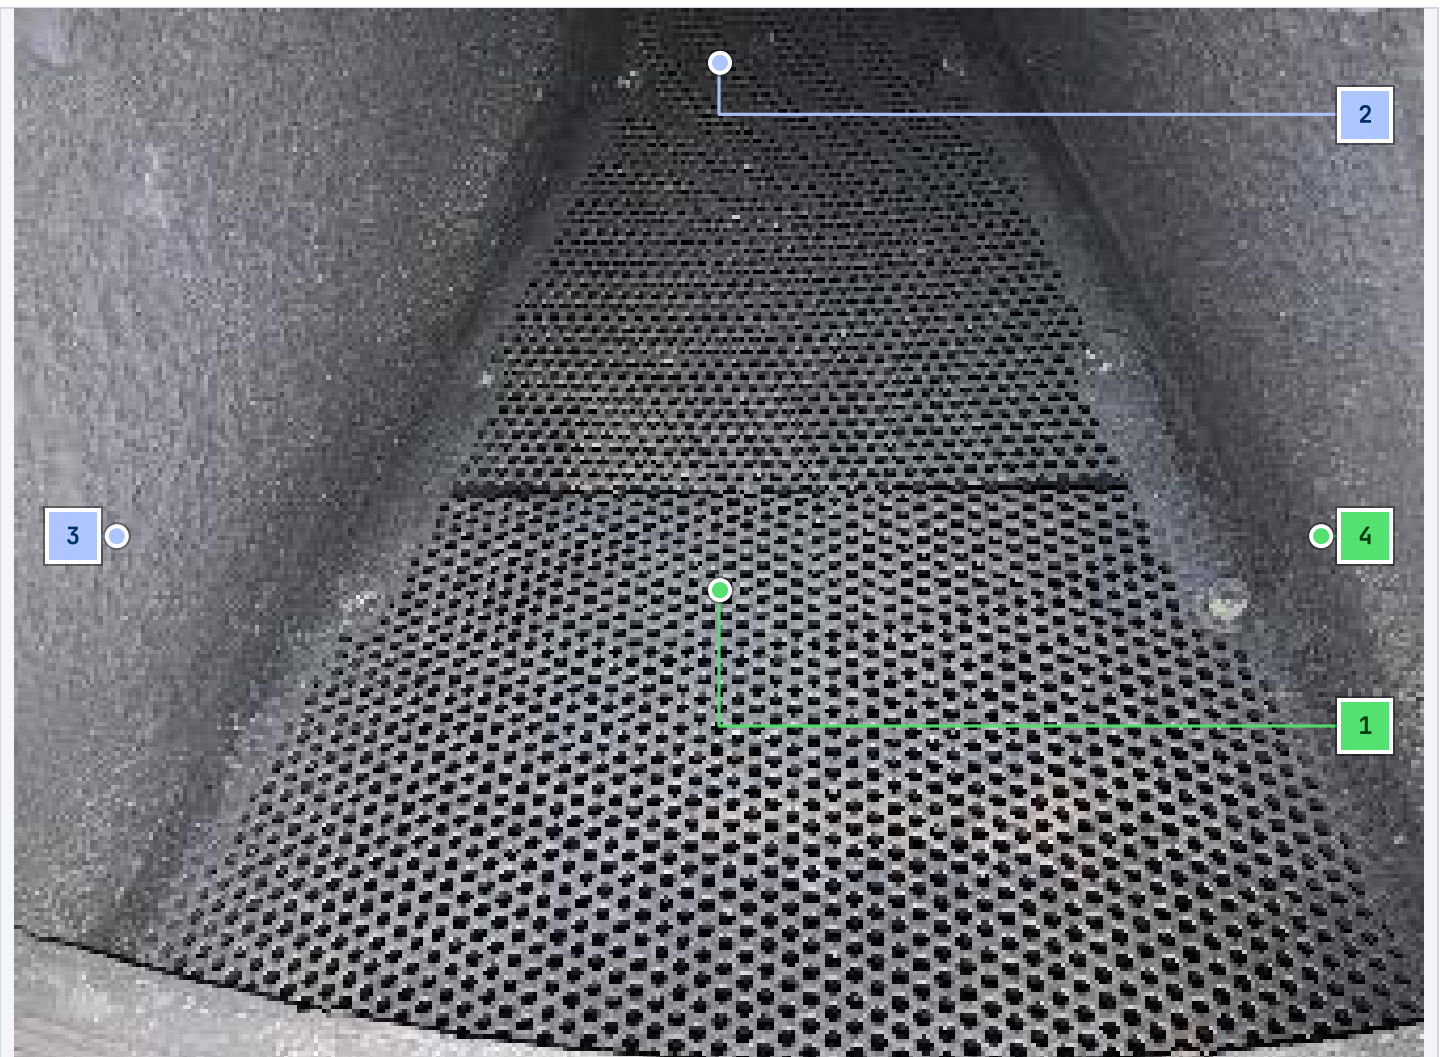
05 Untitled finding

- 1 Perforated Valve Face**
Perforated valve face plate, uniform hole pattern intact
- 2 Inlet Baffle Edge**
Inlet baffle leading edge above valve face
- 3 Main Seal Ring**
Main valve seal ring along chamber wall
- 4 Opposing Seal Ring**
Opposing seal ring surface, no visible wear

Reference view confirms uniform perforation pattern on the valve face and intact seal rings on both opposing surfaces. Inlet baffle leading edge is visible above the valve face with no displacement. Use this image as the orientation reference for the findings in Photos 3 and 4.

No action; retain as reference image for next walkdown comparison.

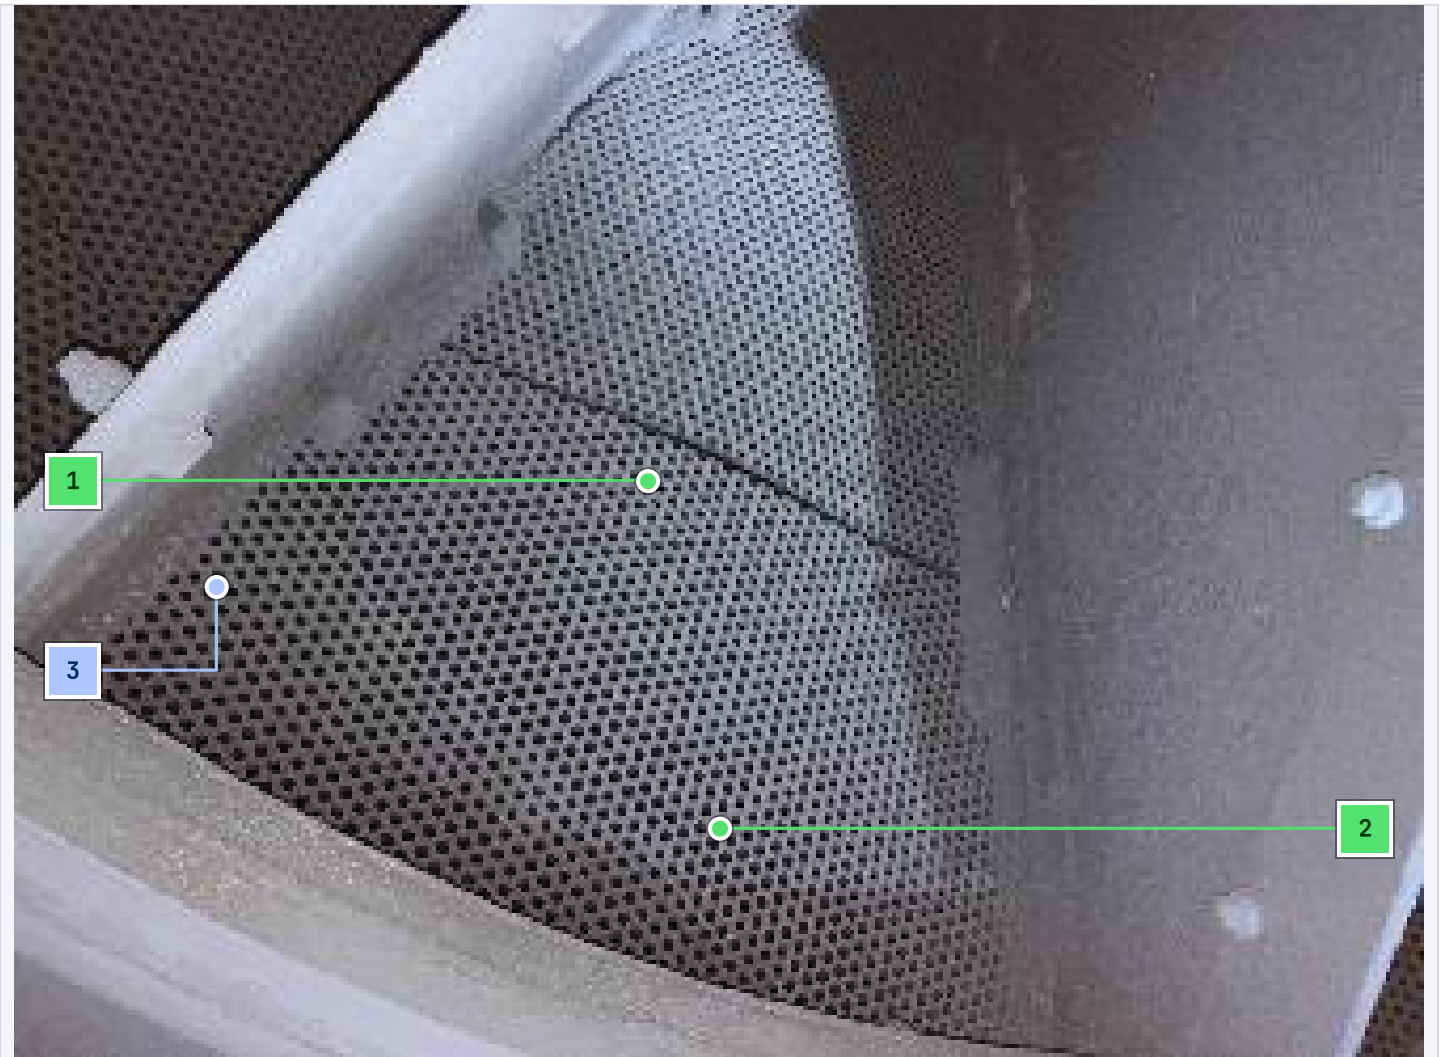
06 B side screens

- 1 Perforated Screen Surface**
Uniform perforation pattern, no blinding observed
- 2 Lower Screen Seam**
Seam intact, no debris accumulation visible
- 3 Side Frame Edge**
Frame-to-screen interface clean and aligned

B-side media support screens show uniform perforation with no blinding, intact lower seam, and clean frame-to-screen interface. No debris accumulation observed.

No action required; continue routine DP monitoring.

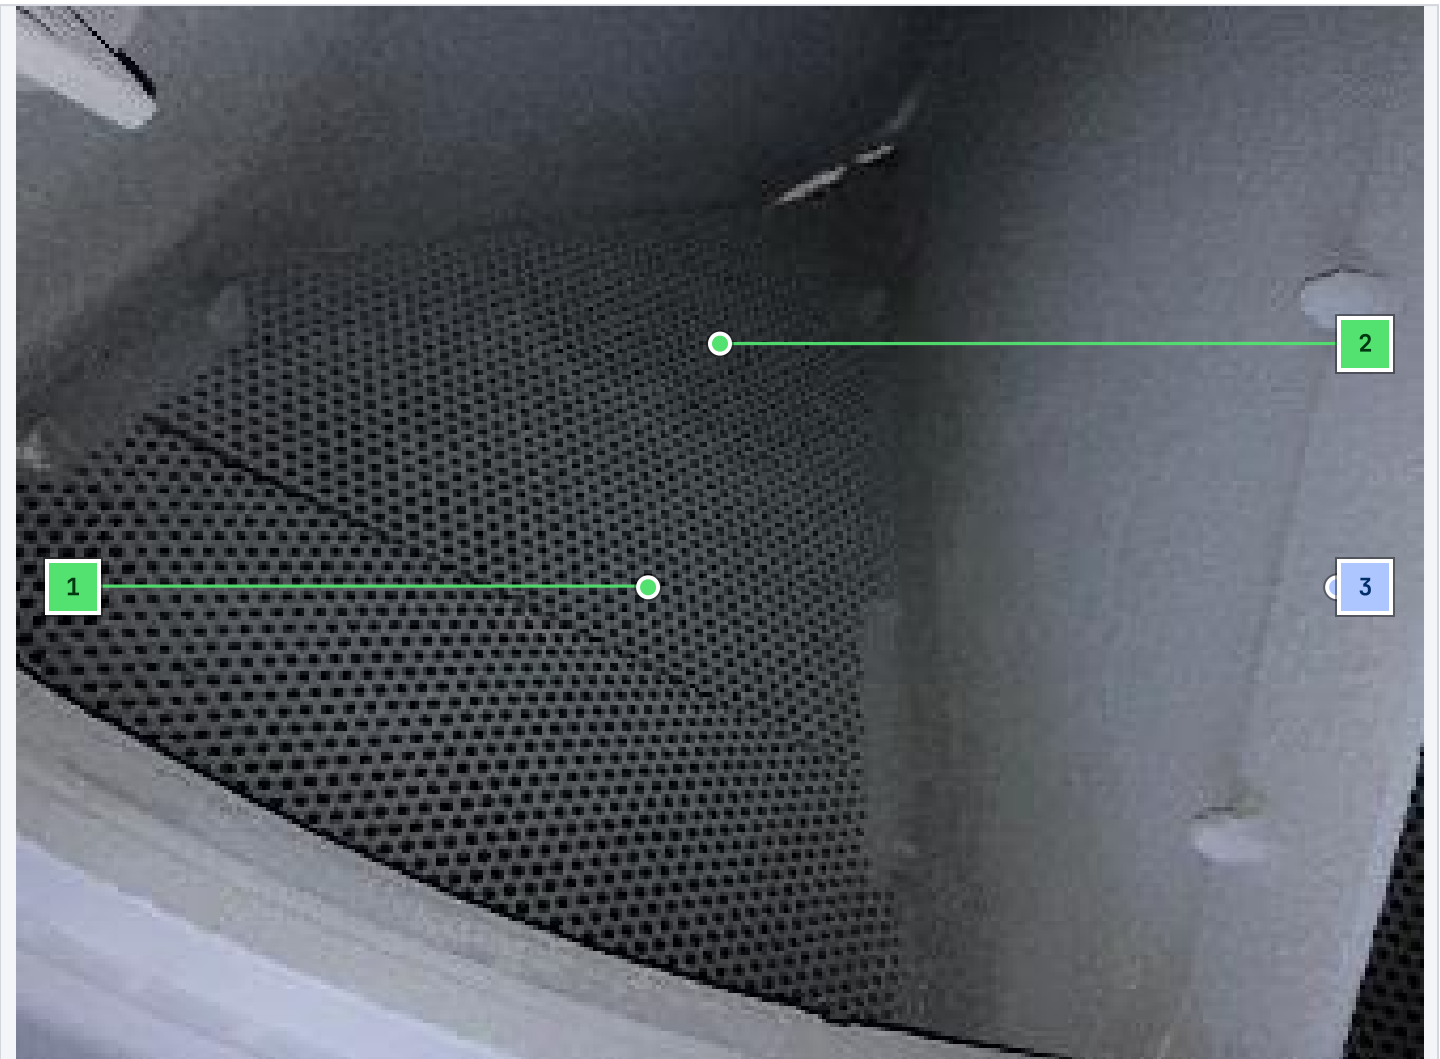
07 Cleaned screen

1 Clean Perforated Screen

Media support perforations clear, unobstructed

2 Seam Joint

Screen panel seam intact, properly seated

3 Vessel Wall Interface

Screen-to-wall edge sealed without gaps

Cleaned media support screen with clear perforations, properly seated panel seam, and tight screen-to-wall edge. Condition is consistent with the B-side screens and represents a good post-clean baseline.

Document cleaned screen condition as baseline for differential pressure trending.

No action required; photo serves as cleaned-condition baseline.

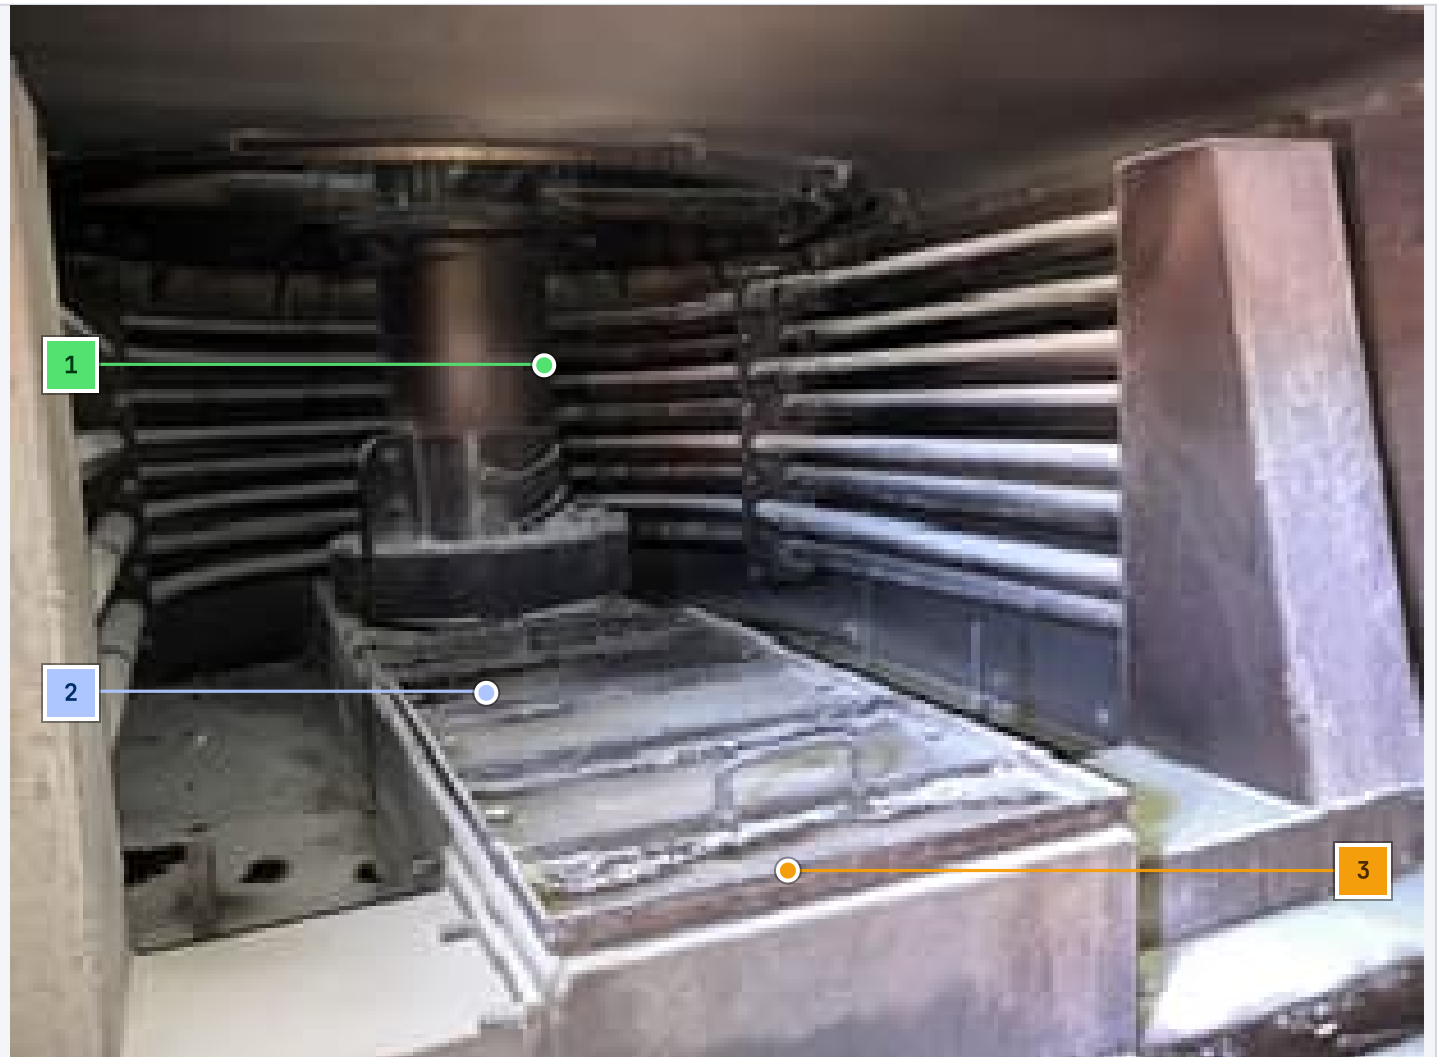
08 Exhaust end of manifold

- 1 Manifold Tube Bundle**
Exhaust tubes intact, no visible deformation
- 2 Central Hub Flange**
Bolted hub seated, light surface deposits
- 3 Rotary Valve Face**
Sealing face shows wear streaks and debris

Exhaust manifold tube bundle is intact with no visible deformation and the bolted central hub flange is seated with only light surface deposits. The rotary valve sealing face, however, shows wear streaks and entrained debris — a precursor to bypass leakage and reduced VOC destruction efficiency.

Inspect rotary valve sealing face, measure wear, and clear debris from sealing land.

At the next planned outage, pull the rotary valve, measure sealing face wear, clean the sealing land, and replace the seal if wear exceeds OEM limits.

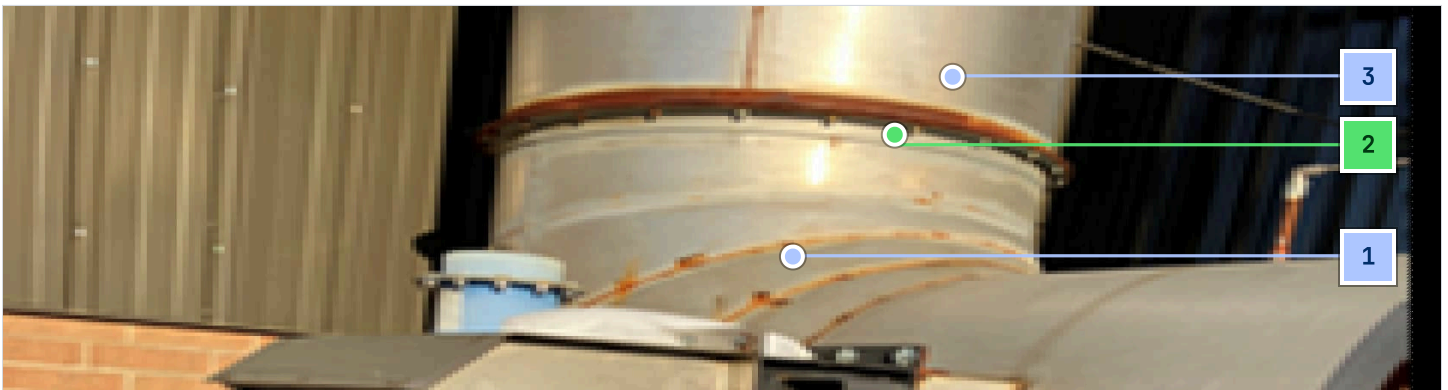
09 Untitled finding

- 1 Rust Staining At Seam**
Corrosion streaks along lower stack weld seam
- 2 Flanged Joint**
Bolted flange ring intact, no gasket weep
- 3 Upper Stack Seam**
Vertical weld seam shows minor oxidation

External walkdown of the exhaust fan, bearings, gas train, and fresh air/purge damper shows components in serviceable condition. Bolted flange ring shows no gasket weep, but rust staining is visible along the lower stack weld seam and minor oxidation on the upper vertical seam. Cosmetic at this stage, but worth tracking.

Wire-brush and touch-up stack weld seams showing rust streaking to halt oxidation.

Wire-brush affected weld seams and apply touch-up coating at the next quarterly inspection to arrest oxidation.
