# EXECUTIVE SUMMARY

Process buildup throughout the rotary valve assembly prevented vane tip-to-housing gap measurements on both A-side and B-side rotor sectors, leaving wear trend data incomplete for this cycle. Heavy product accumulation is visible on the rotor vanes, around the valve base, and on the surrounding deck plate. Drive train, switchgear, VFD, and combustion air damper hardware all inspected clean with no mechanical defects identified. Schedule a cleaning intervention and re-attempt gap measurements before the next reporting cycle.

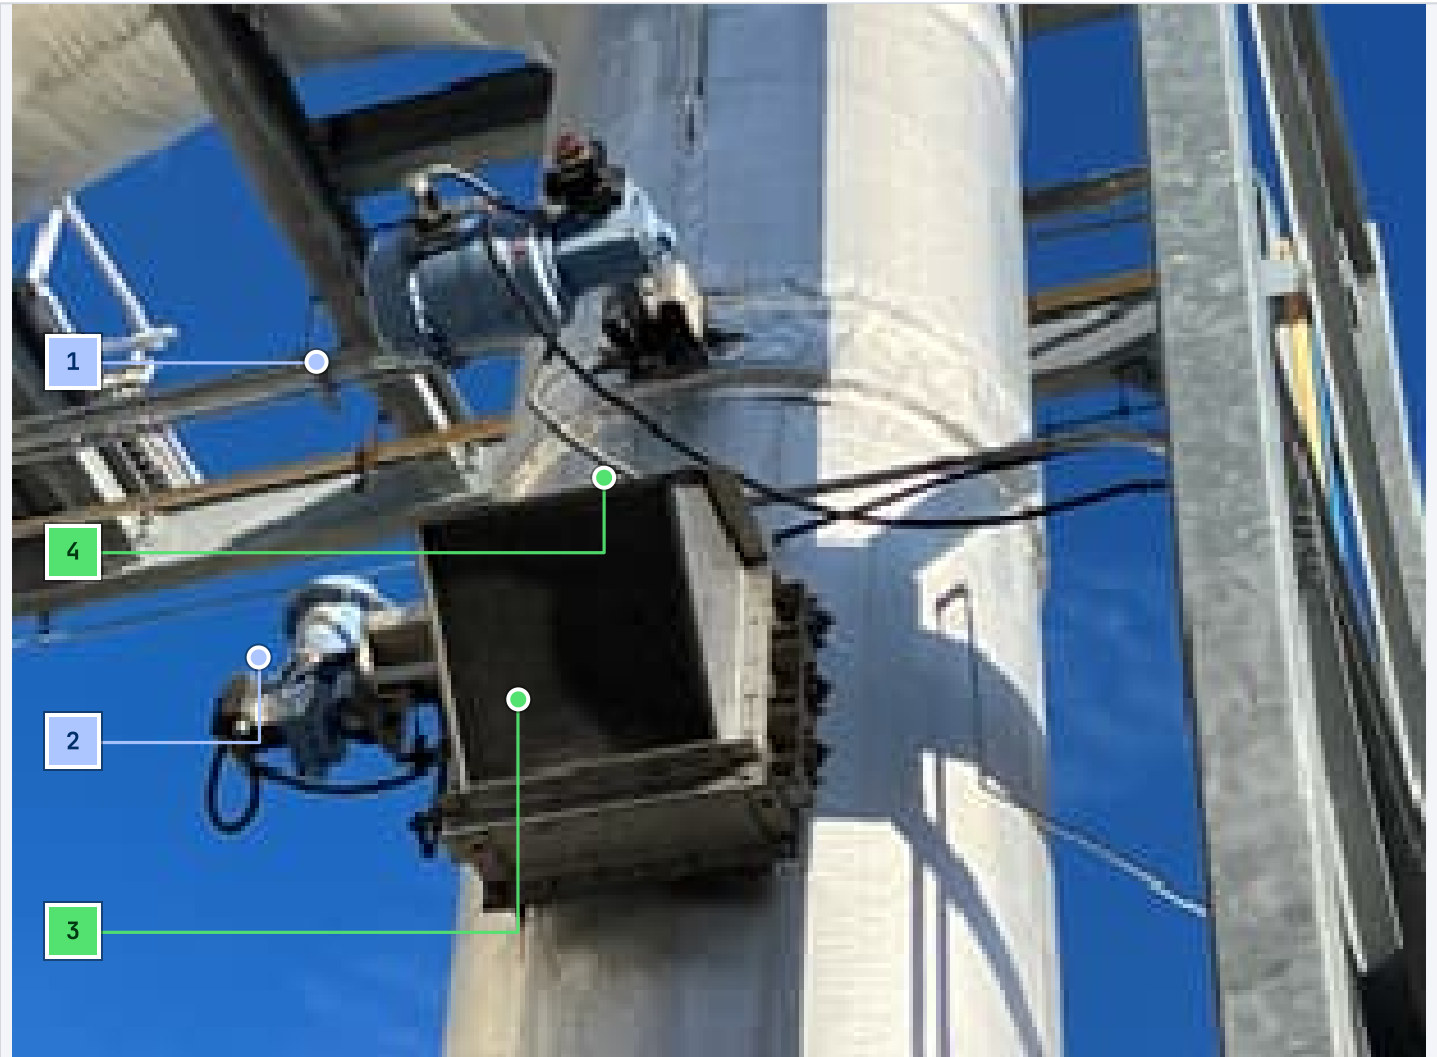
### 01 Fresh air / purge damper

- 1 **Upper Damper Actuator**  
Electric actuator mounted on purge damper
- 2 **Lower Damper Actuator**  
Second actuator driving fresh air damper
- 3 **Damper Housing**  
Square duct housing appears intact
- 4 **Silo Wall Interface**  
Duct penetration into silo, no leakage

Fresh air and purge dampers photographed from grade, both electric actuators mounted and intact. Square duct housing and the silo wall penetration show no leakage or deformation. No action required.

Maintain on standard PM cycle; verify actuator stroke during next functional test.

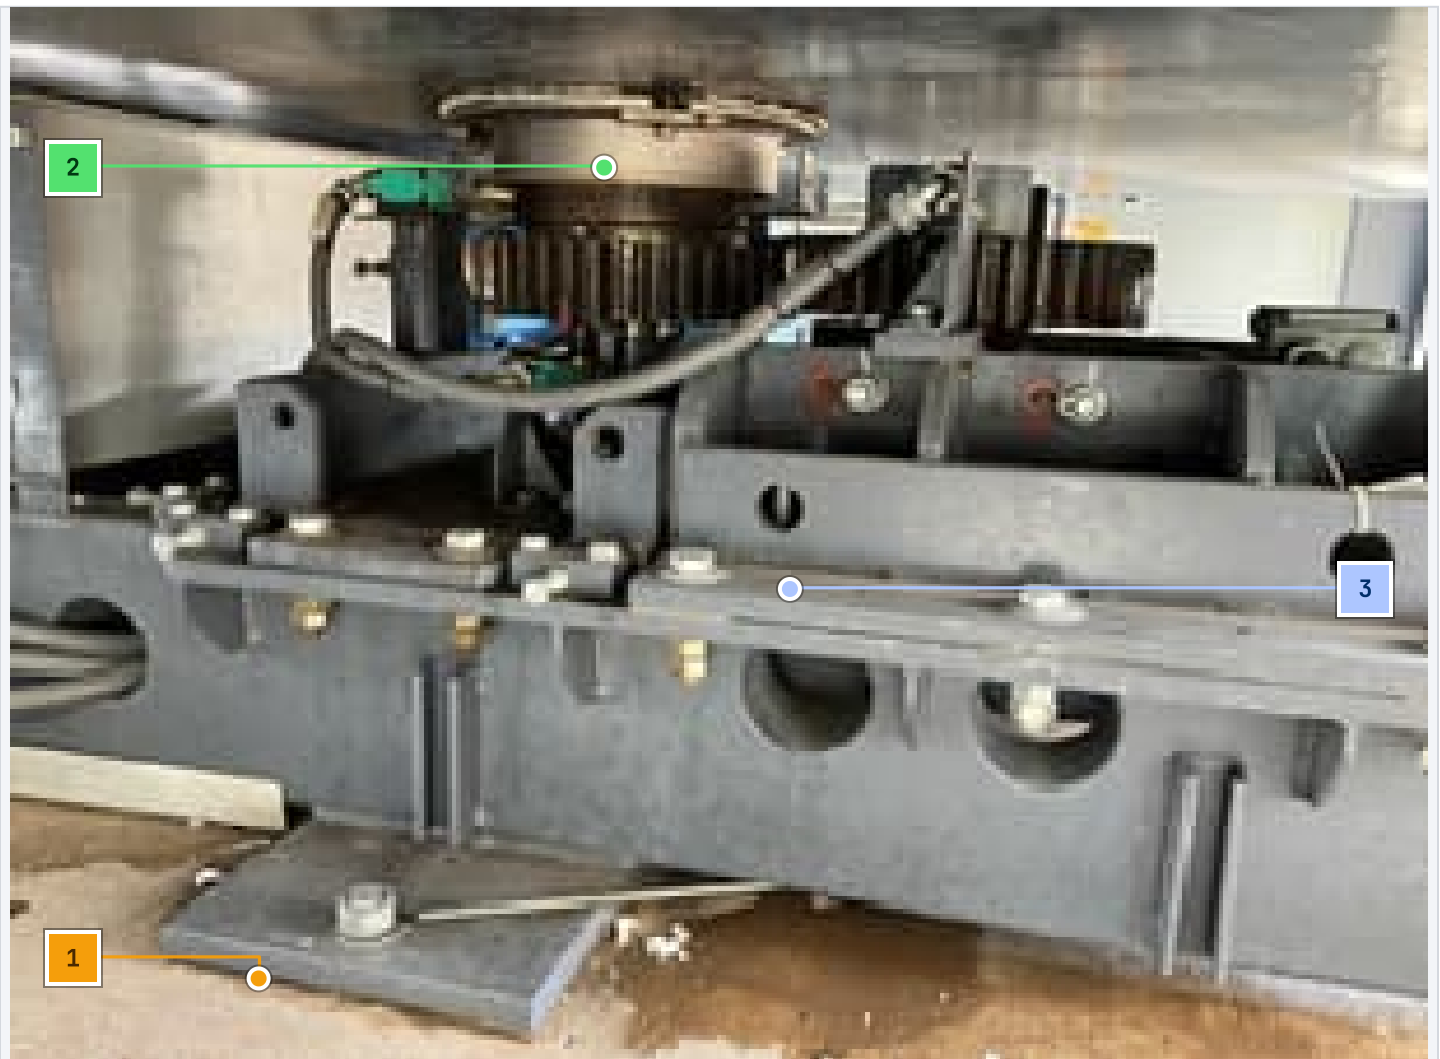
## 02 Untitled finding

- 1 Floor Debris Accumulation**  
Excess material buildup around valve base
- 2 Switch Gear Assembly**  
Switchgear inspected, no issues found
- 3 Housing Bolt Flange**  
Flange bolts seated, no leakage visible

Switchgear assembly and housing bolt flange inspected clean, but the deck plate around the valve base shows significant product accumulation. Buildup at this location masks any developing leakage at the flange and creates a housekeeping hazard.

Remove product buildup from valve base, deck plate, and surrounding floor area

Vacuum and remove floor debris around the valve base, then re-inspect the flange face for seepage.

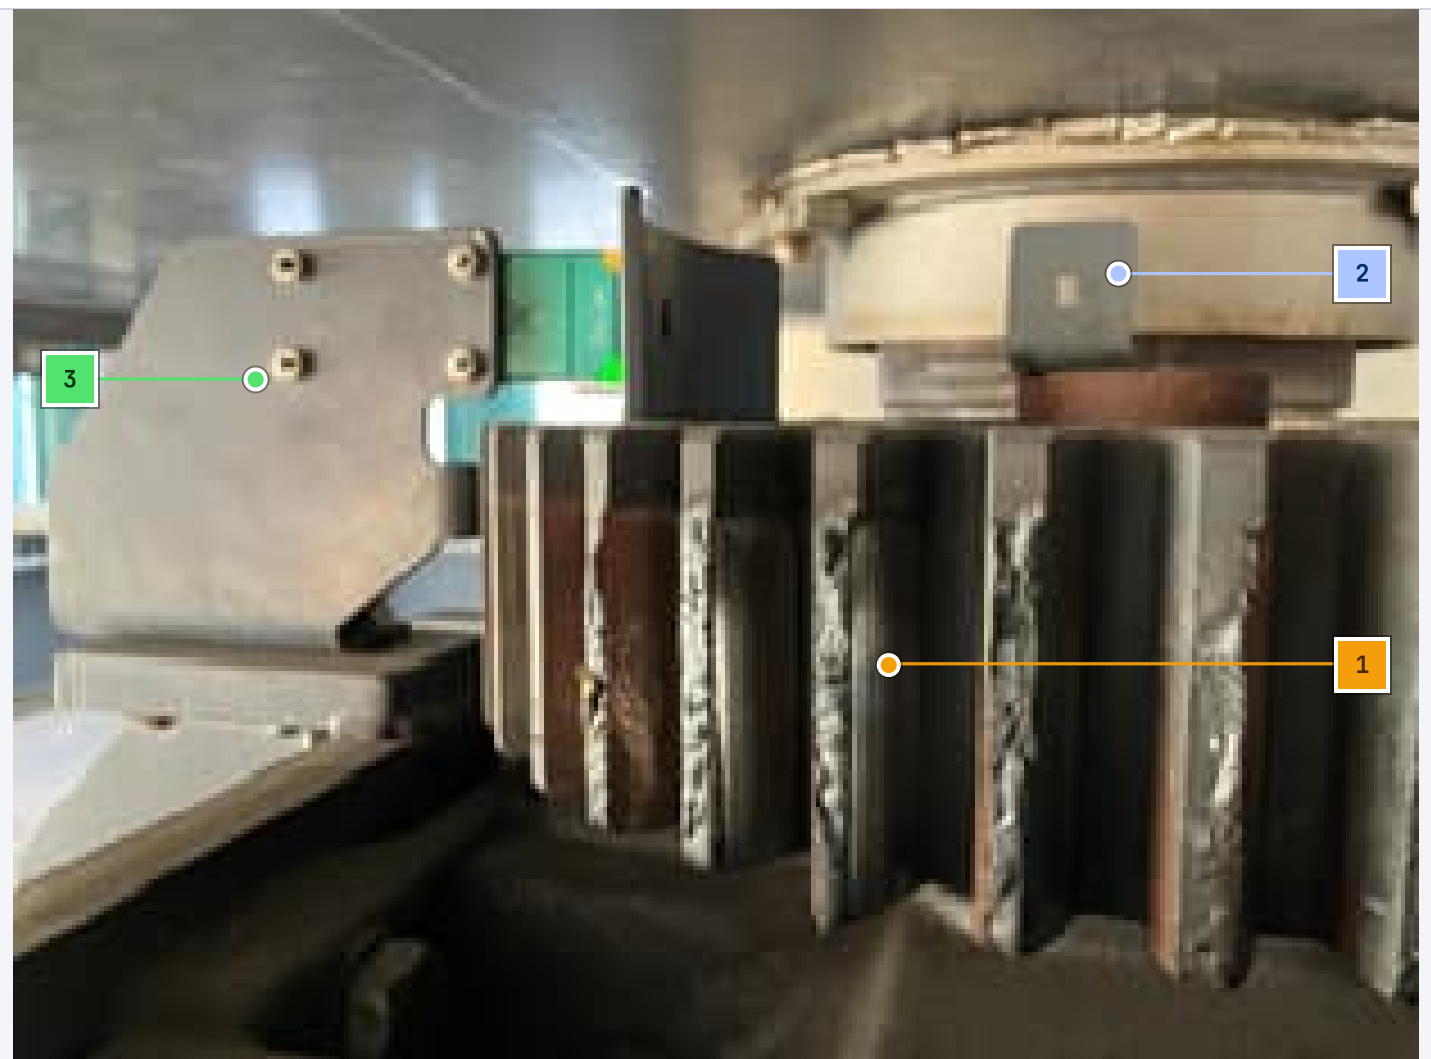
### 03 Untitled finding

**1 Material Buildup**

Heavy product accumulation on rotor vanes

**2 Rotor End Plate**

Visible wear pattern on rotor hub

Heavy product is packed onto the rotor vanes and across the visible rotor end plate, with a wear pattern beginning to form at the rotor hub. The switch gear housing itself is intact, but the vane fouling is what blocked gap measurements elsewhere in this walkdown.

Inspect rotor end plate wear pattern once vanes are cleaned and document baseline

Clean vane faces and rotor end plate during the next planned outage and photograph the hub wear pattern for trending.

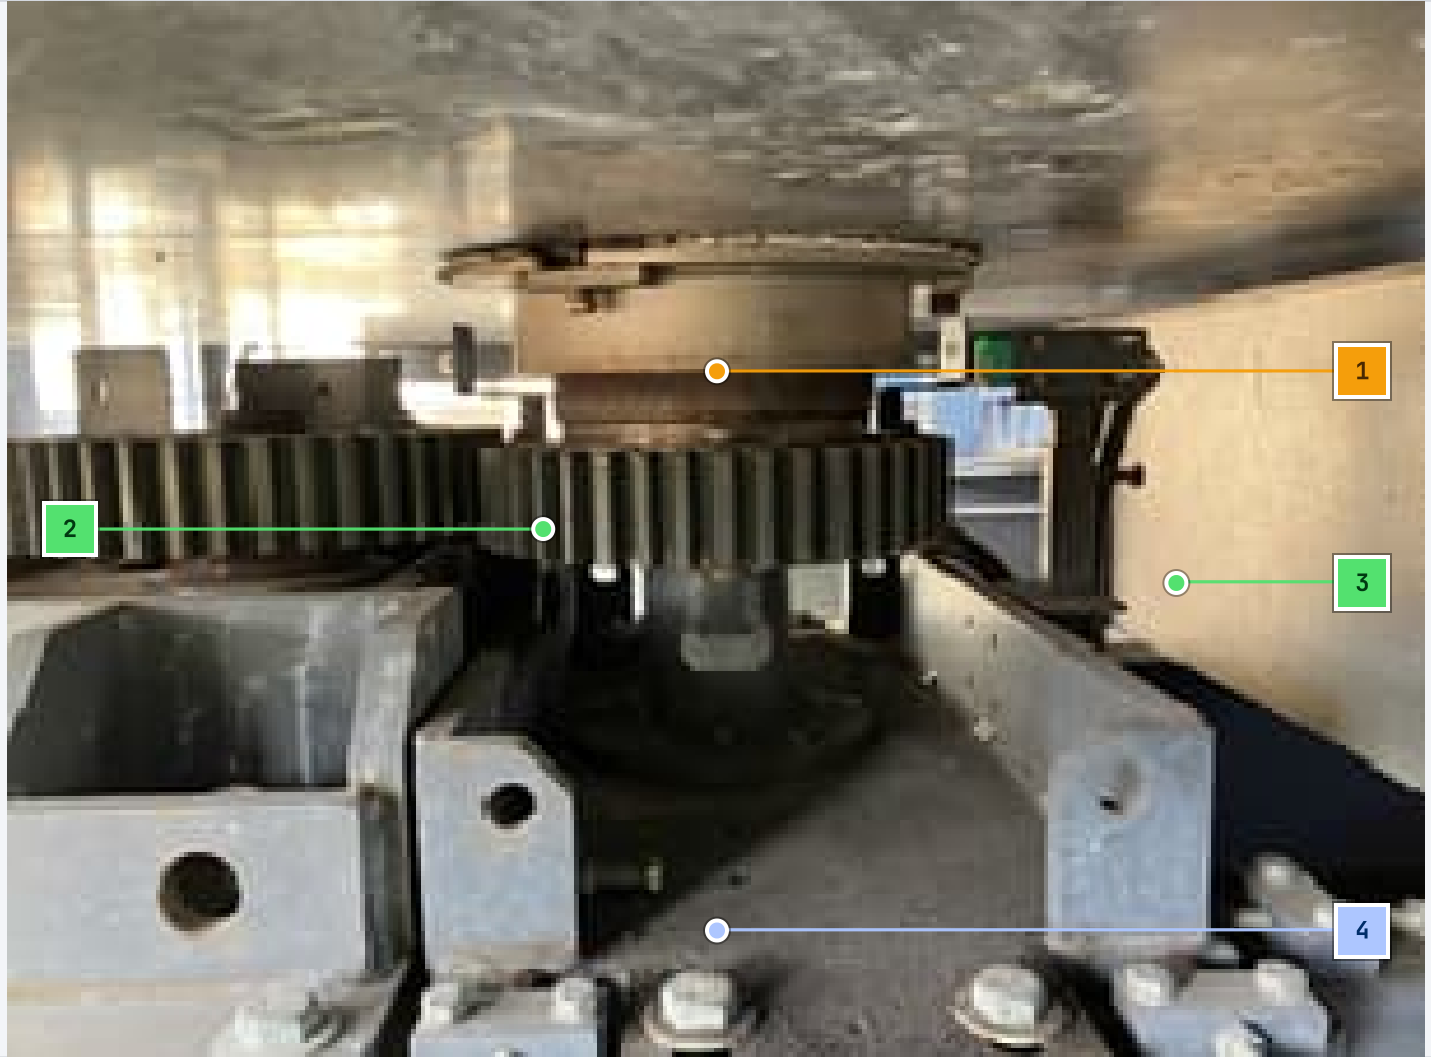
# 04 Untitled finding

**1 Material Build-Up**

Excess dust accumulation around valve body

**4 Base Mount Bolts**

Anchor bolts seated, no looseness observed

Excess dust coats the valve body and lower housing. Drive gear mesh and switch gear housing are sound, and the base mount anchor bolts are seated with no looseness.

Verify housing bolt flange and base anchor torque during cleaning shutdown

Include this valve body in the cleaning scope and confirm anchor bolt torque while access is open.

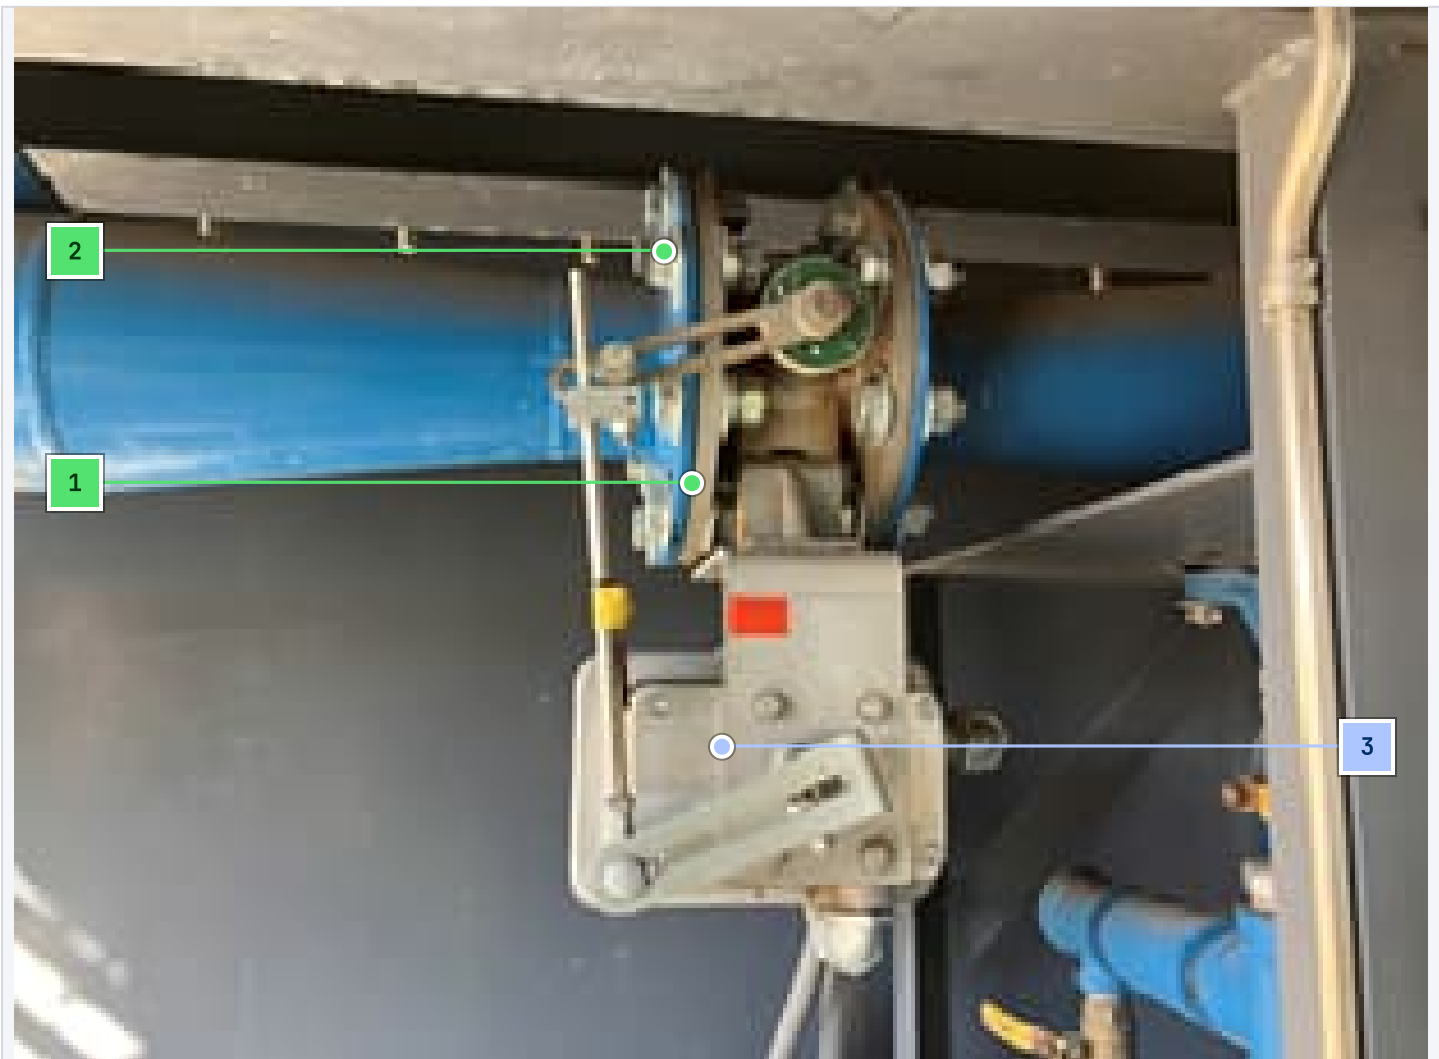
## 05 Untitled finding

- 1 Damper Linkage**  
Combustion air damper linkage intact and aligned
- 2 Handwheel Actuator**  
Manual handwheel actuator in normal position
- 3 Mount Bracket**  
Valve mount bracket secure, no deformation

Burner walkdown covered burner stone, nozzle, gas train, gas transmitter, mount, and combustion air damper. Damper linkage is aligned, handwheel actuator is in its normal position, and the mount bracket shows no deformation.

No action required; retain on standard burner PM interval.

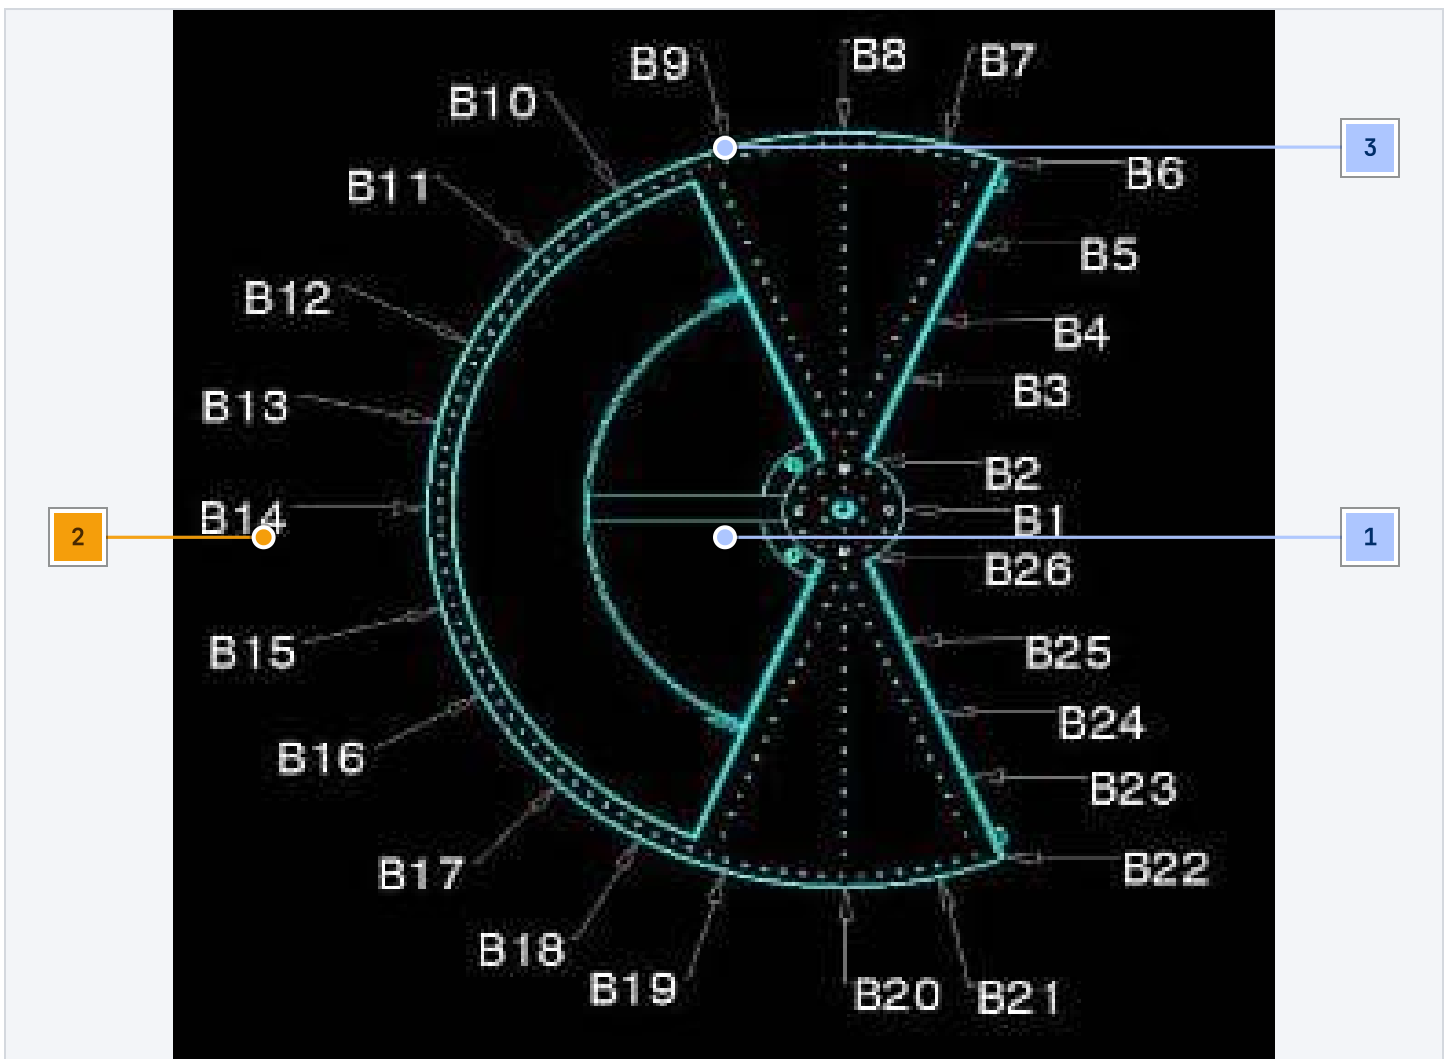
## 06 Untitled finding

**2 Vane Tip Clearance**

Housing -to- vane gap location, measurement obstructed

B-side rotor diagram shows vane positions B1 through B26 with the central hub as datum. Tip clearance measurements at the housing -to- vane interface could not be obtained because product buildup obstructed access to the gap stations.

Clean rotor vanes and housing bore, then complete A-side and B-side vane tip gap measurements

After cleaning, perform full B-side tip clearance sweep and log values against the B7–B26 station map.

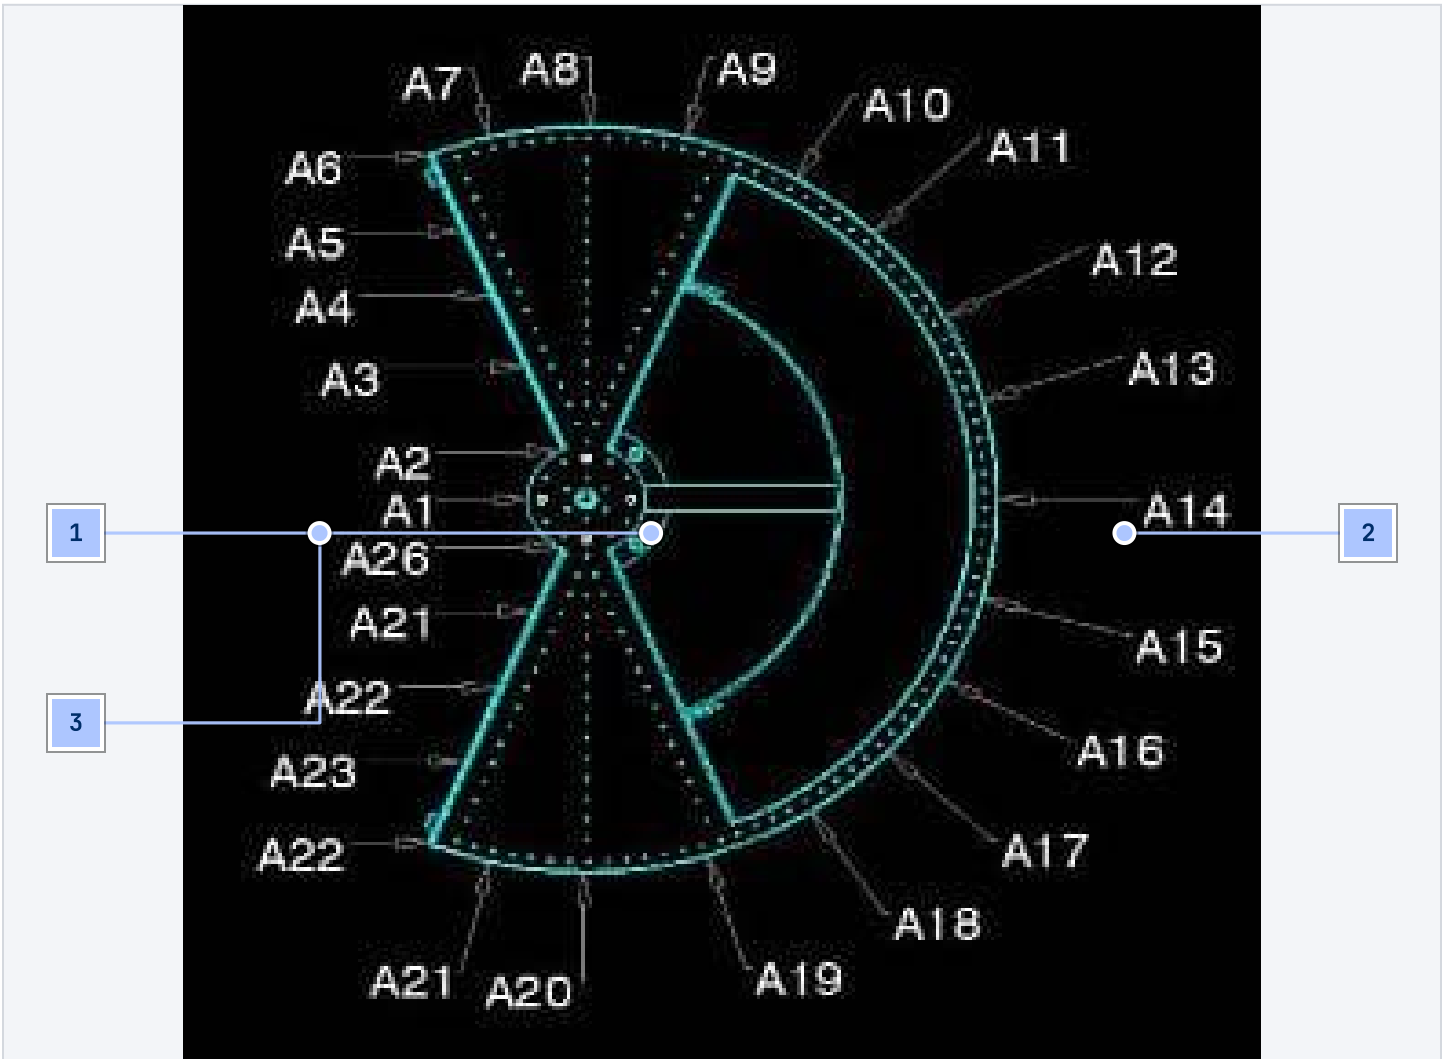
# 07 Valve Gap measurements

- 1 Rotor Tip Gap**  
Rotor vane tip-to-housing clearance measurement points
- 2 Housing Bore Stations**  
Circumferential measurement positions around housing
- 3 Shaft Reference Point**  
Central shaft datum for gap indexing

A-side rotor diagram identifies tip gap measurement stations A1 through A26 indexed off the central shaft datum. As with the B-side, process buildup prevented feeler gauge access at the housing bore stations, so no clearance data was captured this cycle.

Complete A-side tip gap measurements at all 26 stations once the rotor and bore are cleaned; flag any station exceeding OEM clearance limits.

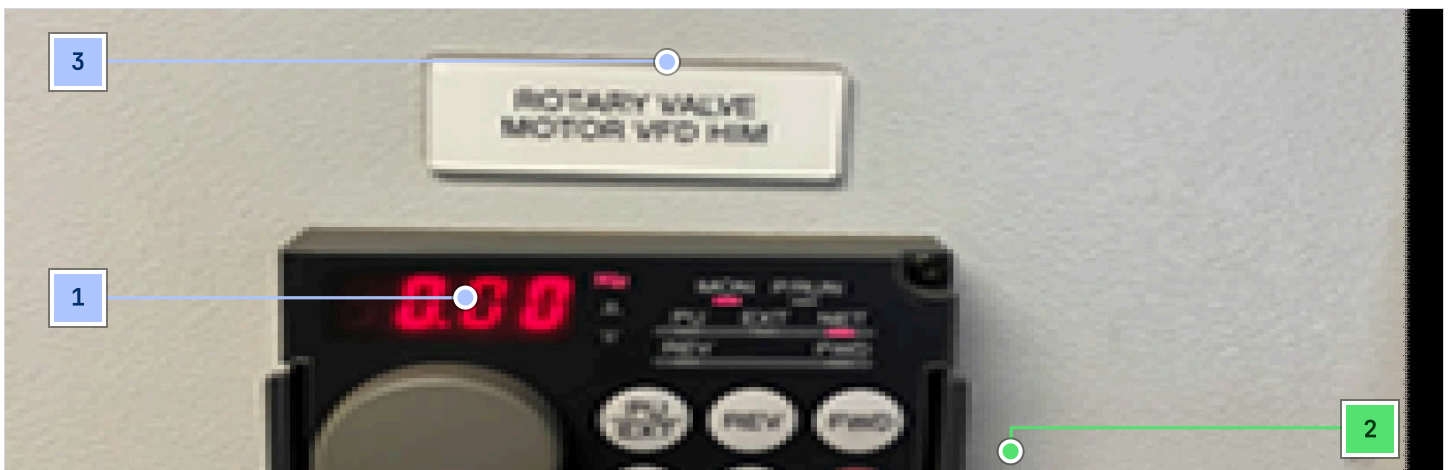
## 08 Switch valve AC drive

- 1 VFD Display Reading**  
Display shows 0.00 Hz, drive stopped
- 2 Control Keypad**  
FWD/REV/EXT keys intact and legible
- 3 Equipment Identification**  
Rotary Valve Motor VFD HMI label

Switch valve AC drive HMI shows 0.00 Hz with the drive stopped at time of inspection. Keypad legends (FWD/REV/EXT) are intact and the Rotary Valve Motor VFD HMI identification label is in place.

No action required; verify drive parameters at next controls PM.

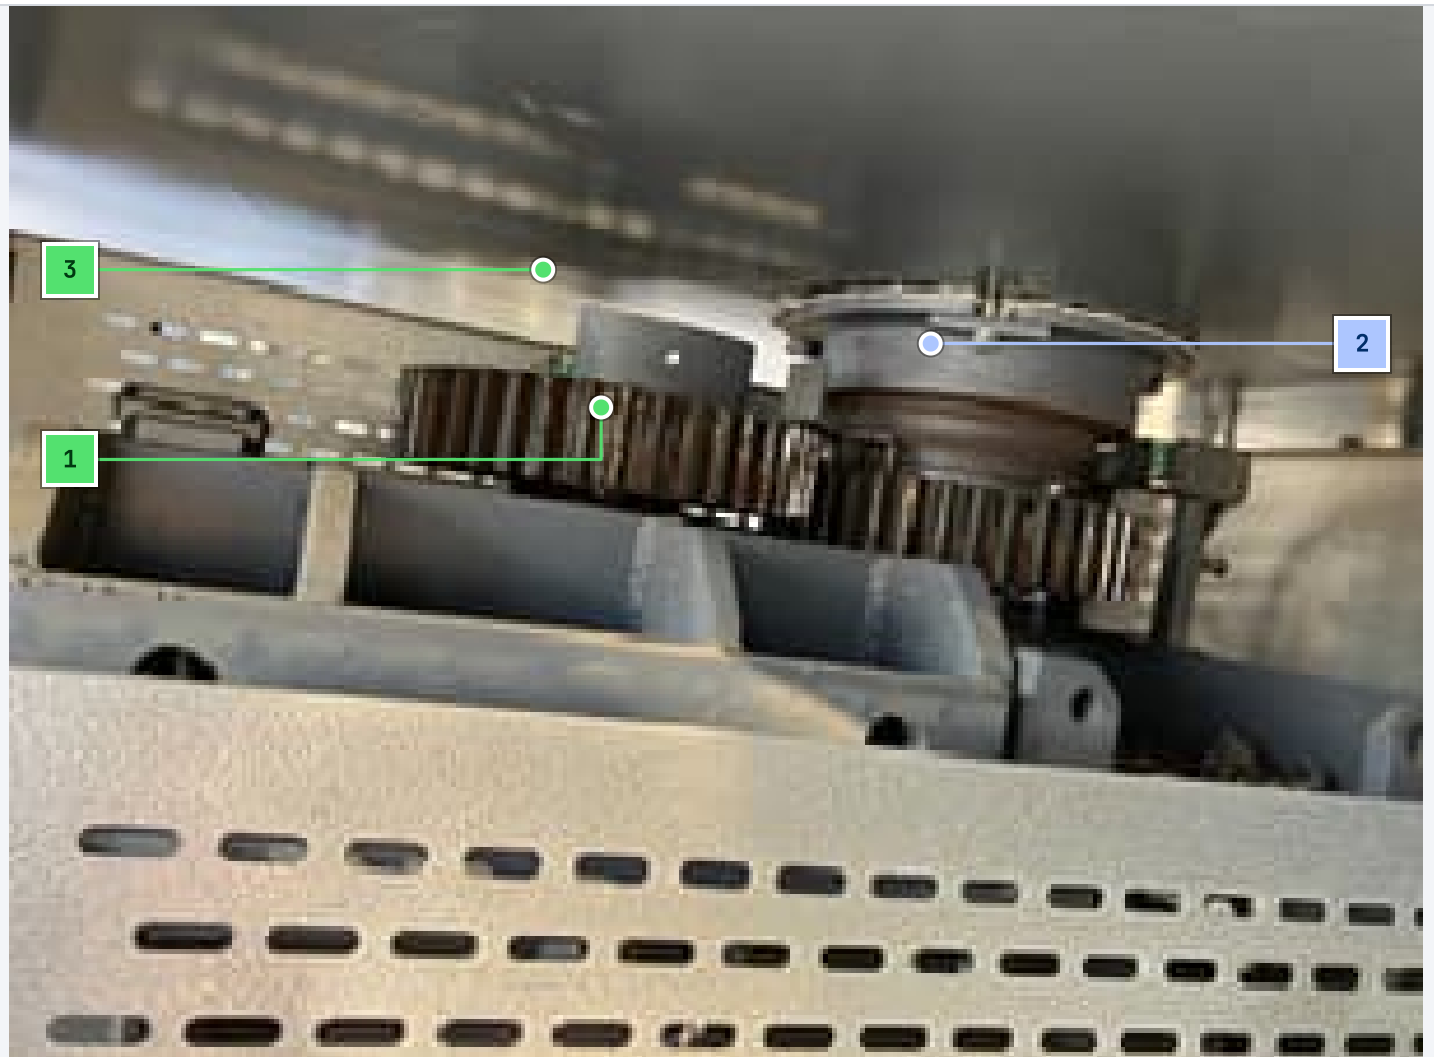
## 09 Switch valve drive assy.

**1 Gear Mesh Engagement**

Drive and pinion gear teeth meshed correctly

**3 Gear Tooth Condition**

Teeth show clean wear pattern, no chipping

Switch valve drive assembly shows correct gear mesh engagement between drive and pinion, with clean wear pattern and no chipping on the tooth flanks. Valve shaft coupling hub is seated correctly.

No action required; continue lubrication on existing schedule and re-inspect gear teeth next cycle.
