# EXECUTIVE SUMMARY

Lift cylinder pneumatic fittings on the main control panel circuit failed to hold high lift pressure after retape and retighten; fittings were replaced during this visit. A loose screwdriver was also found inside the live internal PLC panel — an immediate FOD and arc-flash hazard. Remainder of the CleanSwitch RTO (vessel, stack, ductwork, gas train, platforms, electrical cabinet wiring) is in serviceable condition. Verify the lift cylinder repair holds pressure under a full switch cycle before returning the unit to unattended operation.

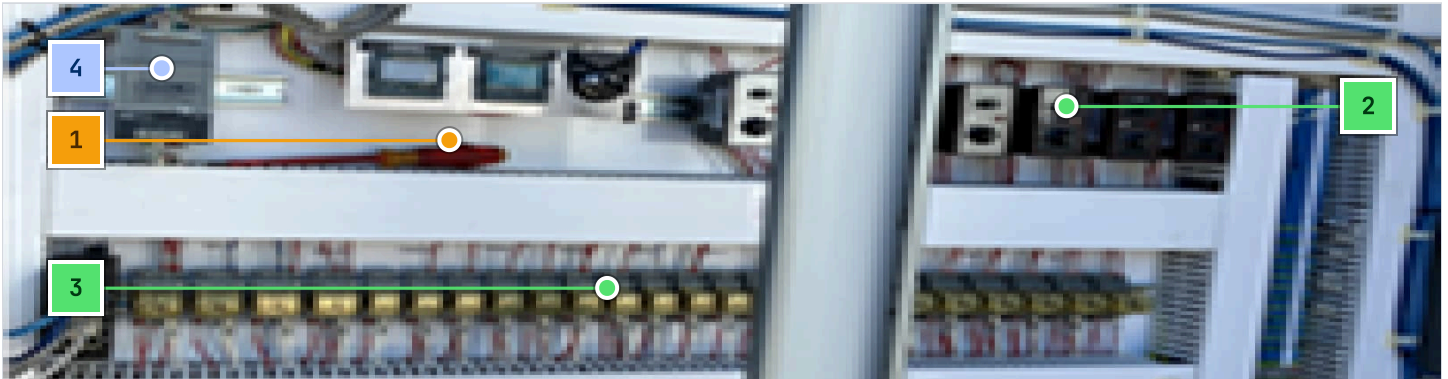
### 01 Internal control panel (PLC)

Tool left inside live panel, FOD hazard

A screwdriver is resting on the internal panel chassis between the PLC module and the breaker bank. Breakers, terminal rows, and controller indicators are otherwise in good order, but a loose ferrous tool inside an energized enclosure is an immediate FOD and short-circuit hazard.

| 1 | Remove screwdriver from internal PLC panel and audit enclosure for any other FOD<br>TARGET: IMMEDIATE | CRITICAL |

Remove the tool now and perform a tool/FOD sweep of the enclosure before closing. Reinforce tool-control discipline with site technicians.

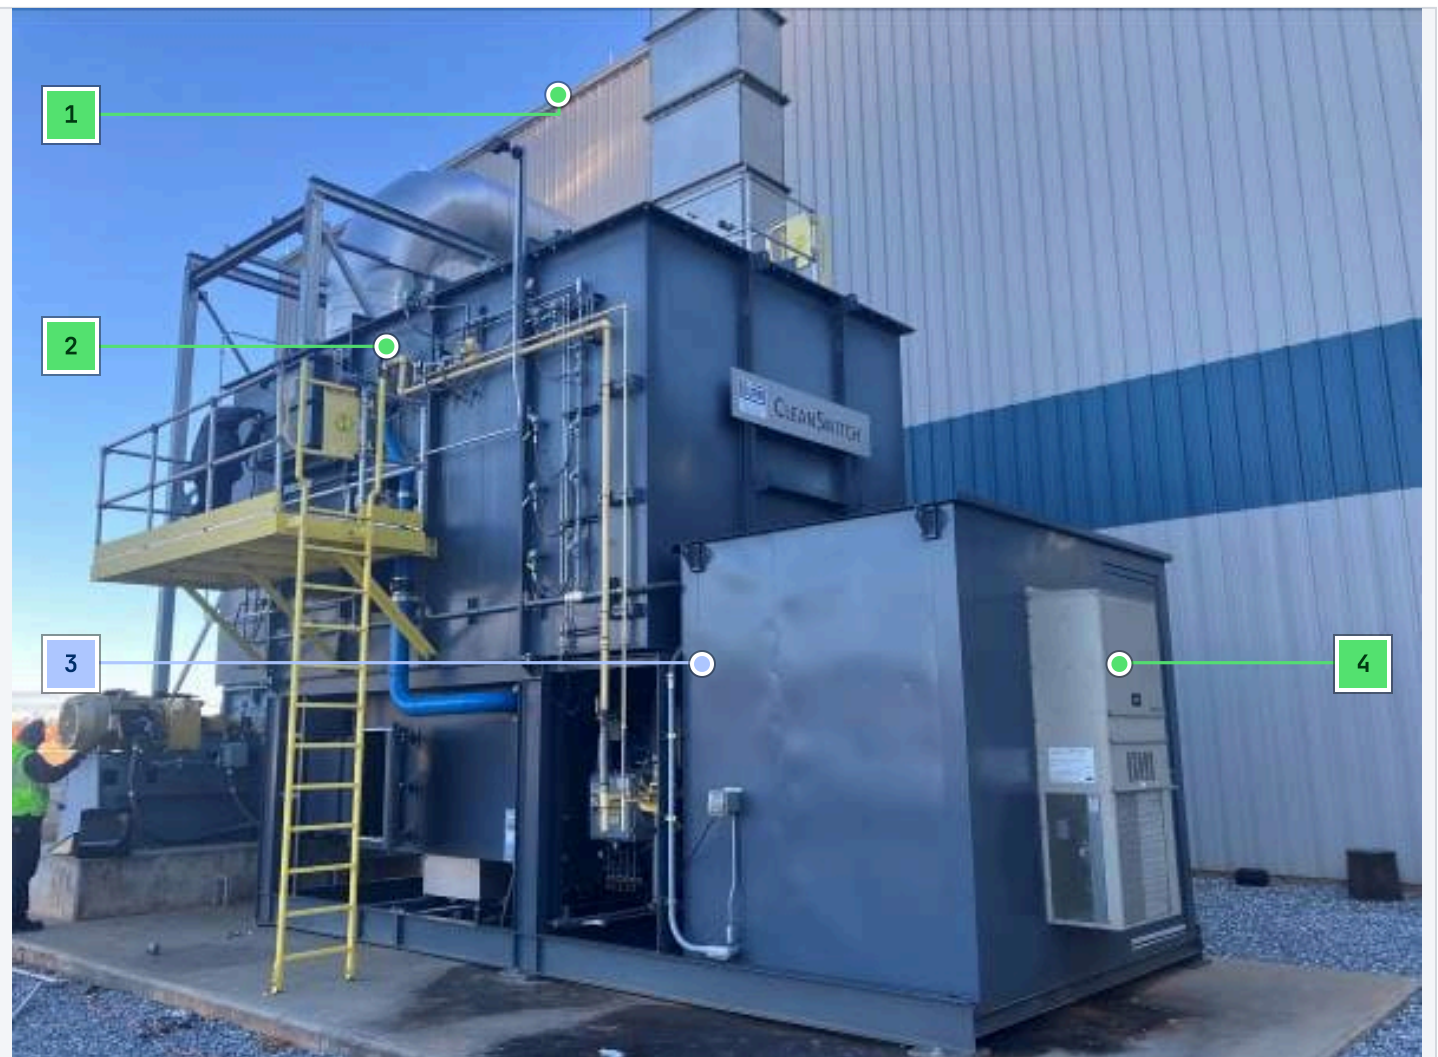
## 02 Overall picture of unit

Overall view of the CleanSwitch RTO shows intact exhaust stack, sound external ductwork and process piping, and a sealed control cabinet. Gas train is accessible with no leaks observed on visual inspection.

No action. Maintain current PM cadence.

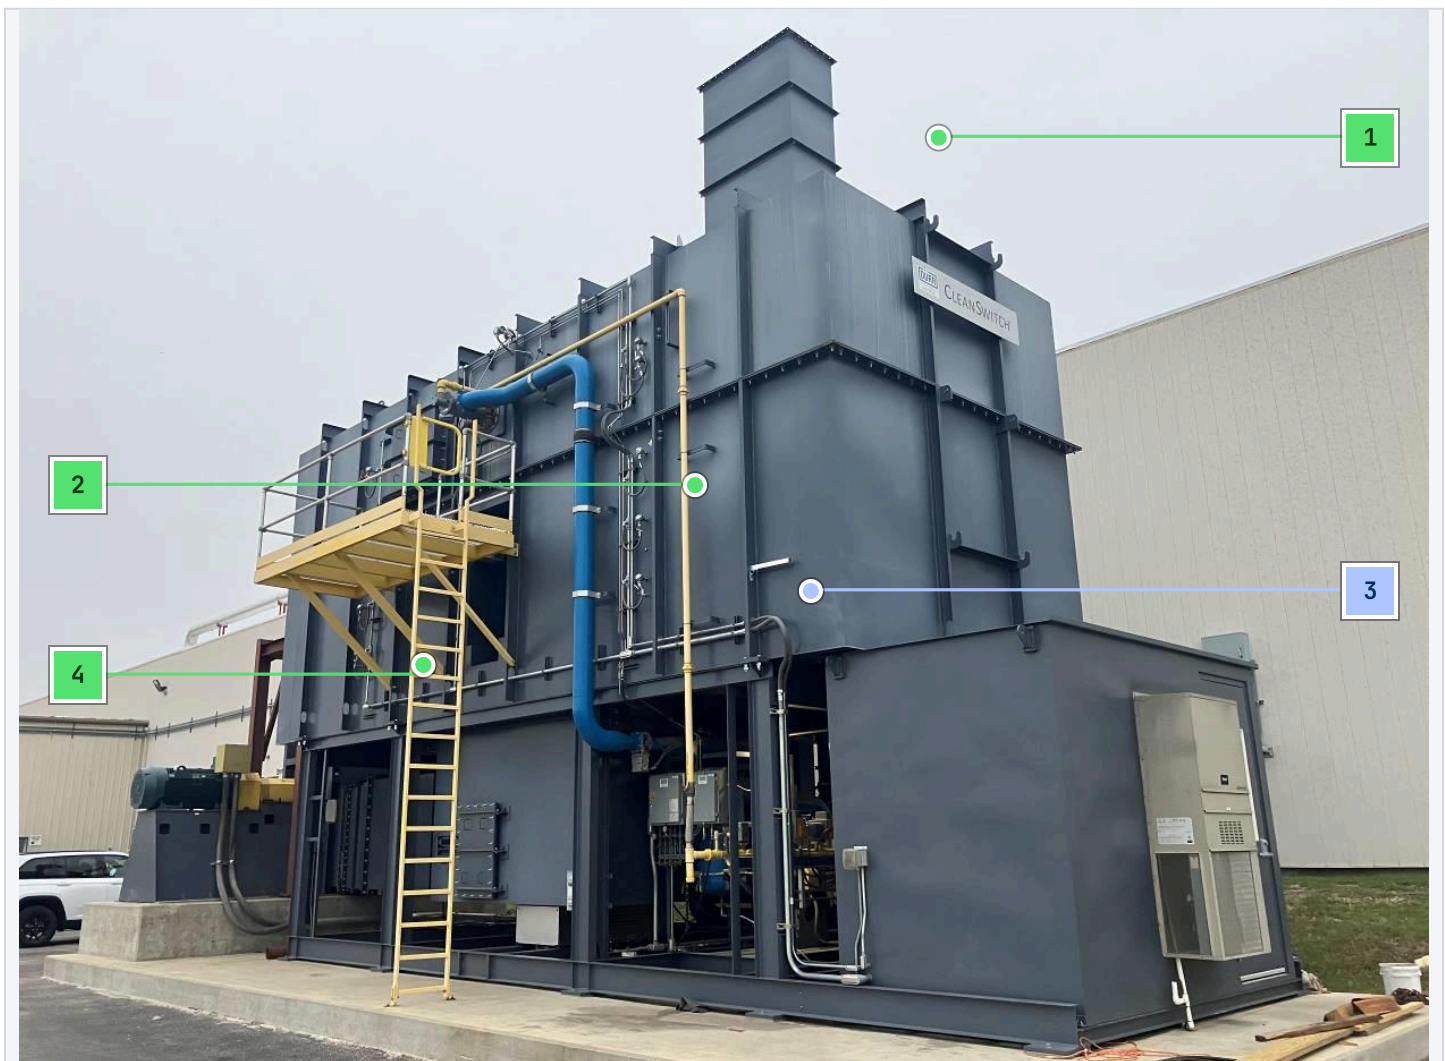
## 03 Overall picture of unit

Second elevation view confirms the RTO exhaust stack, blue VOC inlet duct coatings, and yellow gas supply piping are intact. Caged access ladder and maintenance platform remain serviceable.

No action required.

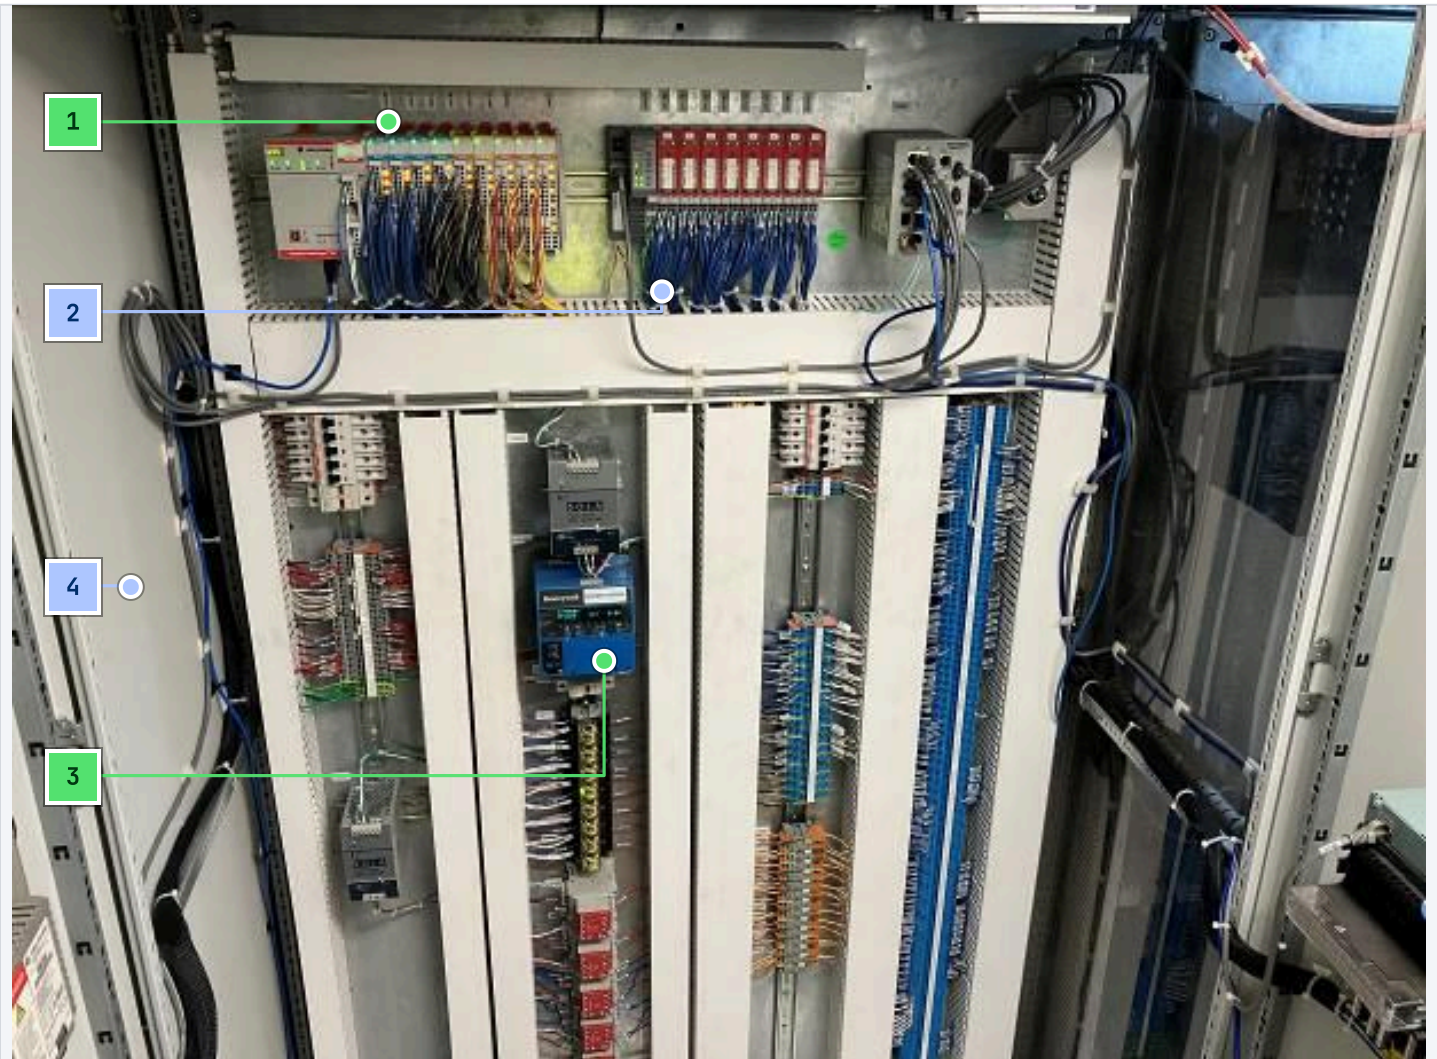
## 04 Electrical Cabinet

Electrical cabinet interior shows neatly ferruled terminal blocks, organized vertical wireways, and a fieldbus gateway mounted on DIN rail. PLC I/O indicators are visible and wiring service loops at the cable entry are properly dressed.

No action. Include in next scheduled torque-check and thermographic survey.

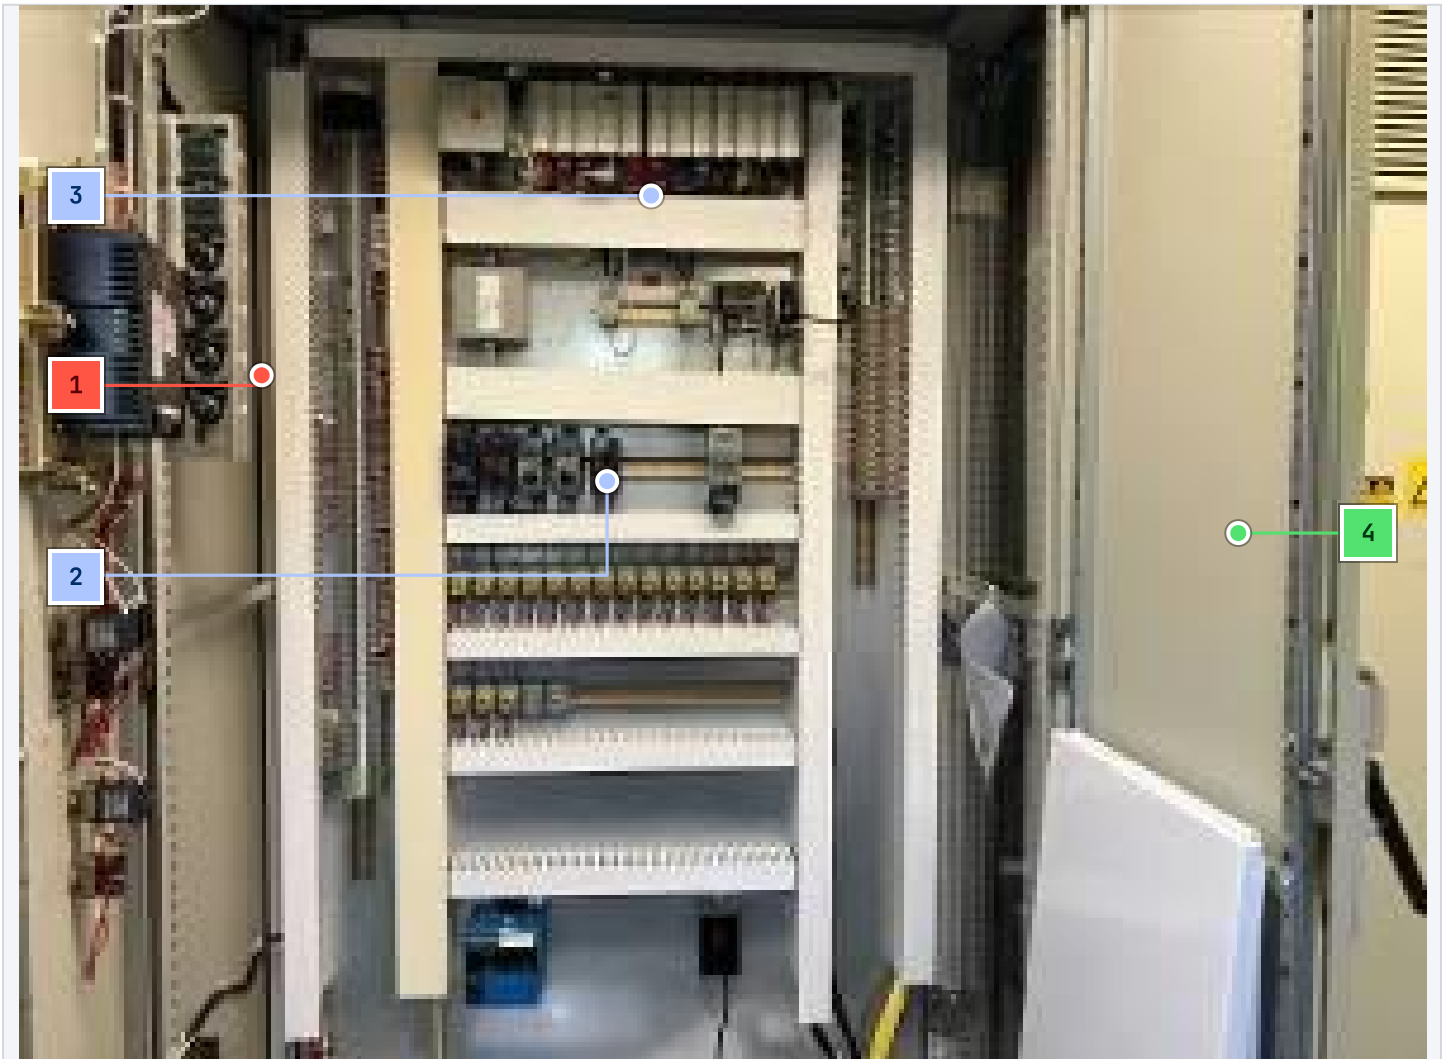
## 05 Main control panel

Air fittings linked to leaking lift cylinder

Main control panel houses the pneumatic fittings feeding the valve lift cylinder; those fittings leaked and would not hold high lift pressure after retape and retighten, so they were replaced during this visit. Surrounding terminal blocks, overhead harness, and cabinet door seal are intact.

| 2 | Verify replaced lift cylinder fittings hold high lift pressure through full switching cycles<br>TARGET: IMMEDIATE | WARNING |
| 3 | Leak-check remaining pneumatic fittings on switching valve actuator circuit<br>TARGET: WITHIN 30 DAYS | WARNING |

Cycle the switching valve under full load and confirm lift pressure is stable. Leak-check the remainder of the cylinder pneumatic circuit and torque-check adjacent terminal blocks.

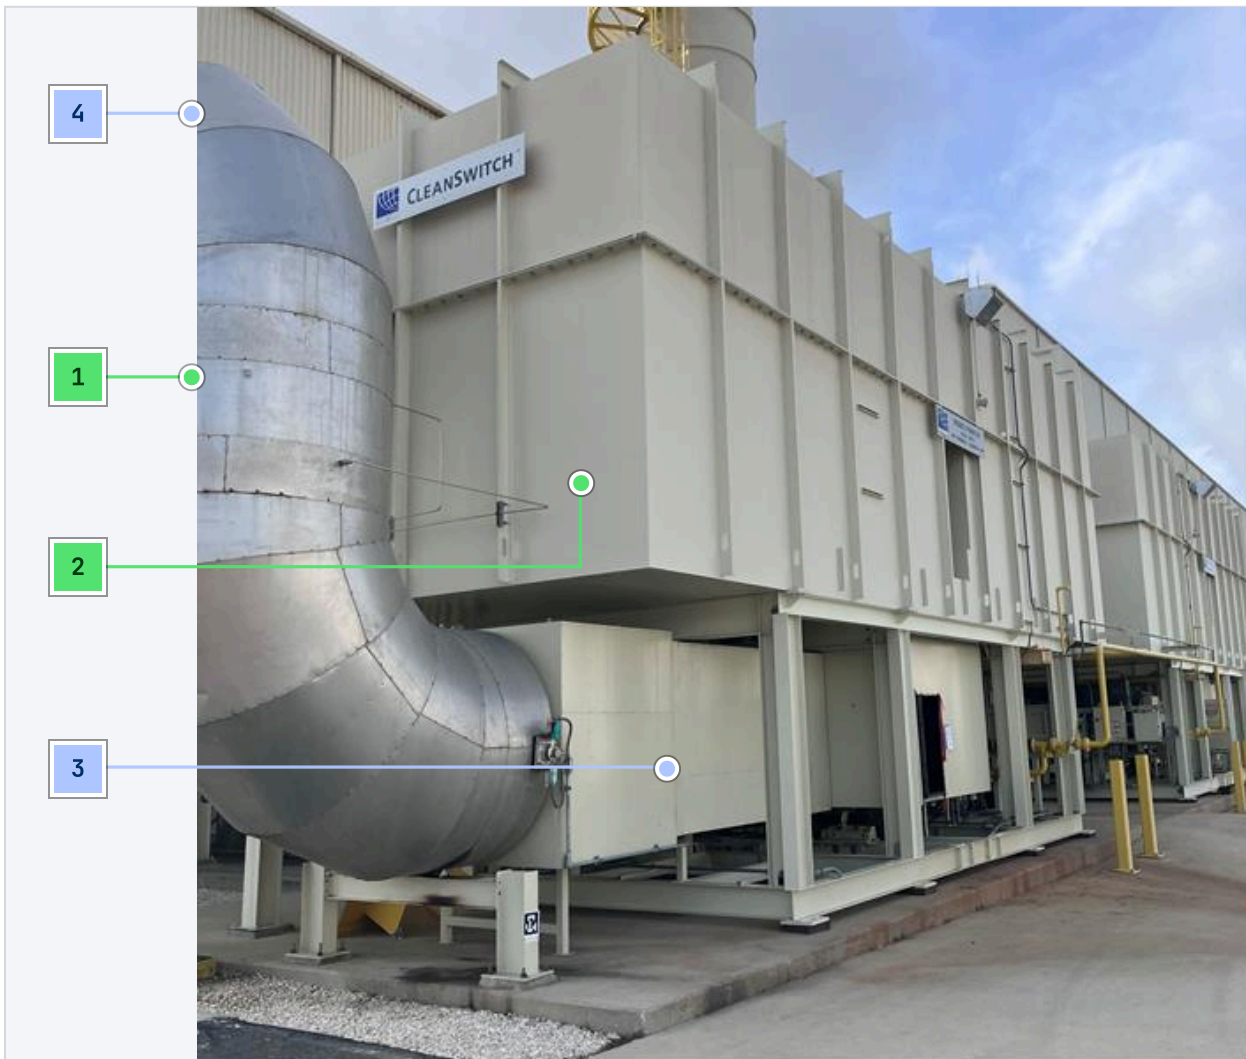
## 06 Overall picture of unit

Side elevation shows insulated inlet ductwork, coated RTO vessel housing, and accessible skid piping with no deformation. CleanSwitch nameplate is legible.

No action required.

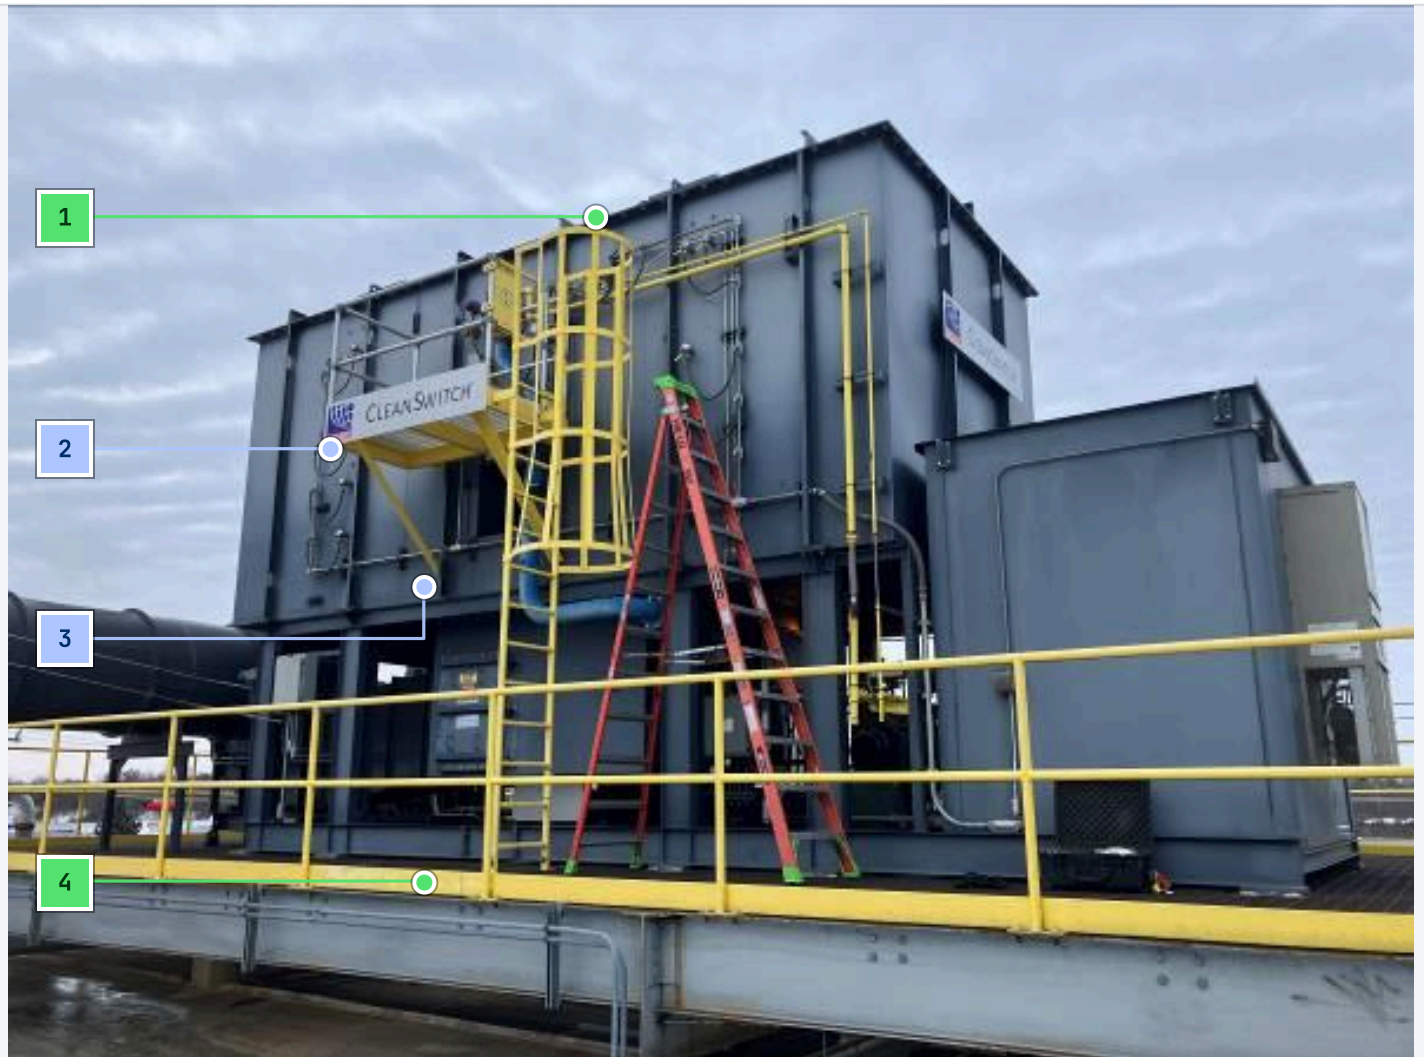
## 07 Overall picture of unit

Unit is shown with caged access ladder secured and platform guardrail intact. A portable fiberglass step ladder is staged for service access; housing exterior is undamaged.

Stow the portable ladder when not in use to keep the platform area clear.

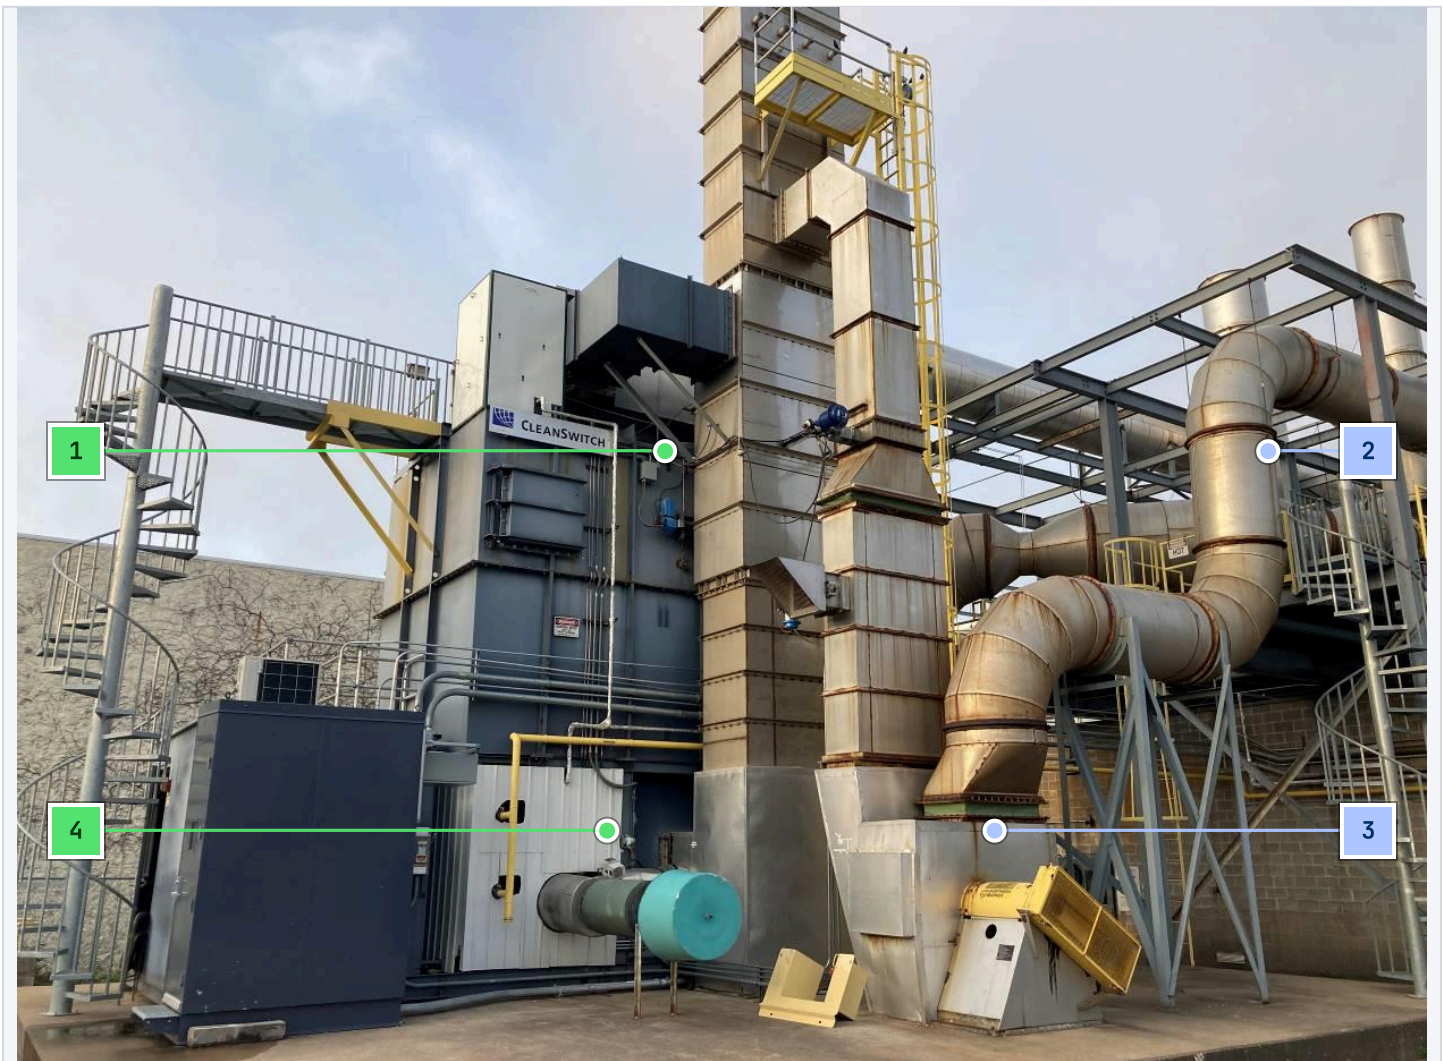
## 08 Overall picture of unit

Surface oxidation on insulated process ductwork

Staining visible at stack base flange

CS-350 main chamber cladding and yellow natural gas supply line are intact. Surface oxidation is visible on the insulated process ductwork and staining is present at the discharge stack base flange — neither is currently a structural concern but both warrant tracking.

| 4 | Investigate staining at exhaust stack base flange and confirm joint integrity<br>TARGET: NEXT QUARTERLY INSPECTION | INFO |
| 5 | Spot-treat surface oxidation on insulated process ductwork to arrest corrosion<br>TARGET: NEXT PLANNED OUTAGE | INFO |

Spot-treat ductwork oxidation and inspect the stack base flange joint for weep or gasket distress at the next outage.
