EXECUTIVE SUMMARY

External walkdown of the CleanSwitch RTO found no abnormalities on the housing, ductwork, gas train, dampers, or access structures. Nameplate data was captured for two units (CS-650 shipped 03/2016 and CS600 shipped 09/2010), and safeties tested OK during the electrical and pneumatic check. Given the 14+ year service age on the older unit, schedule an internal media bed and switching valve inspection at the next planned outage.

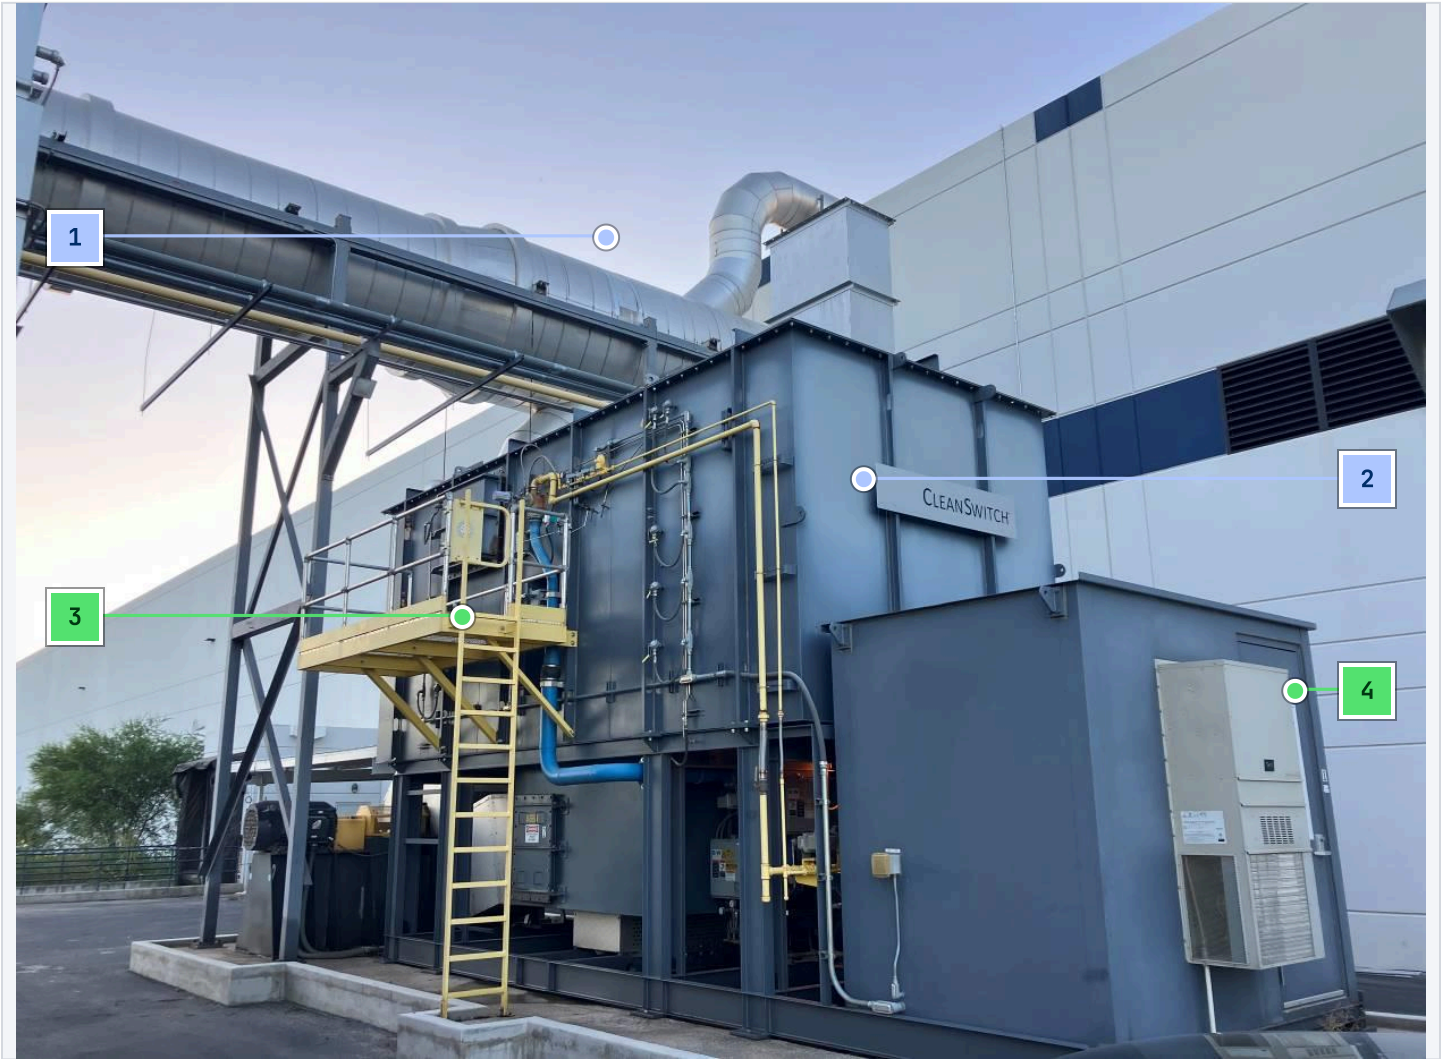
01 Overall picture of unit

Exterior of the CS300 housing, insulated process inlet duct, yellow natural gas train, and yellow access ladder/platform all present as installed with no visible deformation, coating failure, or leakage. Control enclosure with side-mount cooling unit is intact.

No action. Maintain on standard external walkdown cadence.

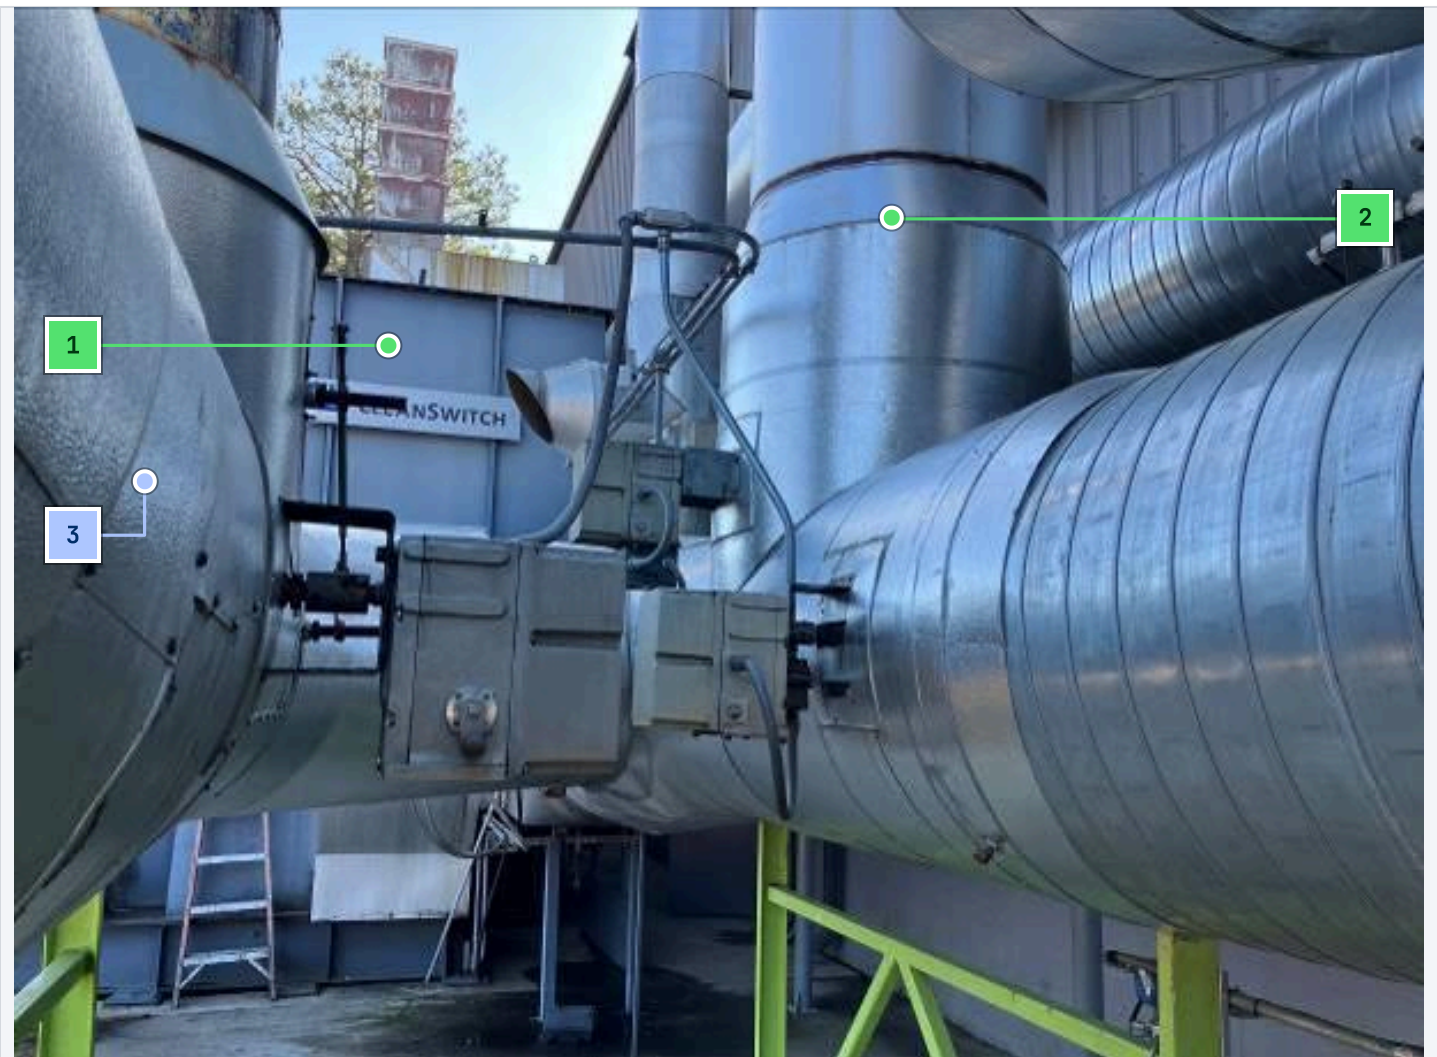
02 Front side view

Damper actuator assembly intact, no leakage

Tee damper ductwork seams sound

Fan housing exterior shows no deformation

Front-side view of the isolation/fresh air damper actuator, tee damper junction, and exhaust fan housing shows sound seams and no actuator leakage or housing deformation. Galvanized ductwork is in serviceable condition.

Trend exhaust fan vibration and damper stroke times at the next PM to confirm continued health.

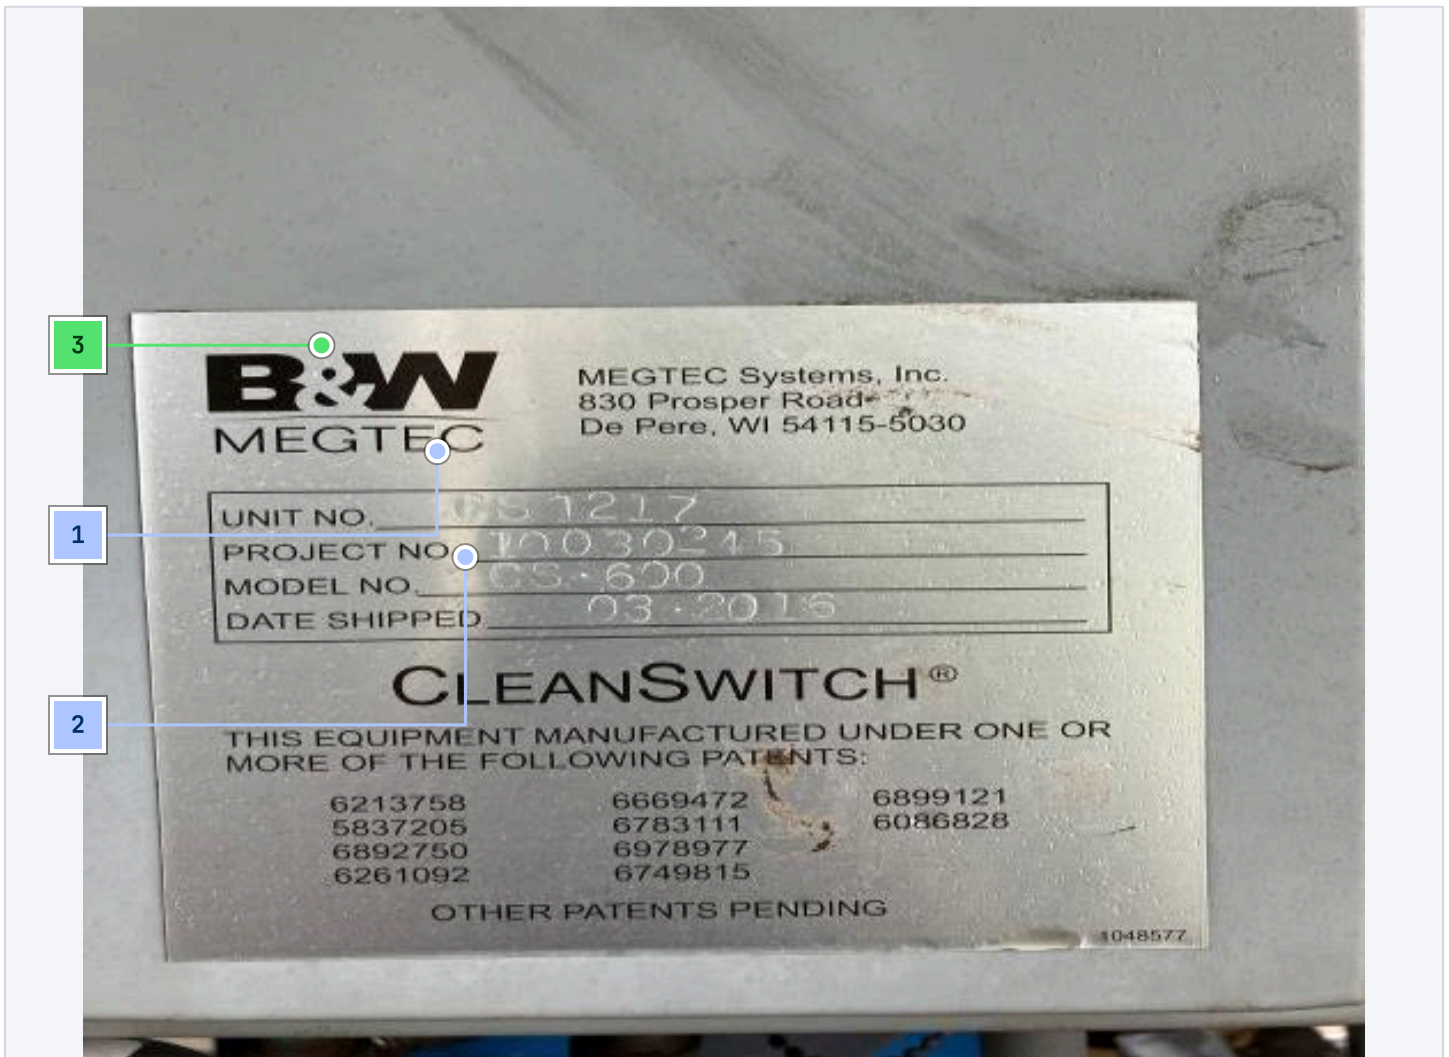
03 Untitled finding

Unit and project numbers documented for traceability

CS-650 model, shipped March 2016

B&W MEGTEC Systems nameplate legible

B&W MEGTEC nameplate is legible: Unit CS1217, Model CS-650, shipped 03/2016. Unit and project numbers recorded for the equipment file.

Log nameplate data in the asset register and link to this walkdown record.

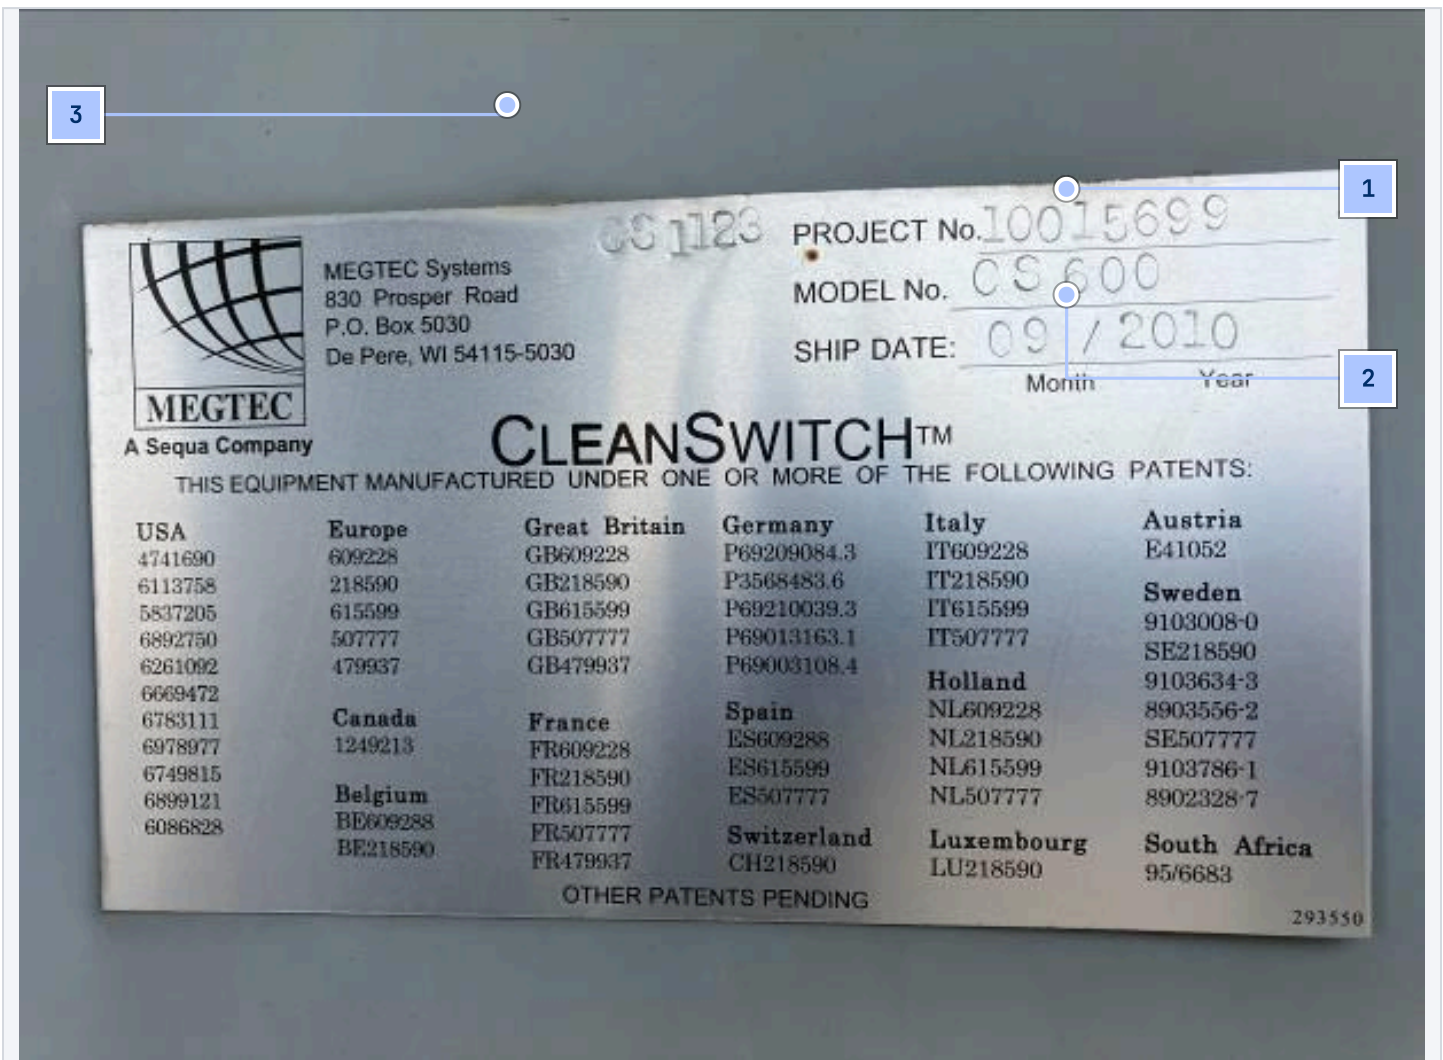
04 Job Tag

Model CS600, Project 10015699 identified

Ship date 09/2010, ~14 year service age

Handwritten unit ID CS1123 noted

Job tag confirms Model CS600, Project 10015699, ship date 09/2010, handwritten unit ID CS1123 — approximately 14 years in service. Electrical and pneumatic safeties tested OK at the time of walkdown.

Plan internal media bed and switching valve inspection at next scheduled outage on CS1123.

Given service age, schedule an internal inspection of media beds, poppet shafts, and switching valve seats at the next planned outage.

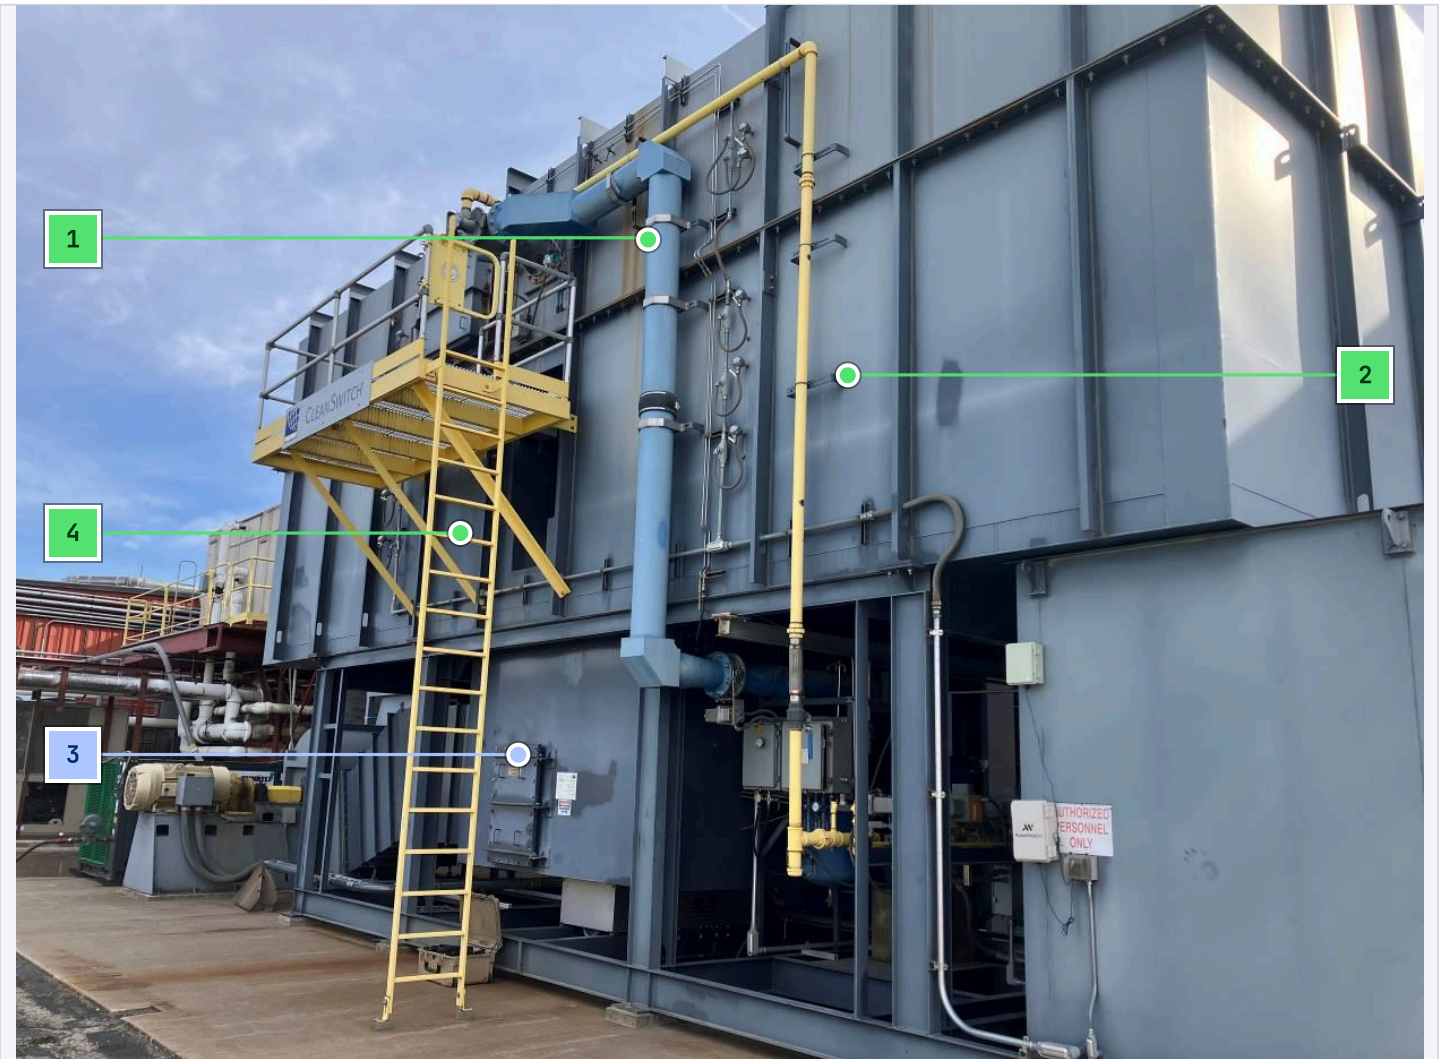
05 Overall picture of unit

- 1 Process Duct Connection**
Main process inlet ductwork intact

- 2 Natural Gas Header**
Burner fuel gas piping run, no leaks visible

- 4 Access Ladder/Platform**
Service platform and ladder appear secure

Internal-inspection-day overview shows the main process inlet duct connection, natural gas header to the burner, Media A access hatch, and service platform/ladder all in sound condition with no visible leaks or structural concerns.

Proceed with planned internal media bed inspection; no external corrective action required.
