EXECUTIVE SUMMARY

Exhaust fan on the MEGTEC CleanSwitch CS-600 (Job 10024557, shipped 02/2014) is exhibiting elevated vibration per technician observation during the walkdown — a leading indicator of bearing wear, impeller imbalance, or loose mounting that will progress to failure if left alone. The remainder of the unit — housing panels, stack, access platform, burner skid, ductwork, and damper bank — is structurally sound with no external defects. Priority next step is to collect vibration spectra on the fan motor and bearings and trend before the next production cycle.

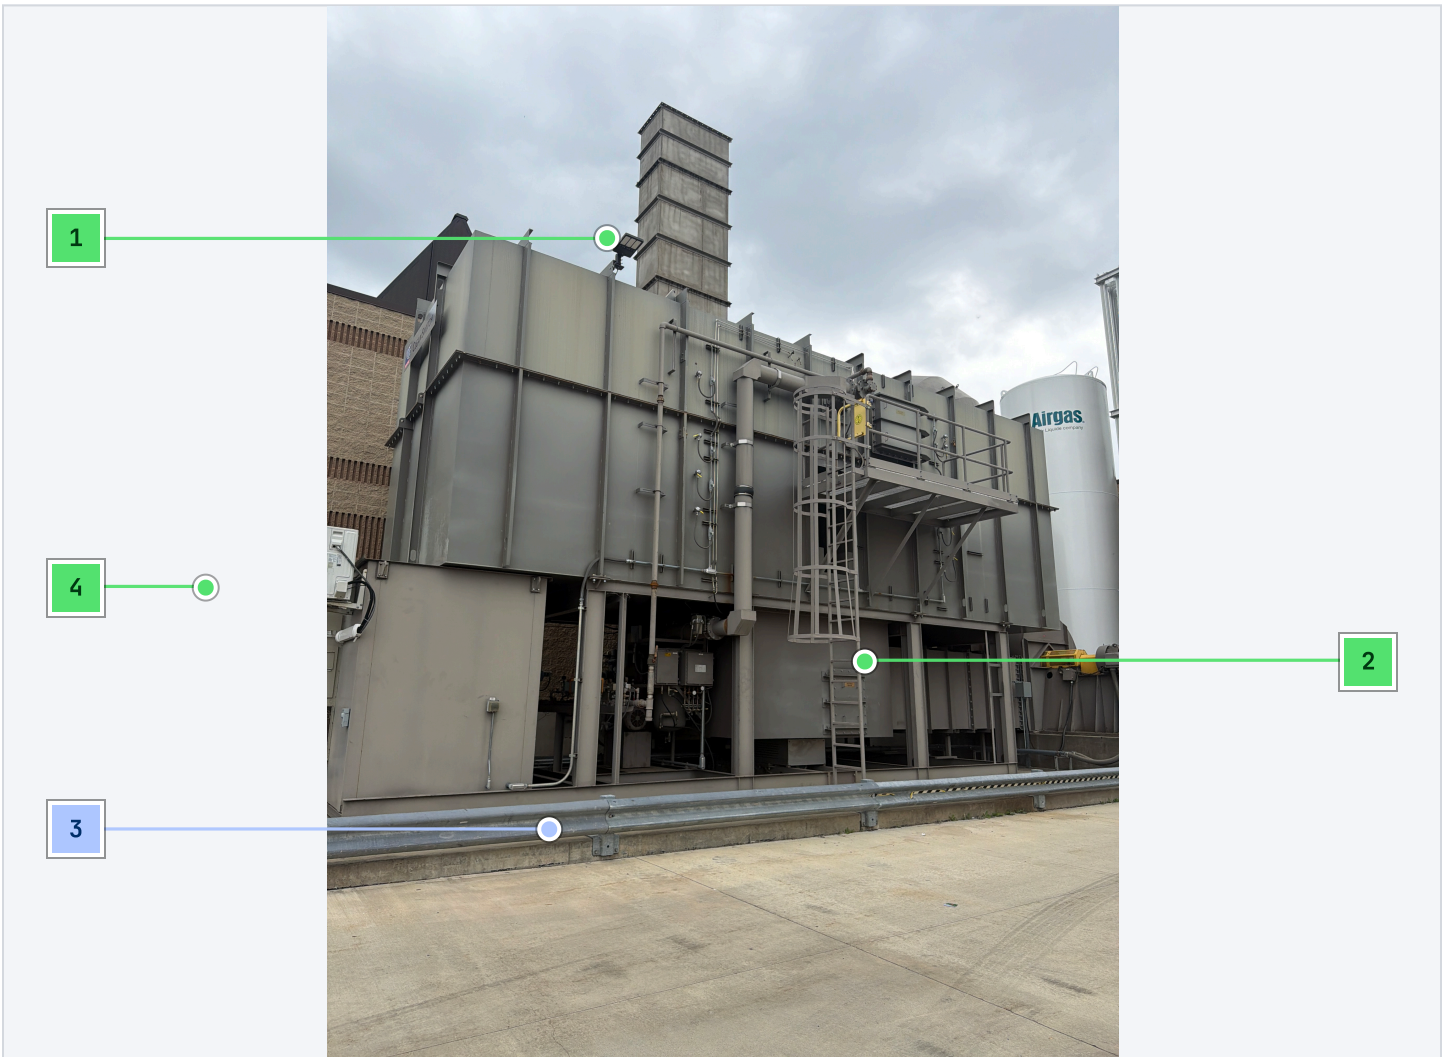
01 Overall exterior view of the Dürr CleanSwitch RTO unit documented during preventive maintenance. Unit appears structurally intact with no visible abnormalities.

Stepped exhaust stack intact, no visible damage

Caged ladder and platform in place

Gas train and piping appear intact

Side panels intact, no corrosion observed

Overall exterior of the CleanSwitch RTO is structurally intact — stepped exhaust stack, side housing panels, caged ladder, and elevated access platform all in serviceable condition with no corrosion, panel deformation, or duct leakage visible. Burner skid piping and gas train at ground level show no obvious leaks or mechanical damage.

No action required beyond routine PM documentation; retain this image as the baseline exterior reference.

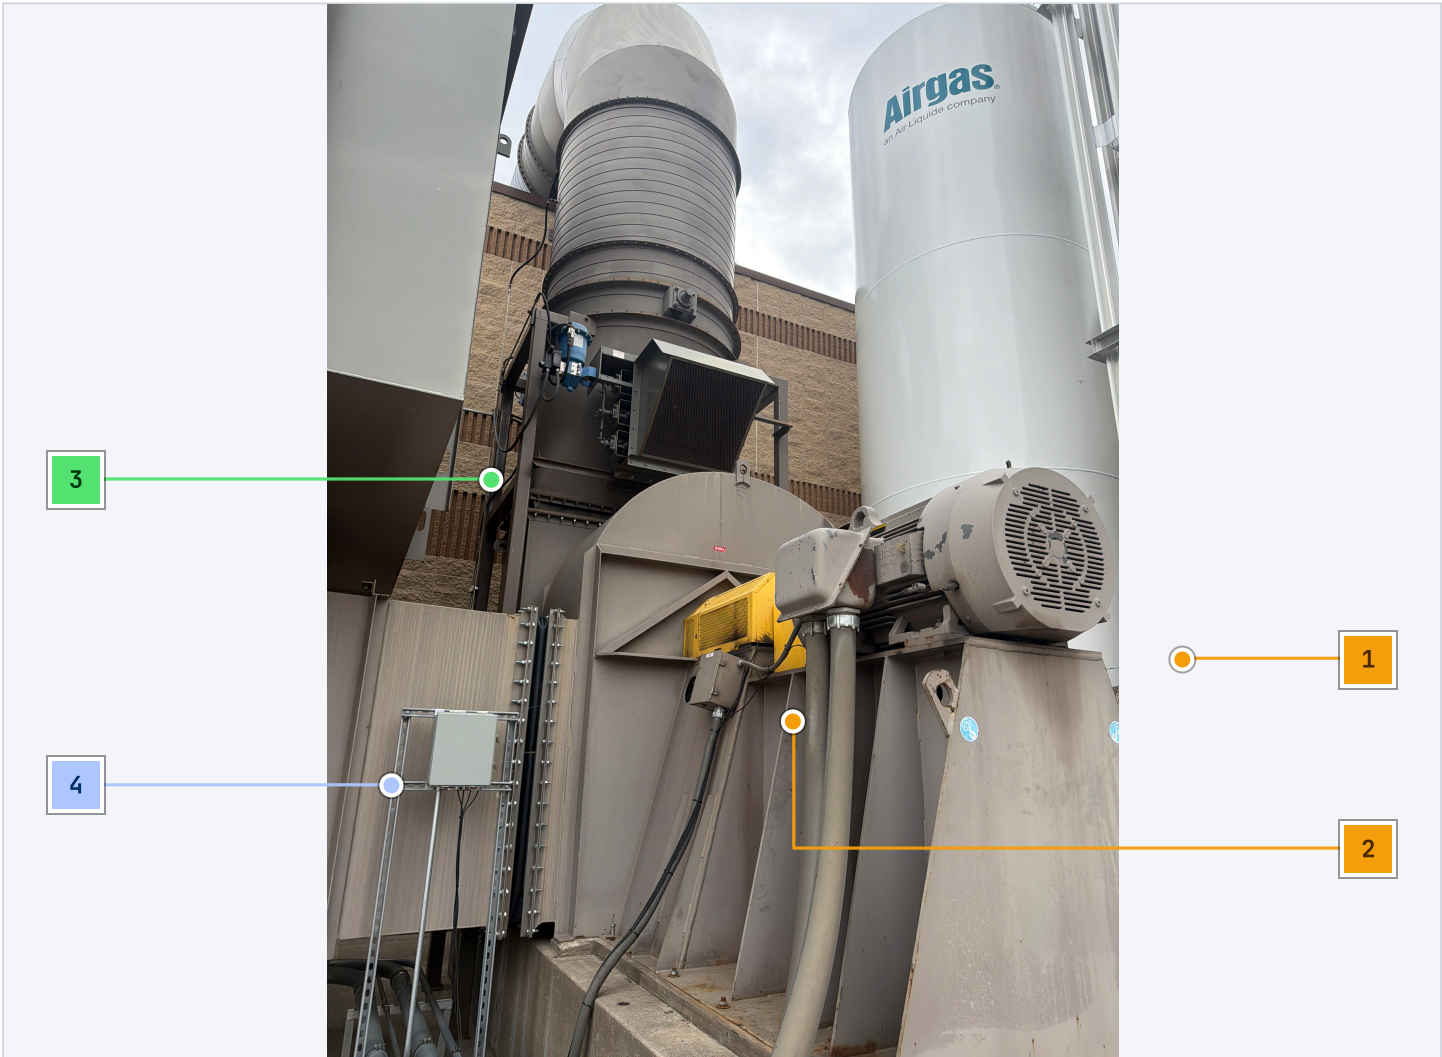
02 Front-side view of Dürr CleanSwitch RTO showing exhaust fan, motor, and damper bank intact; technician reports the exhaust fan was vibrating badly, indicating a developing mechanical issue not externally visible.

Technician reports excessive vibration at fan motor

Fan housing intact, check mounting bolts

Tee damper actuator present and intact

Isolation/fresh-air damper linkage appears intact

Exhaust fan motor, scroll housing, ductwork, and tee damper actuator linkages are all externally intact, but the technician reported pronounced vibration at the fan during operation. That symptom — not visible in the photo — is consistent with bearing degradation, impeller imbalance from process fouling, or loosened mounting hardware, and represents the highest-risk condition observed during this walkdown. Minor paint wear on the motor housing is cosmetic only.

Take vibration readings on exhaust fan motor and bearing housings; capture spectra for trending.

Inspect fan impeller for fouling/imbalance and verify mounting bolt torque and coupling alignment.

Plan exhaust fan bearing replacement and rebalance during next available production window.

Touch up paint wear on fan motor housing to prevent corrosion initiation.

Collect vibration spectra on the fan motor and both bearing housings, then inspect impeller, mounting bolts, and coupling. Schedule corrective work before the condition progresses to a forced outage.

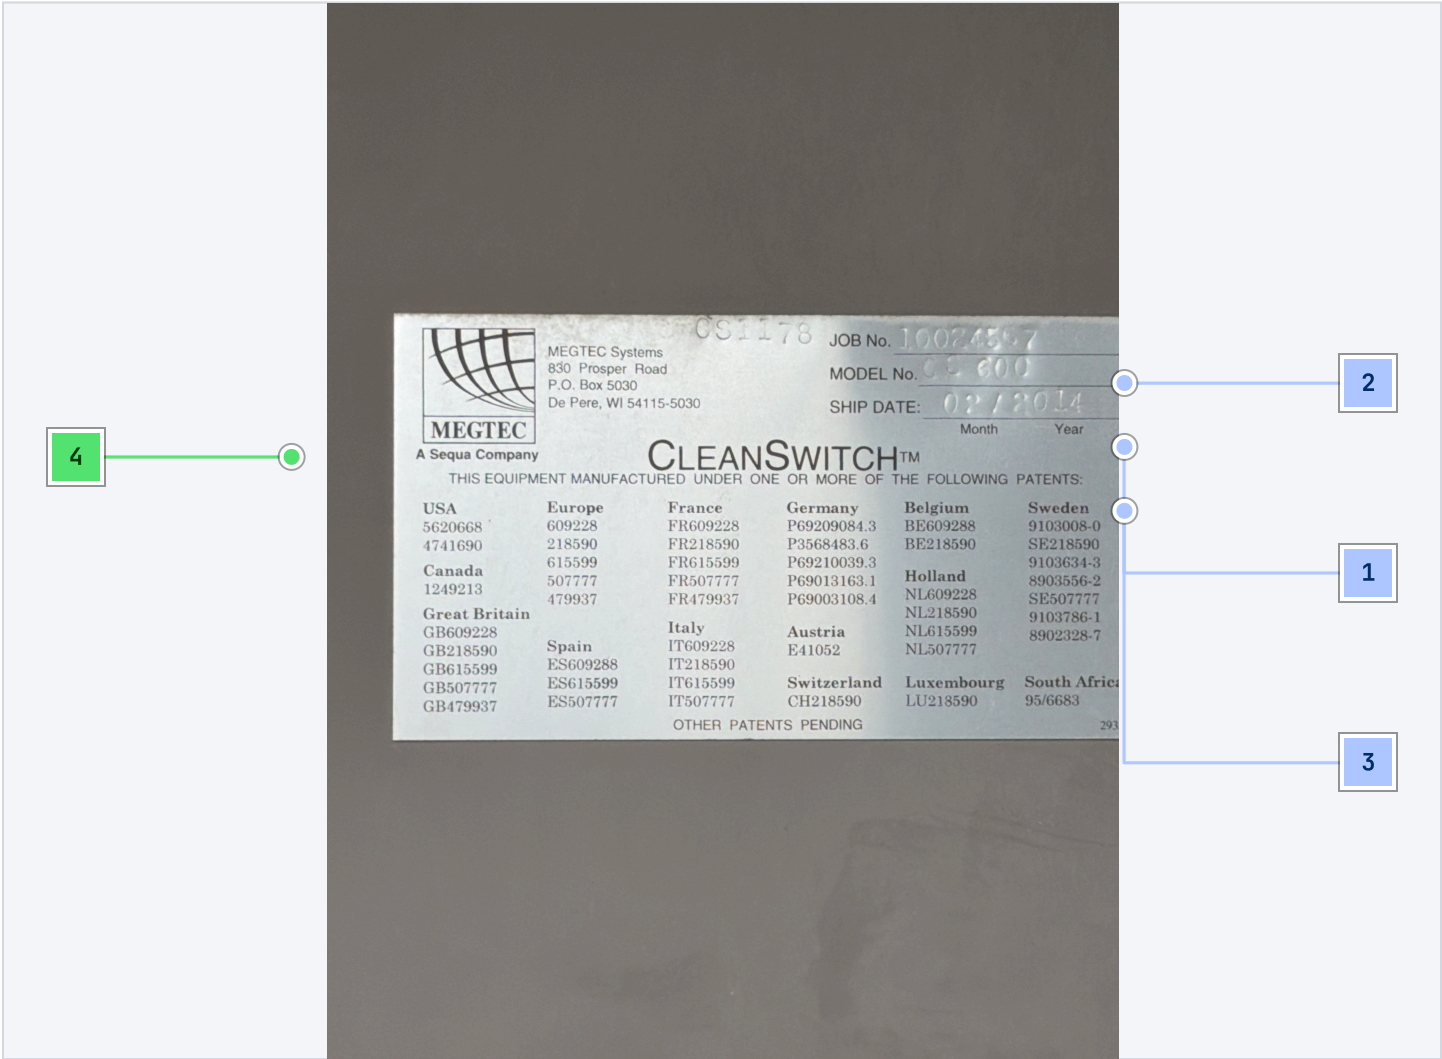
03 MEGTEC CleanSwitch nameplate captured legibly, identifying Model CS - 600 with job number and ship date 02/2014.

Model No. CS-600 stamped on plate

Job No. 10024557 documented

Ship date 02/2014 confirms unit age

MEGTEC Systems CleanSwitch identification plate

Nameplate is legible and undamaged, confirming the unit as a MEGTEC Systems CleanSwitch Model CS-600, Job No. 10024557, ship date 02/2014. This establishes the asset at roughly 12 years in service, which is relevant context for the developing fan vibration finding.

Record CleanSwitch Model CS-600, Job No. 10024557, ship date 02/2014 in CMMS asset record.

Enter model, job number, and ship date into the equipment record and cross-reference with OEM service bulletins applicable to this vintage.
