EXECUTIVE SUMMARY

Walkdown of the Type #1451 asset found no defects requiring intervention. Display, hinge, keyboard deck, trackpad, left-side port bank, and chassis edge all passed visual inspection. Only cosmetic wear was noted: light dust between keycaps and key shine on high-frequency keys (E, R, T, A, S, D). Recommend a routine compressed-air cleaning of the keyboard deck at the next housekeeping cycle; no service action is otherwise warranted.

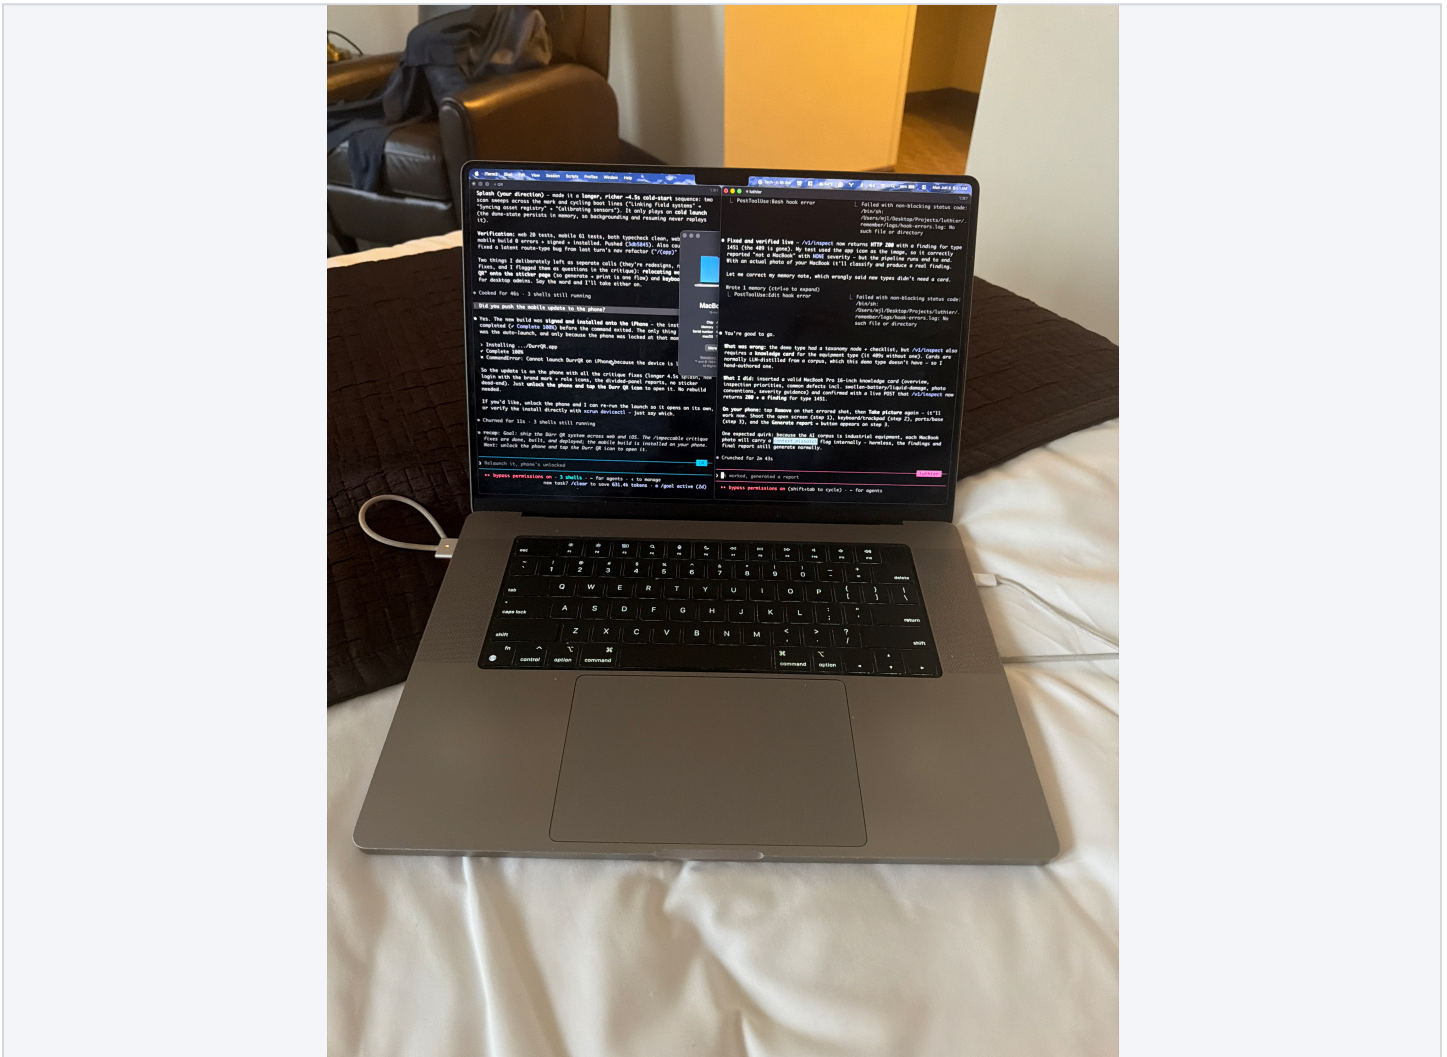
01

Display panel appears intact with no visible cracks, dead pixels, or backlight bleed; lid is open at a stable angle indicating a functional hinge. Technician notes minor scratches flanking the trackpad, which fall outside this checklist item but the screen and lid themselves look clean.

Display panel and lid assembly are in serviceable condition. Screen renders uniformly across both terminal windows with no dead pixels, backlight bleed, or coating delamination, and the hinge holds the lid at roughly 100 degrees without sag. Lid bezel and chassis edges are free of dents or deep scratches.

No action required on display or hinge. Capture the trackpad -area scratches noted by the technician under the keyboard-deck checklist for completeness.

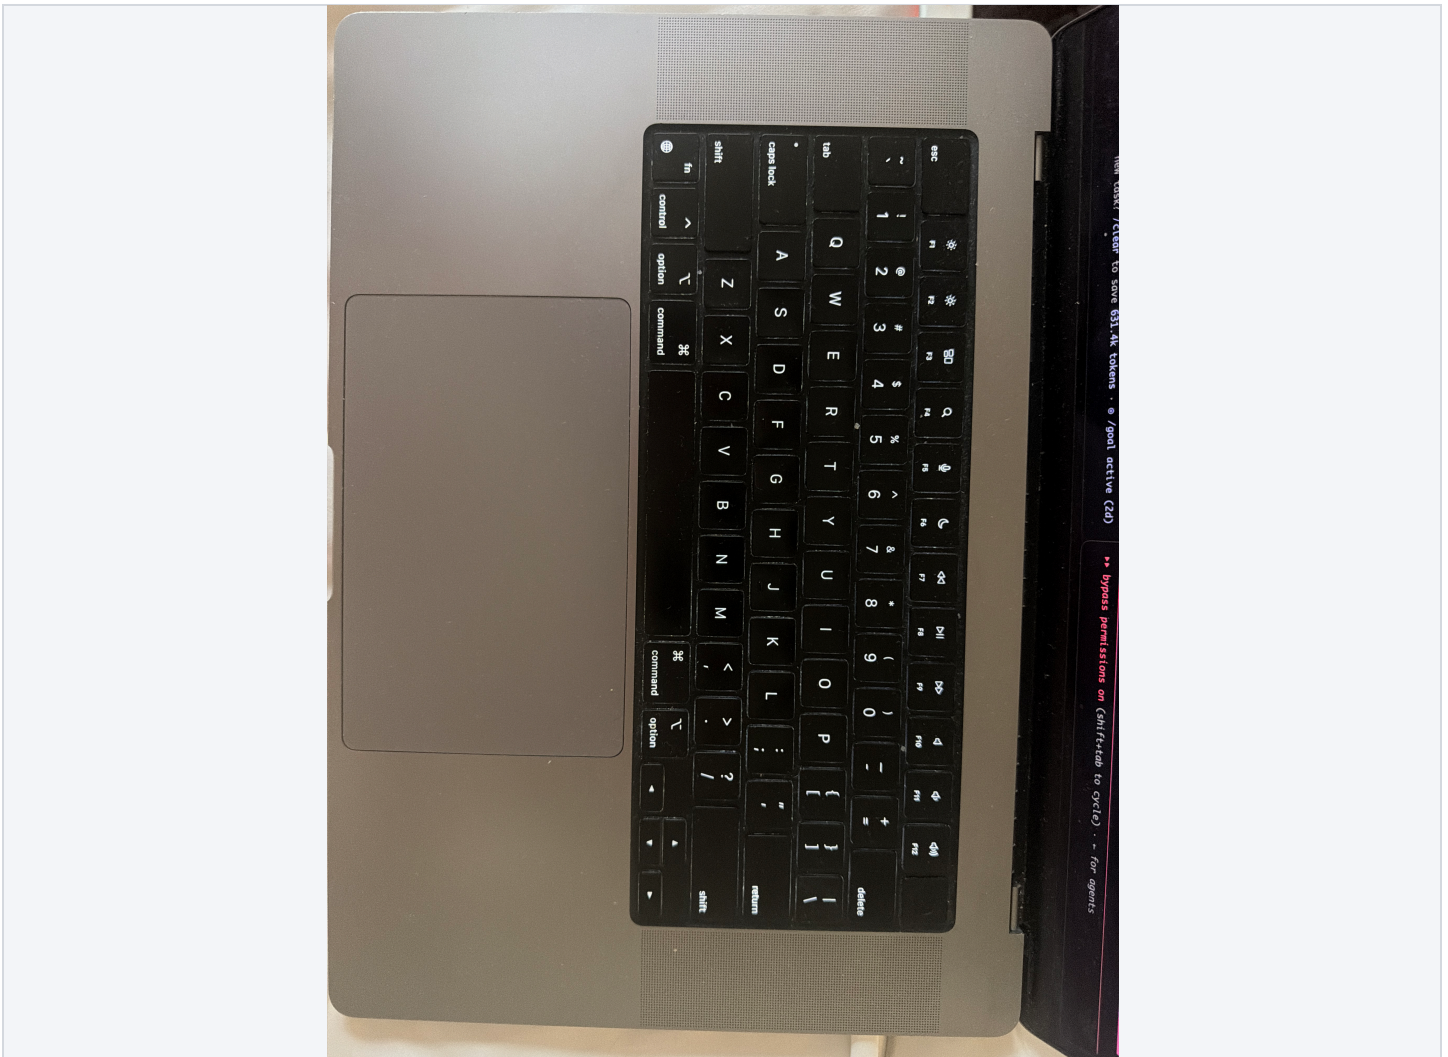
02 MacBook Pro 16 - inch keyboard deck shows all keys present with light dust and visible key shine on high - use keys; trackpad appears flat and deck shows no signs of swelling or liquid damage.

Keyboard deck is fully populated with all keycaps intact and the trackpad sitting flush — no bulging that would indicate battery swell, and no liquid staining or corrosion on the palm rest. Cosmetic wear is present: light dust and debris between keycaps and visible key shine on the high-use E, R, T, A, S, D cluster, consistent with normal duty cycle.

Clean the deck with compressed air at the next housekeeping window. No mechanical service required; trend key - shine progression at the next inspection.

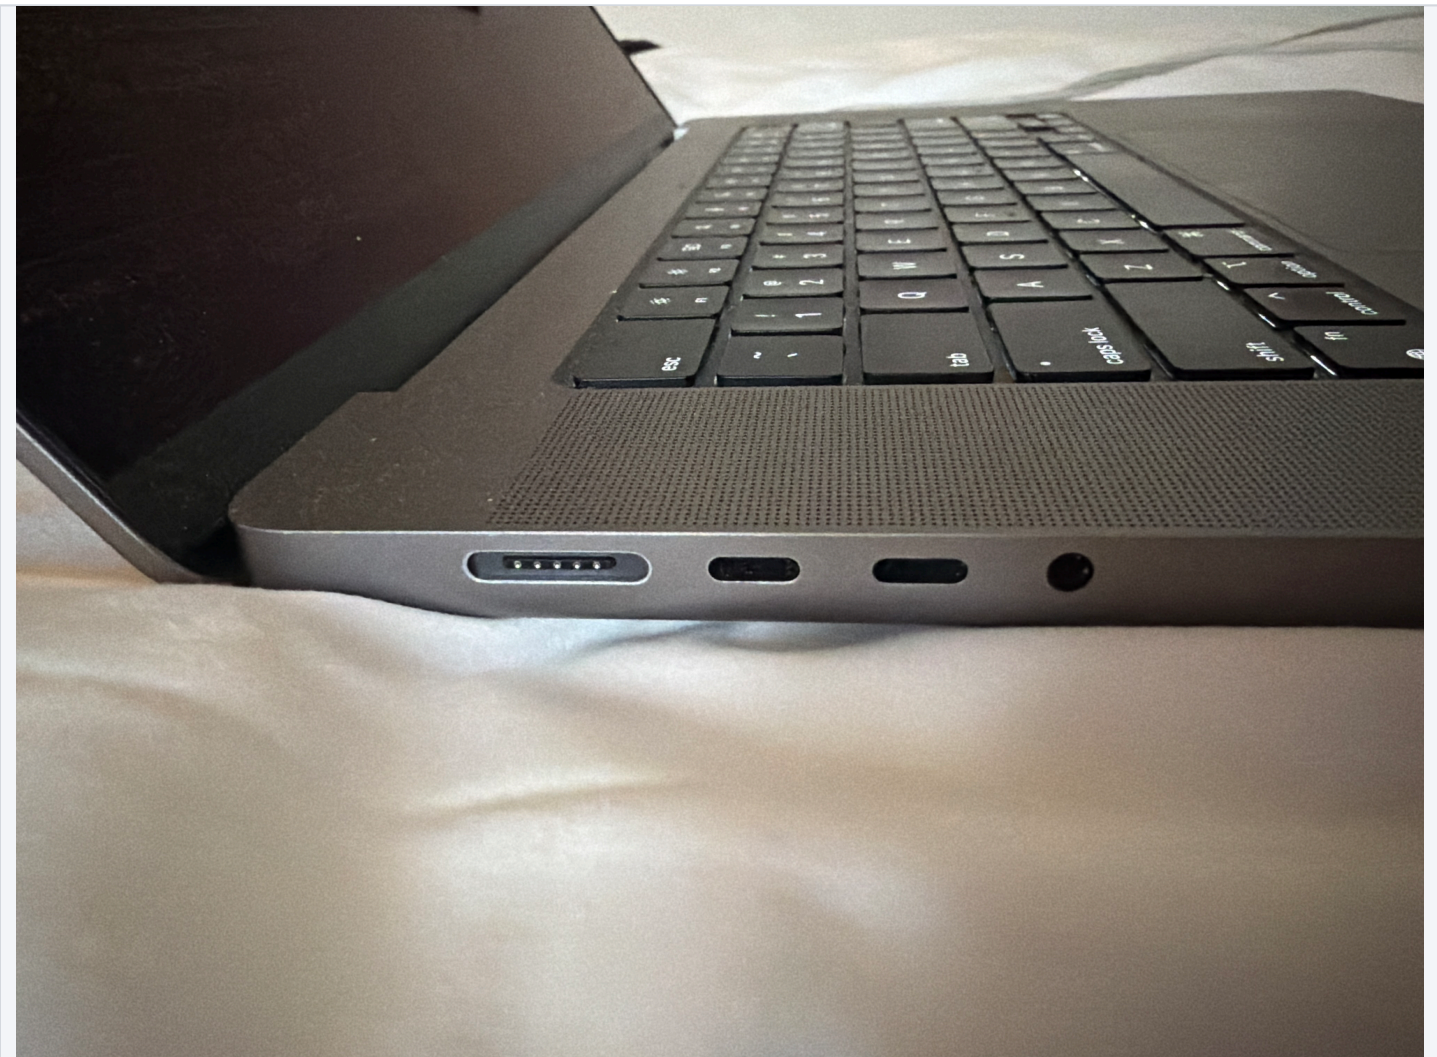
03 Left-side ports and chassis edge appear clean and undamaged. MagSafe, two USB-C/Thunderbolt, and headphone jack show no visible debris, corrosion, or bent contacts; chassis edge is straight with no warping.

Left-side port bank and chassis edge pass inspection. MagSafe contact pads, both USB-C/Thunderbolt openings, and the headphone jack are clean with no debris, bent shielding, or corrosion, and the base seam runs straight with no warping. Speaker grille shows only light surface dust, no clogging.

No action required on ports or chassis edge. Include the speaker grille in the next routine wipe-down.
