EXECUTIVE SUMMARY

MacBook Pro 16-inch walkdown found the unit in fully serviceable condition with no functional defects. Display, keyboard, trackpad, hinge, left-side ports, and speaker grille all pass visual inspection. Only cosmetic items noted: light dust on the deck and keys, and minor scratches on the palm rest flanking the trackpad. Recommend a routine surface cleaning at the user's convenience; no service intervention required.

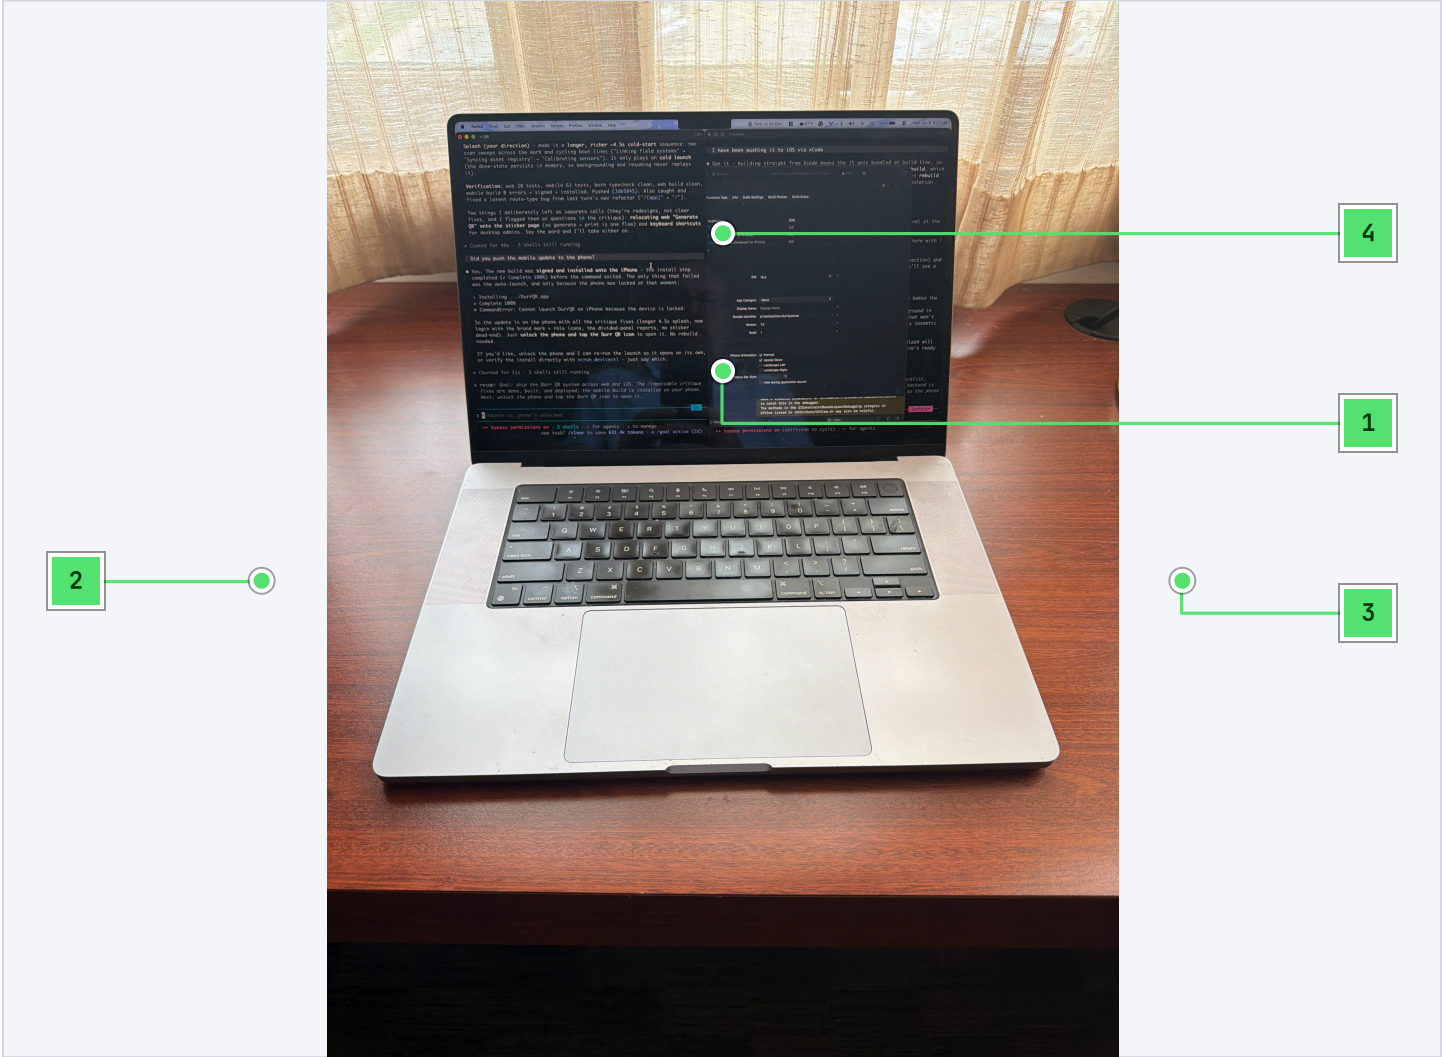
01

Display panel appears intact and powered on with no visible cracks, dead pixels, or coating delamination. Lid is open and holding position normally.

1 Display Active

Panel renders text cleanly, no cracks visible

2 Left Bezel Edge

No backlight bleed along left edge

3 Right Bezel Edge

Even bezel gap, no coating lift

4 Top Menu Bar

Menu bar pixels uniform, no dead row

Display panel is powered and rendering terminal and IDE content uniformly across the full active area, with no cracks, dead rows, or backlight bleed along either bezel edge. The hinge is holding the lid open at a stable angle without sag, and no anti-reflective coating delamination (staingate) is visible on the inspected surface.

No action required. Continue normal use and revisit at the next scheduled inspection.

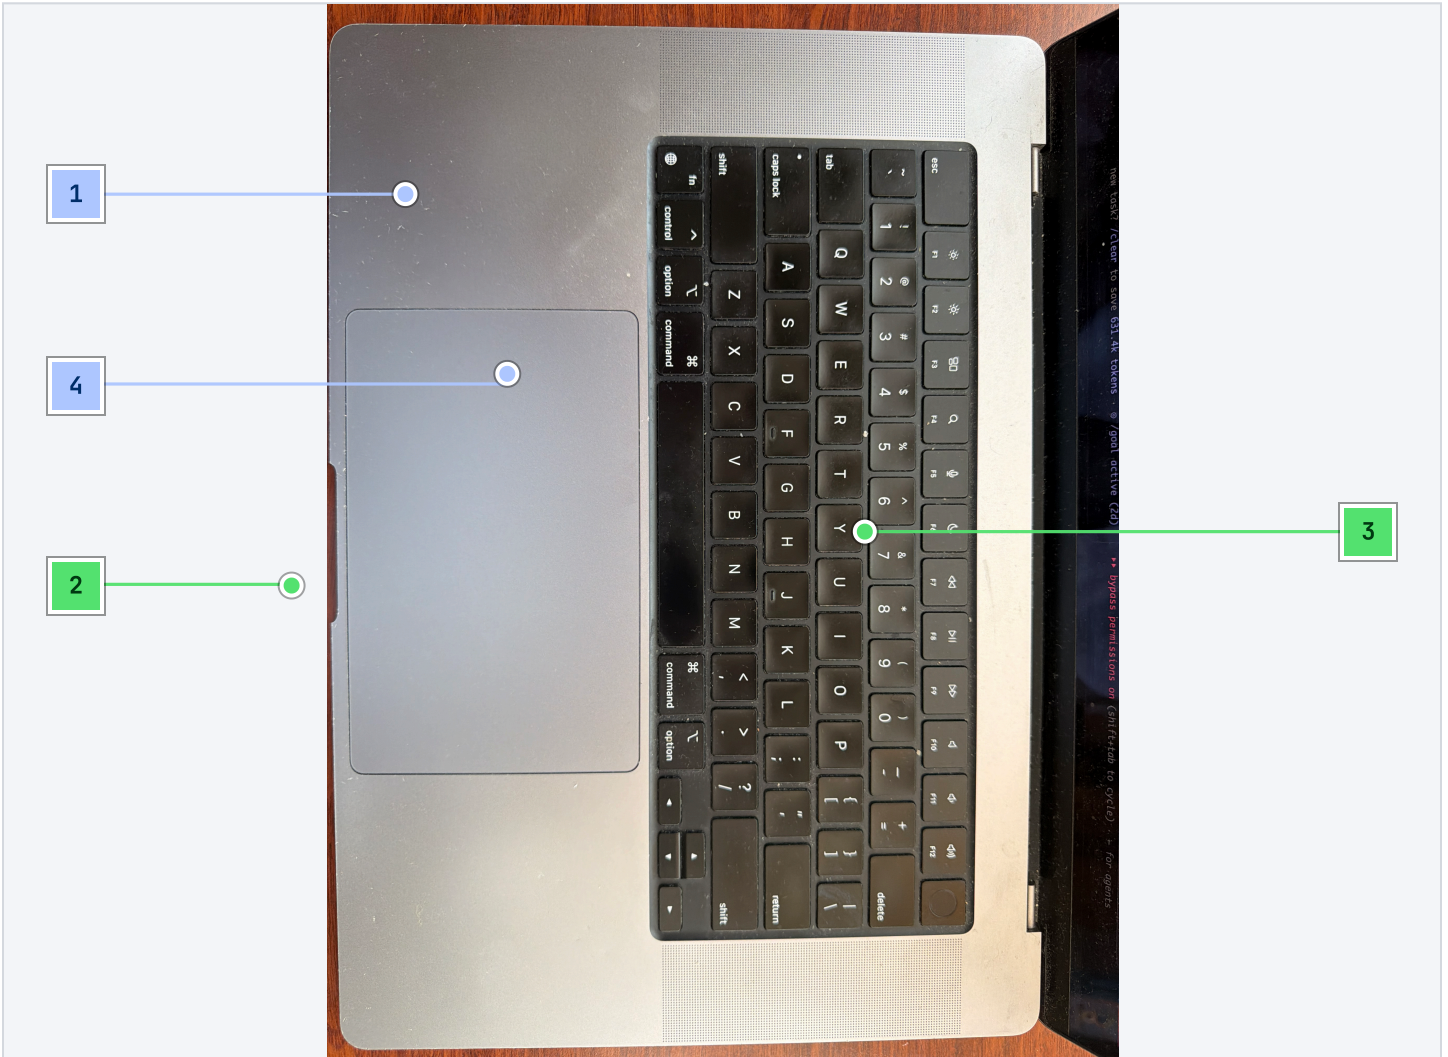
02

MacBook Pro 16-inch keyboard deck and trackpad appear intact with all keys present and a flat trackpad. Minor cosmetic scratches are visible on the deck adjacent to the trackpad, along with light dust on keys and palm rest.

1 Deck Scratches

Minor cosmetic scratches on palm rest near trackpad

2 Trackpad Flat

Trackpad flush with deck, no swelling lift

3 Keycaps Intact

All keys present, no shine or stickiness

4 Surface Dust

Light dust on keys and deck

All keycaps are present and seated flat, and the trackpad sits flush with the deck — no lift or bulge that would indicate battery swelling underneath. Light dust is present across the keys and palm rest, and minor cosmetic scratches are visible on the deck on both sides of the trackpad; neither affects function.

Wipe keyboard deck, keys, and display with approved microfiber cloth to remove dust.

Log palm rest scratches as cosmetic baseline; no repair action.

Re-verify trackpad remains flush at next inspection to rule out battery swelling.

Wipe the deck and keys with a microfiber cloth. Record the palm rest scratches as cosmetic baseline and recheck trackpad flushness at the next inspection.

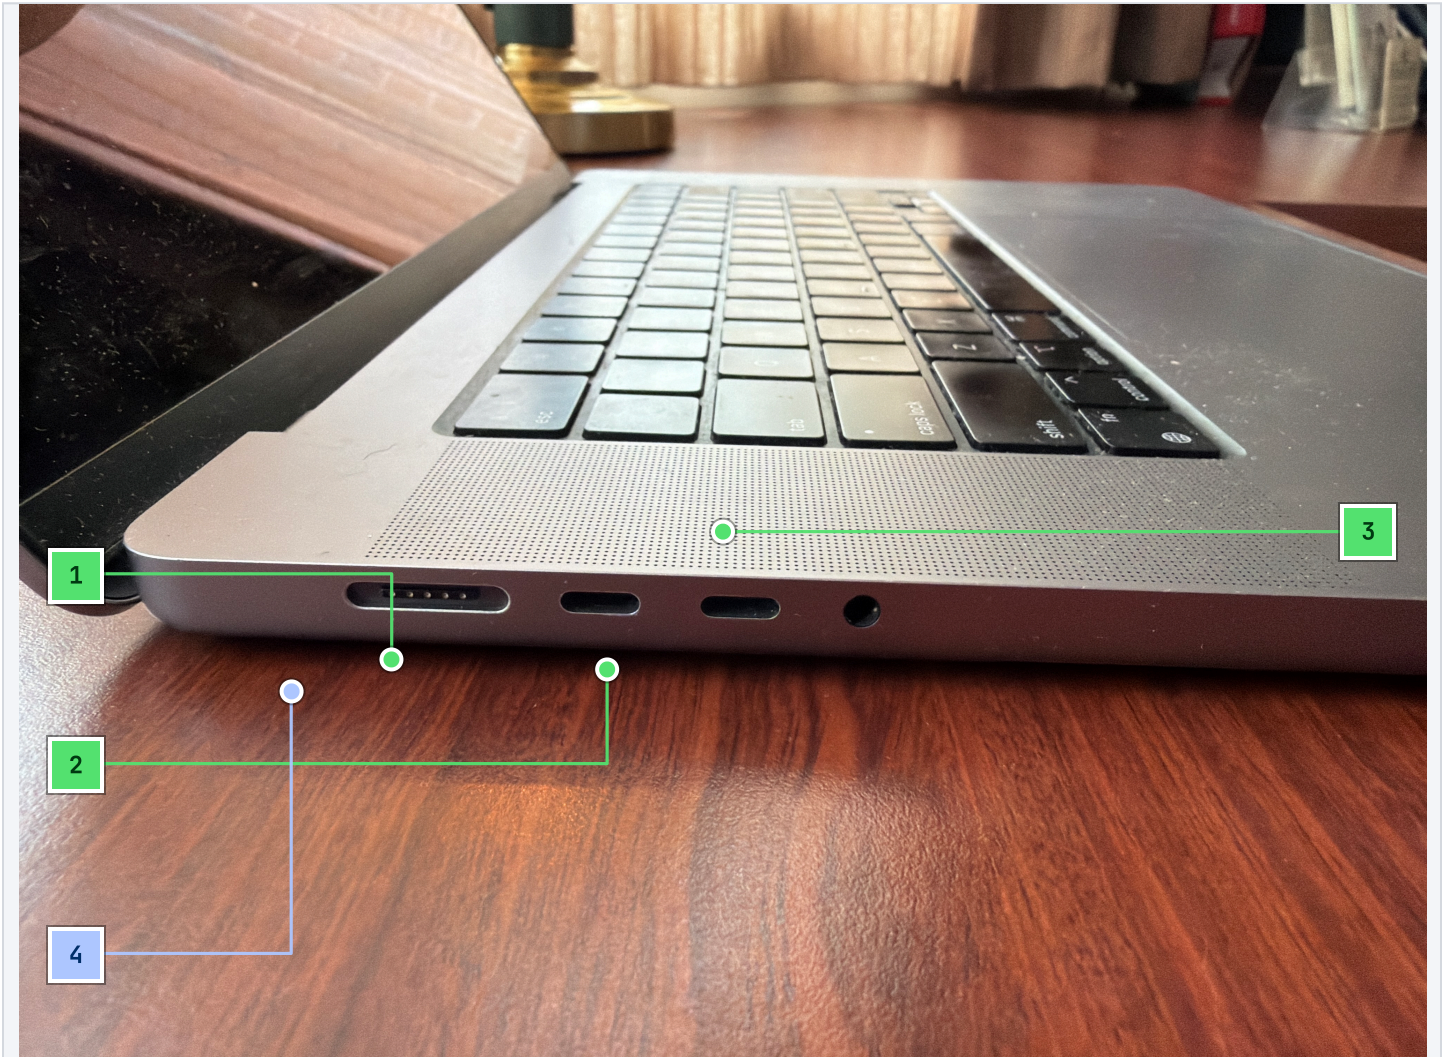
03

Left-side ports (MagSafe, two USB-C/Thunderbolt, headphone jack) and speaker grille appear intact with no visible bent pins, corrosion, or debris. Light dust is visible on the display and keyboard deck, but the chassis sits flat on the table.

1 MagSafe Port

Contacts clean, no corrosion or bending

2 USB-C Ports

Both Thunderbolt ports clear of debris

3 Speaker Grille

Perforations intact, no dust packing visible

4 Chassis Edge

Base seated flat, no warping observed

The left-side I/O cluster — MagSafe, both USB-C/Thunderbolt ports, and the headphone jack — shows clean contacts with no bent pins, corrosion, or debris packing. The speaker grille perforations are intact and unobstructed, and the chassis base is seated flat against the table with no warping at the edge.

Confirm MagSafe and Thunderbolt ports remain debris-free during routine checks.

No action required on ports or chassis. Include a light dust wipe of the surrounding deck during the cleaning pass already scheduled.
